# 360° Car Inspection Report

Professional Vehicle Assessment

Report ID: 46b59250

Date: 2026-08-27

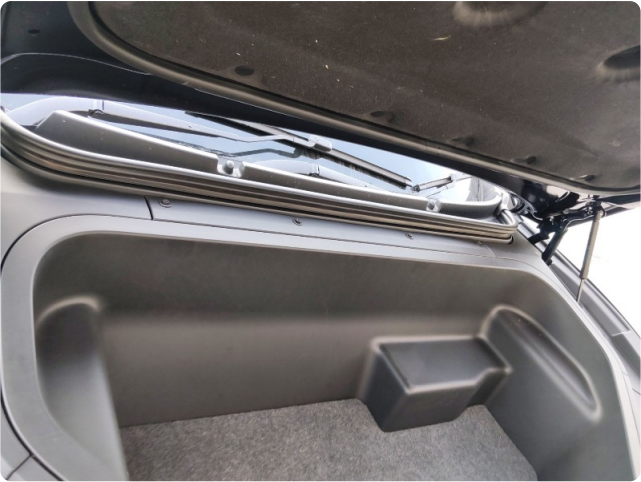
fire wall

Good

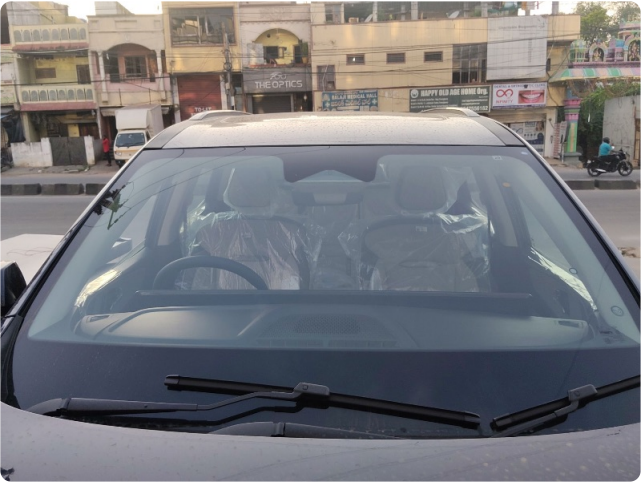
windshield

Good

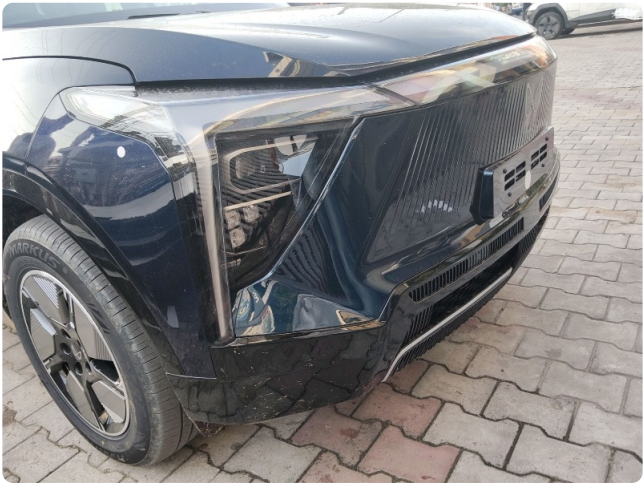
front bumper

Good

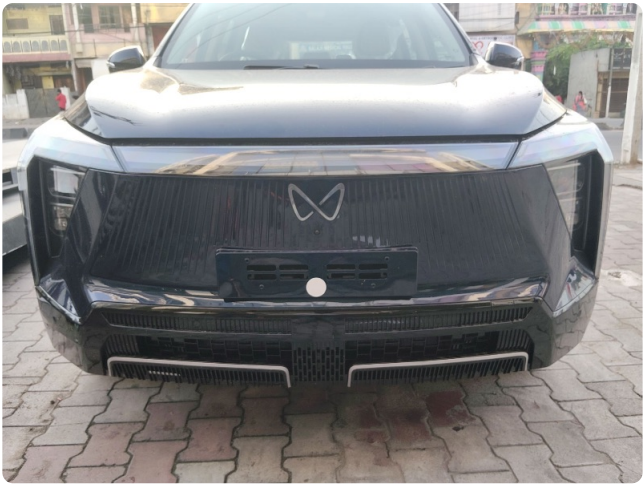
front grille

Good

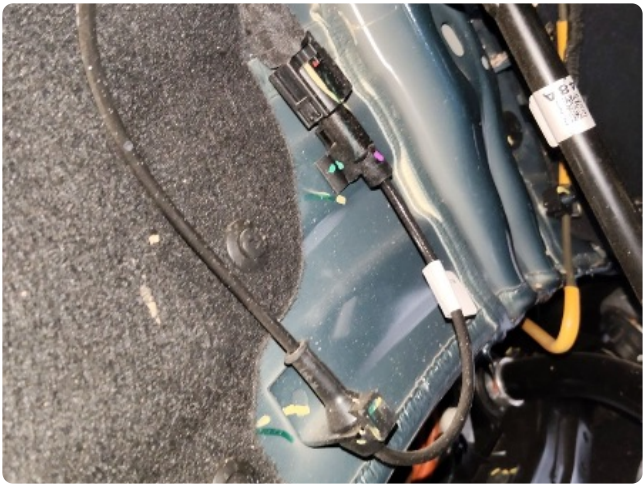
lh leg member

Good

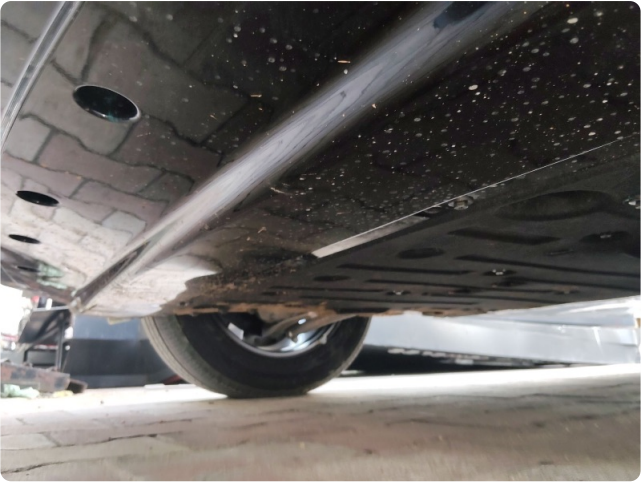
lower cross member

Good

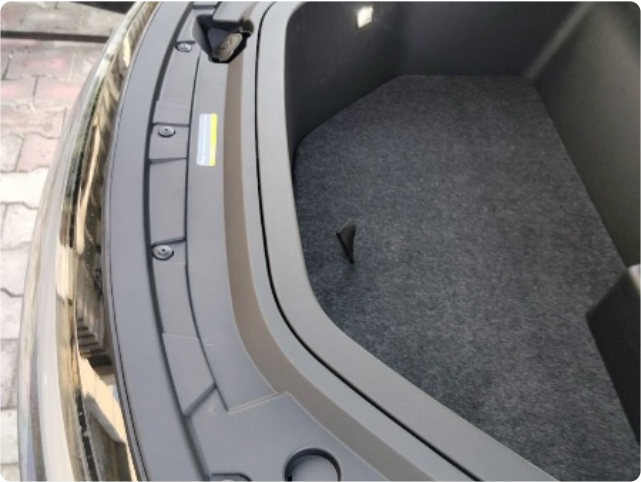
upper cross member

Good

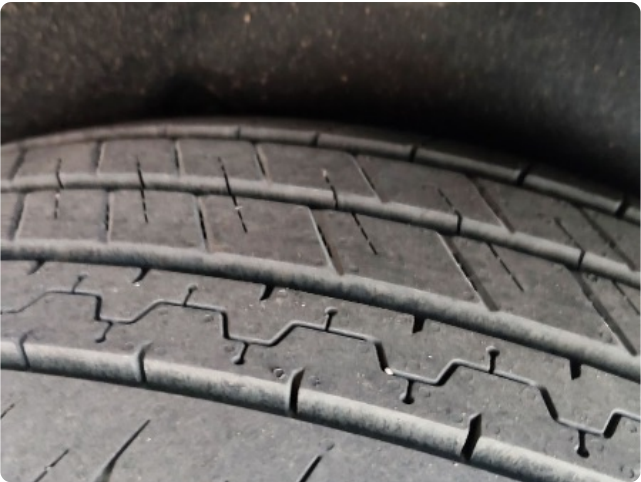
rear tyre

80%-100%

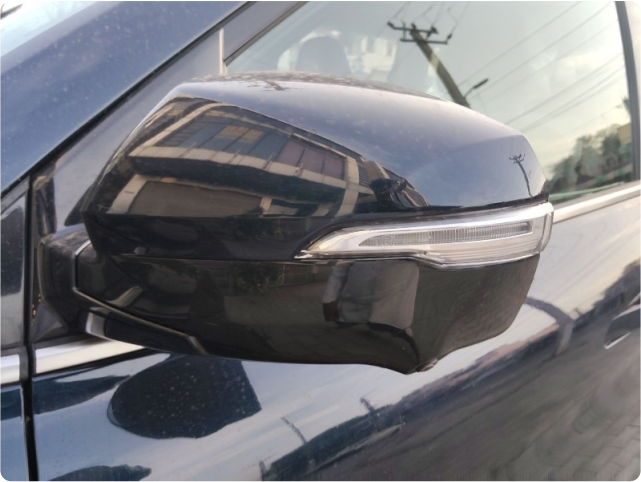
orvm mirror

Good

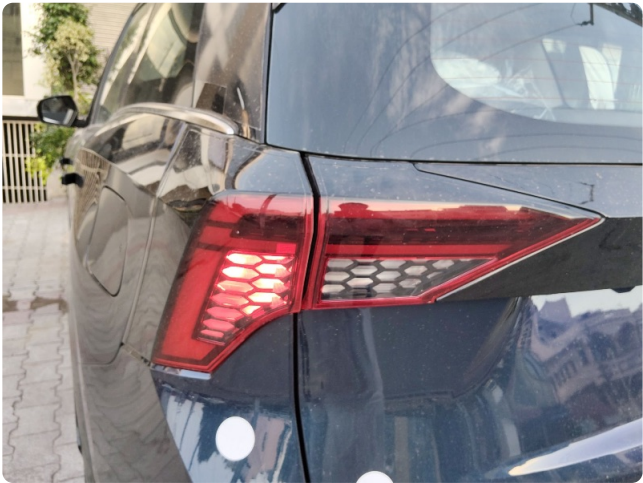
tail light lh

Good

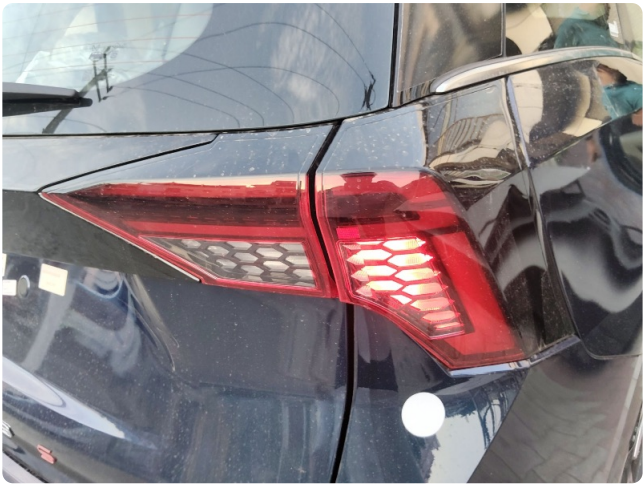
tail light rh

Good

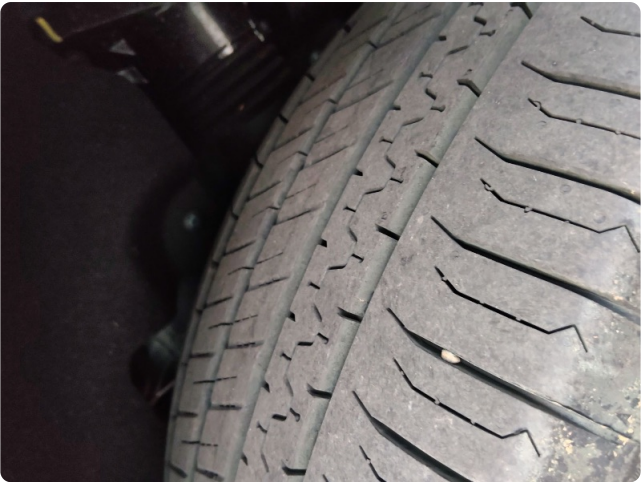
rear tyre

80%-100%

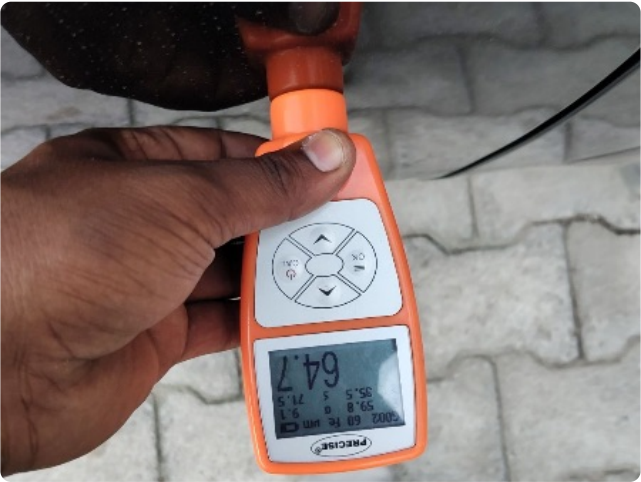
front door

Good

Front rh door panel gap

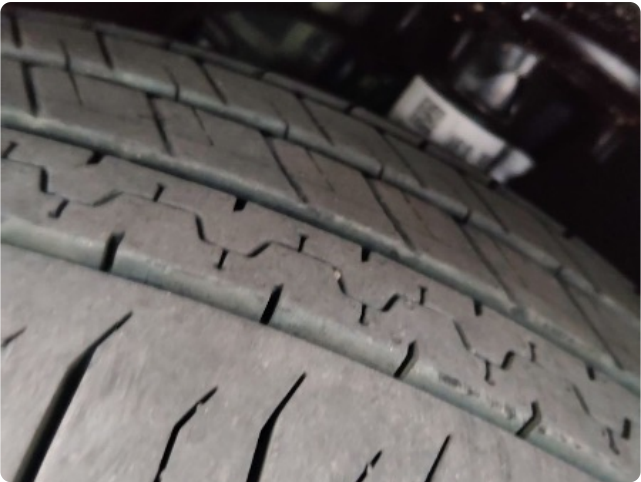
front tyre

80%-100%

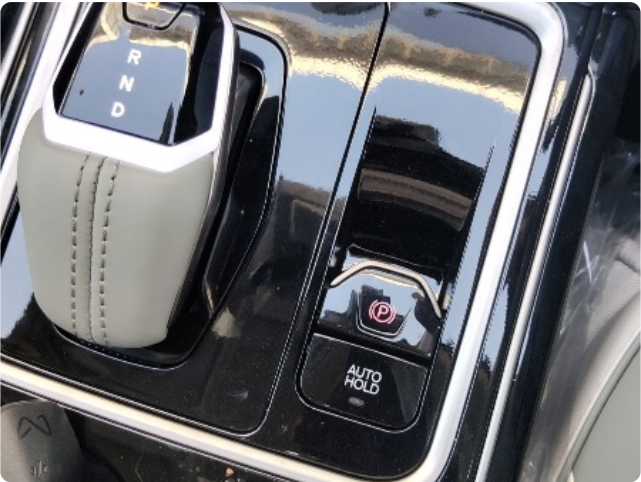
handbrake

Working

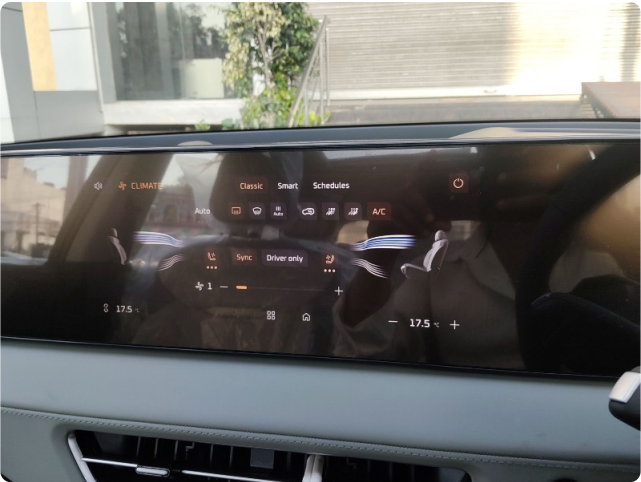
infotainment

Working

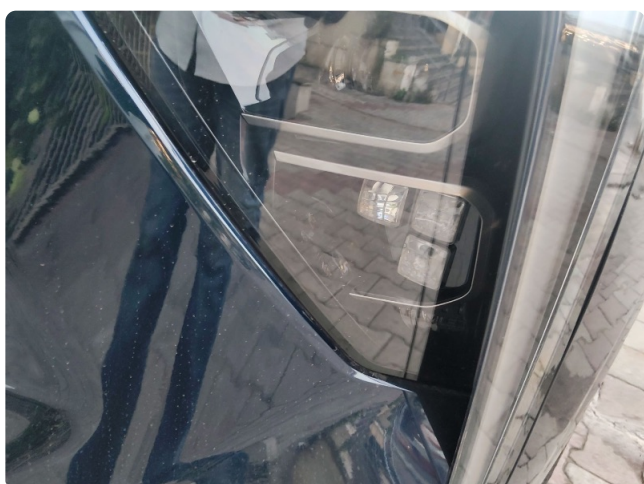
lh fog lamp

| Component | Condition | Status |
|---|---|---|
| Lh Fog Lamp | Good | ● |

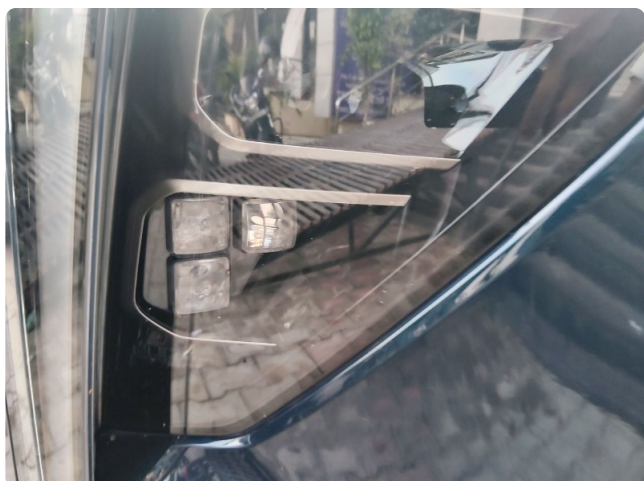
rh fog lamp

Good
