360° Car Inspection Report

Professional Vehicle Assessment

Report ID: 5b770c1b

Date: 2026-04-17

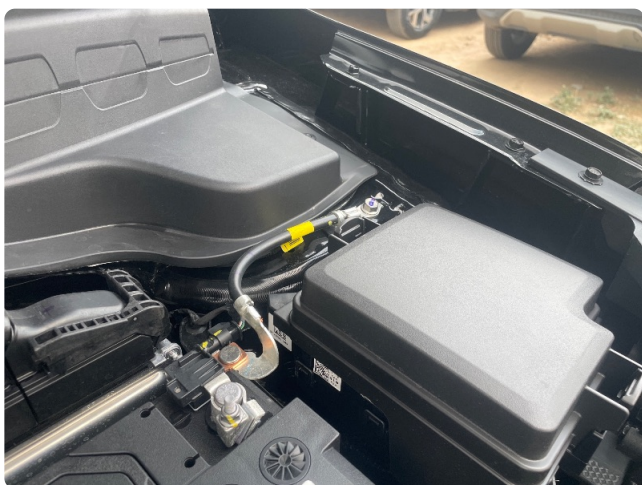
lh apron

| Component | Condition | Status |
|---|---|---|
| Lh Apron | Good | ● |

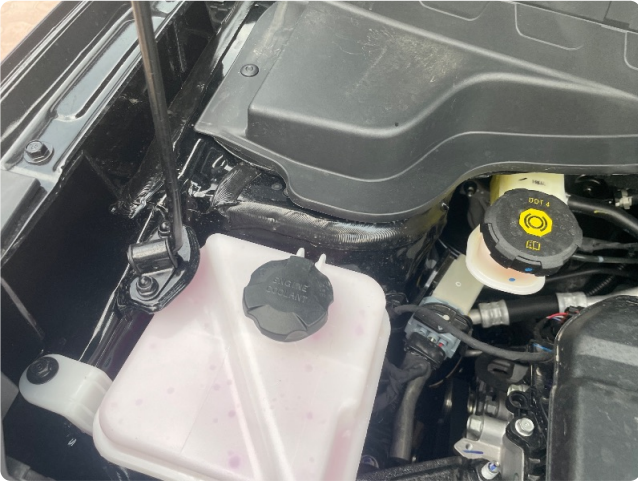
rh apron

Rh Apron

Good

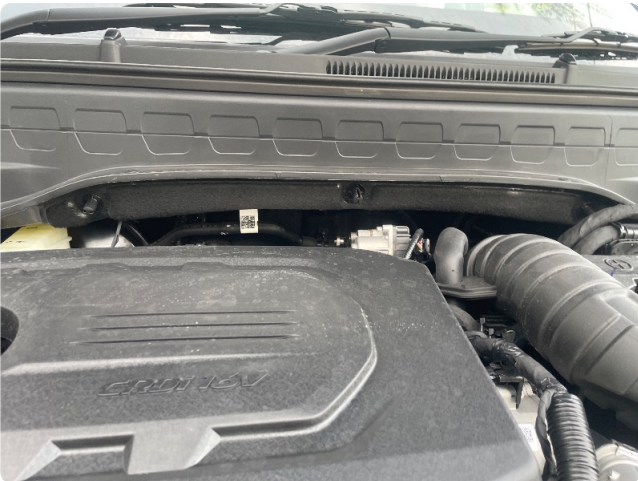
fire wall

Fire Wall

Good

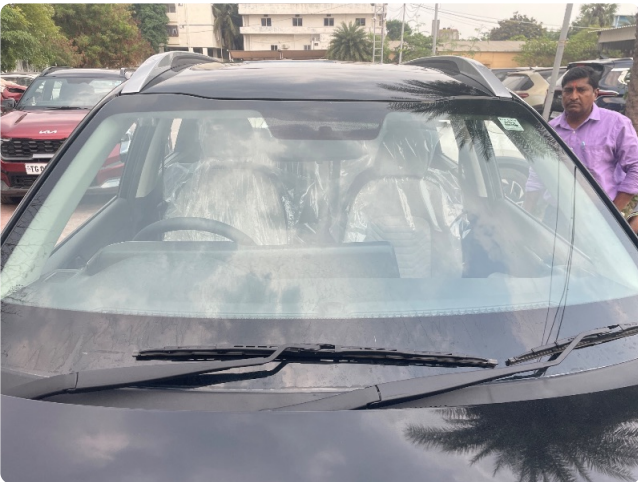
windshield

Windshield

Good

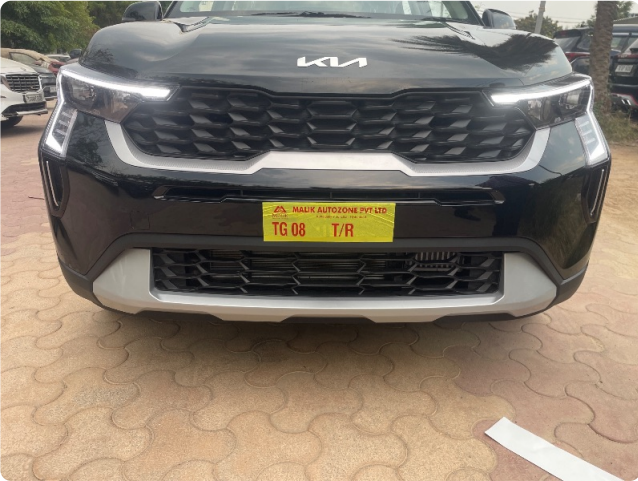
front bumper

Front Bumper

Good

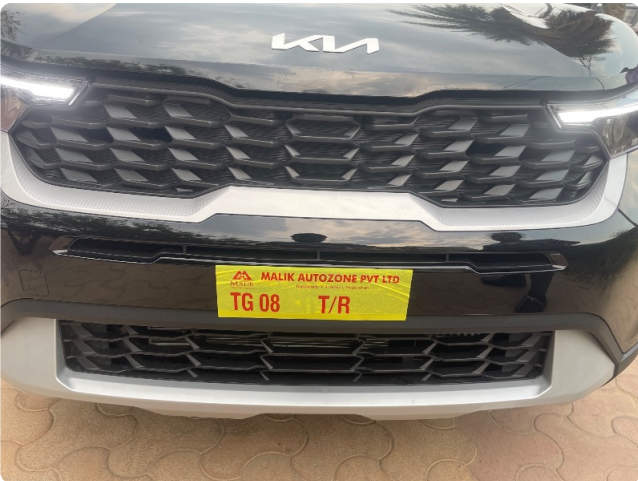
front grille

Front Grille

Good

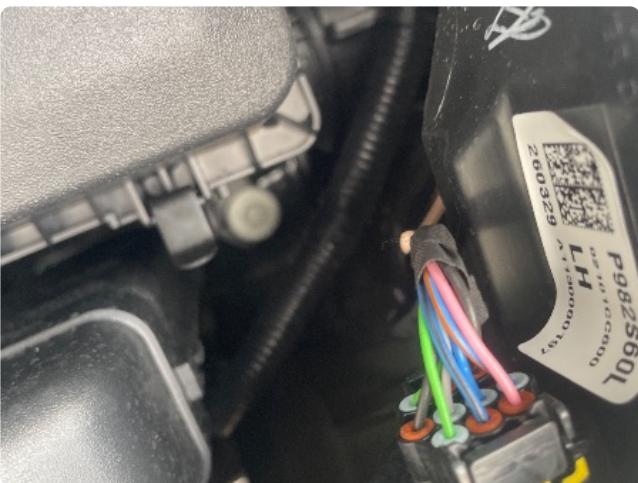
lh leg member

Lh Leg Member

Good

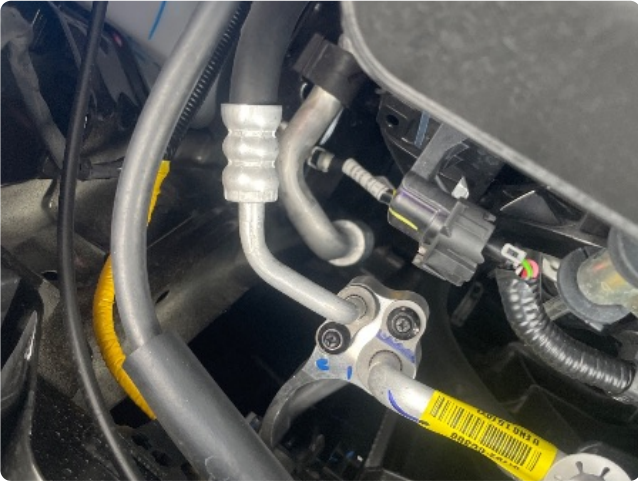
rh leg member

Rh Leg Member

Good

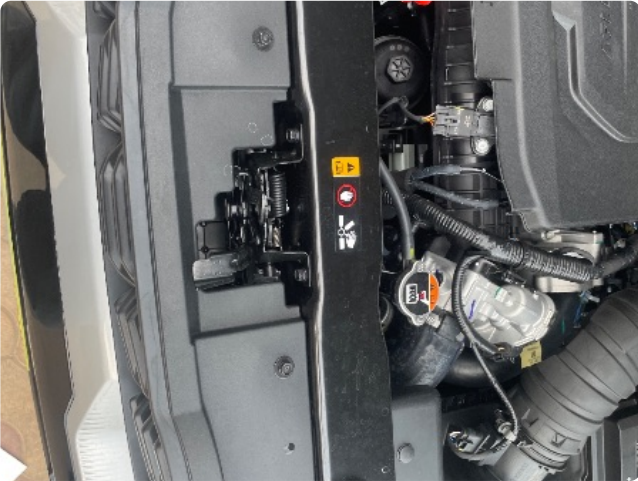
upper cross member

Upper Cross Member

Good

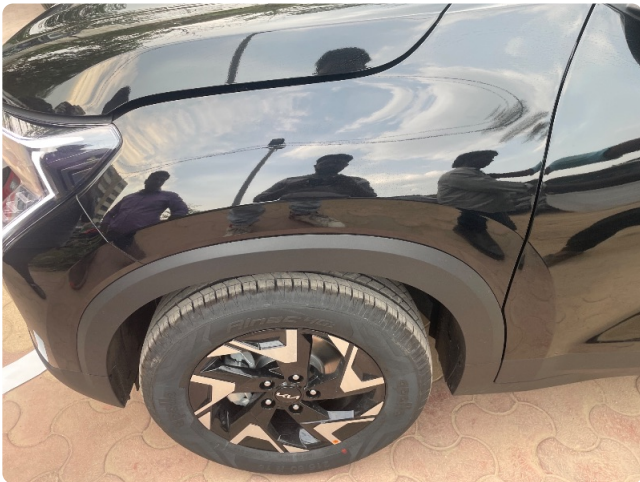
fender

| Component | Condition | Status |
|---|---|---|
| Fender | Good | ● |

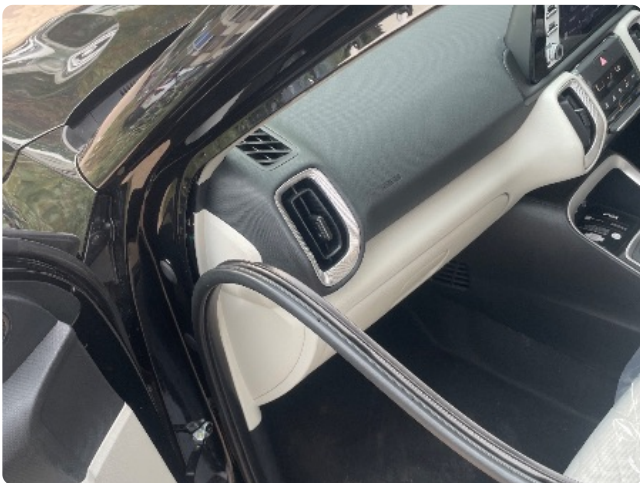
a pillar

| A Pillar | Good | ● |

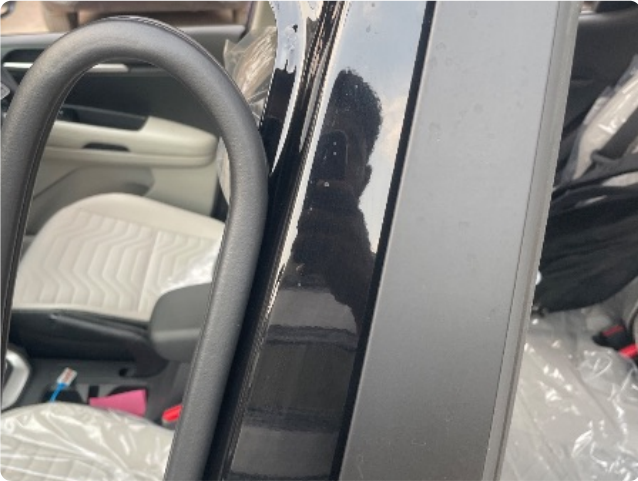
b pillar

B Pillar

Good

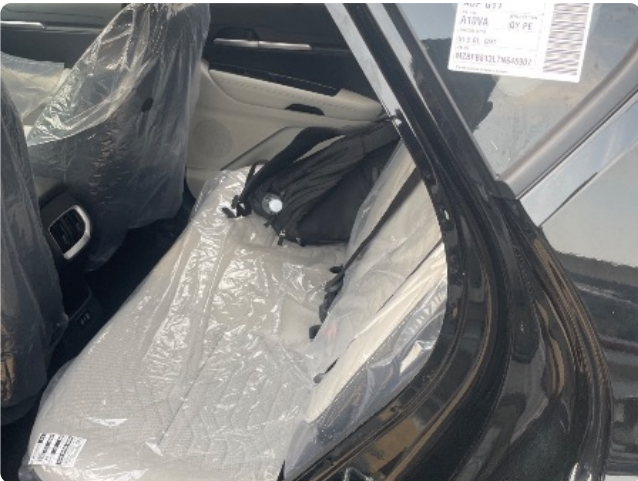
c pillar

C Pillar

Good

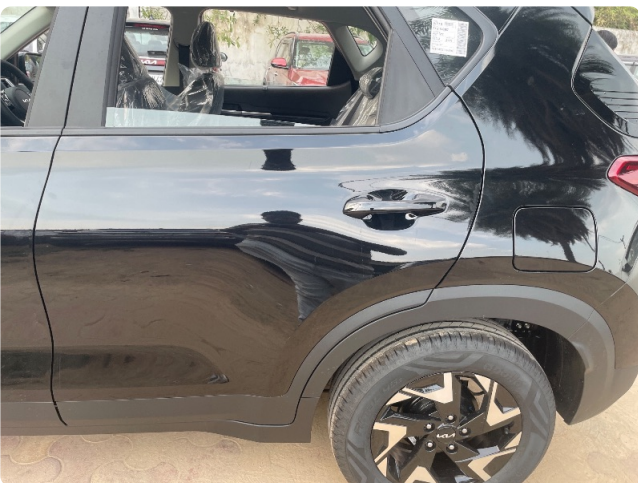
rear door

Rear Door

Good

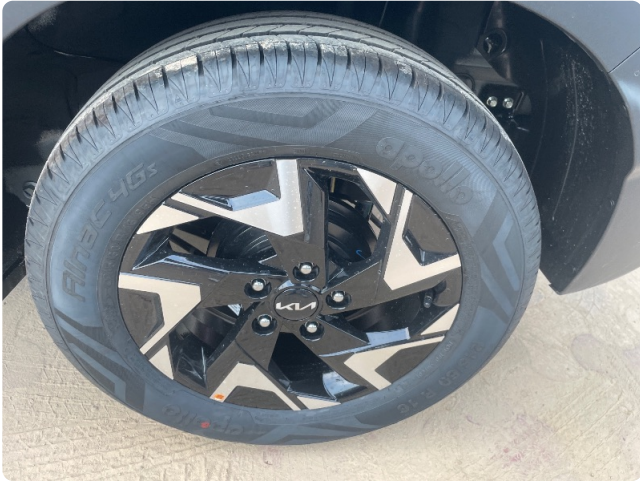
rear tyre

Rear Tyre

80%-100%

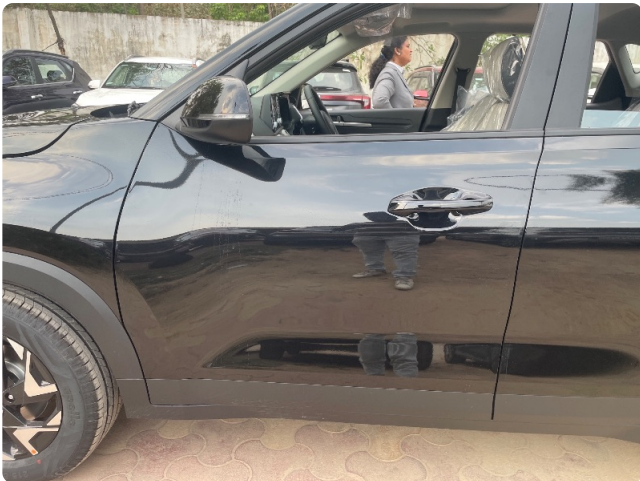
front door

Front Door

Good

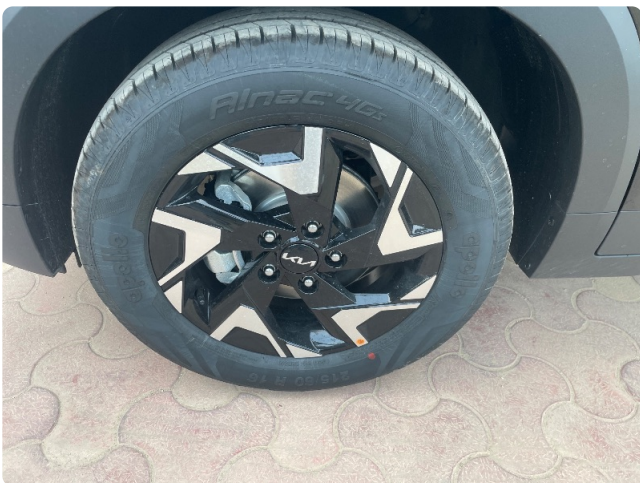
front tyre

Front Tyre

80%-100%

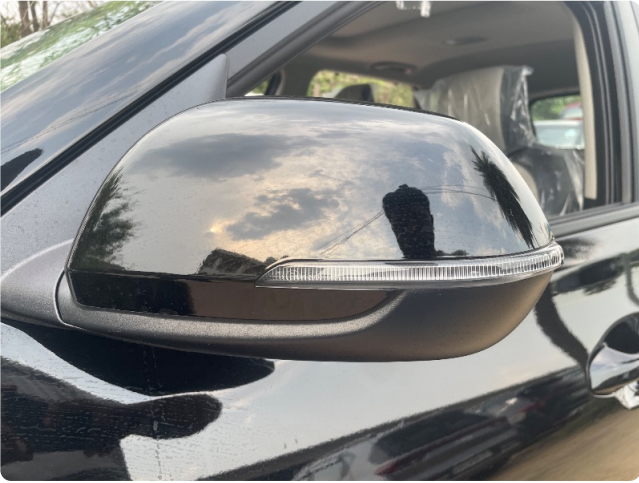
orvm mirror

Orvm Mirror

Good

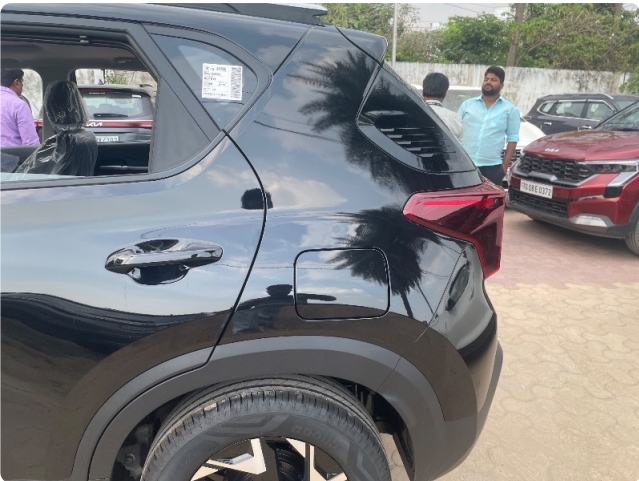
quarter panel

Quarter Panel

Good

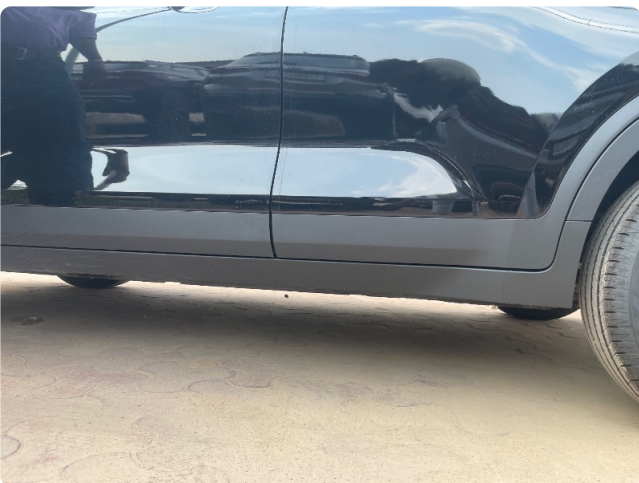
running board

Running Board

Good

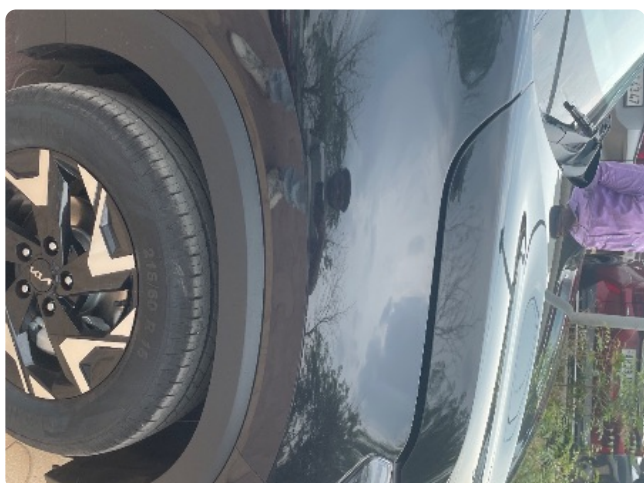
fender

| Component | Condition | Status |
|---|---|---|
| Fender | Good | ● |

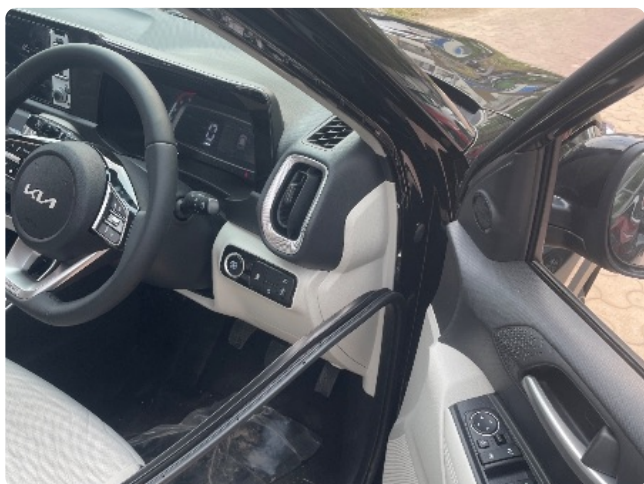
a pillar

| A Pillar | Good | ● |

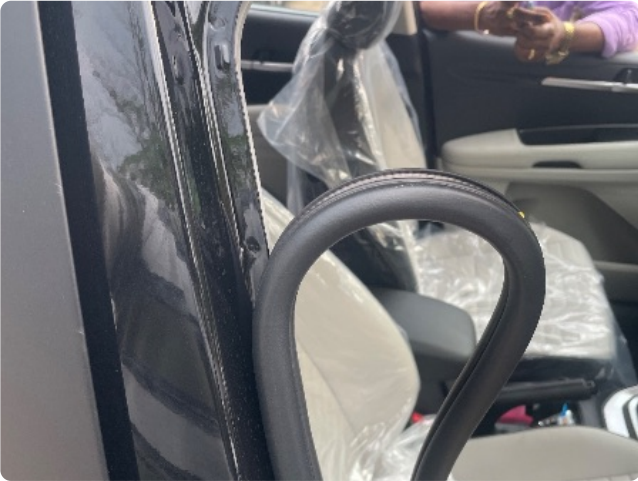
b pillar

B Pillar

Good

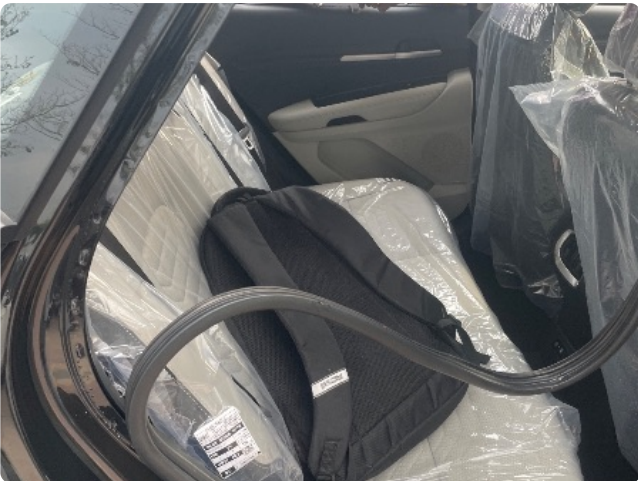
c pillar

C Pillar

Good

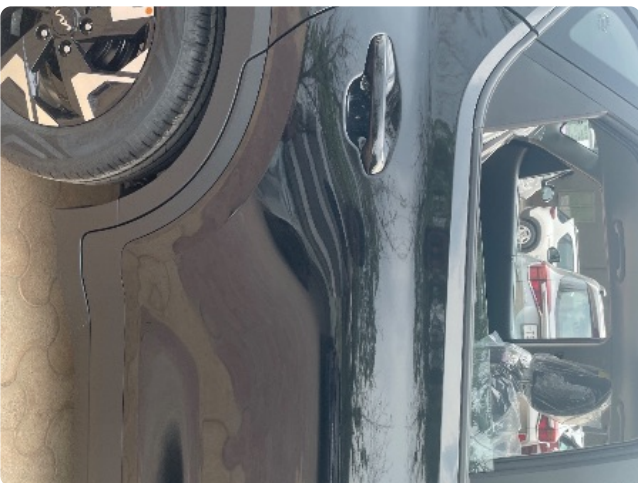
rear door

Rear Door

Good

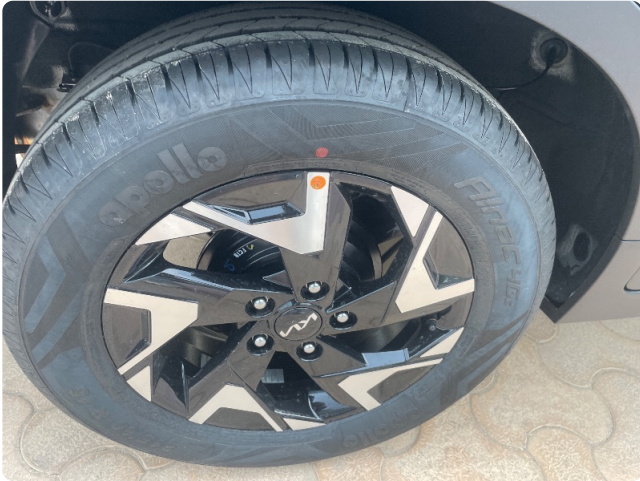
rear tyre

Rear Tyre

80%-100%

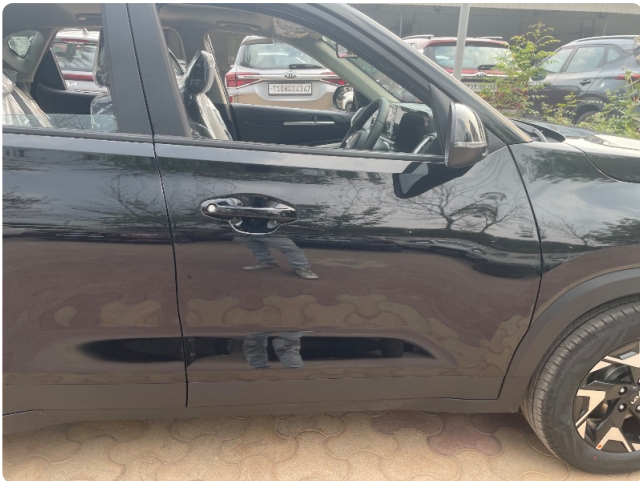
front door

Front Door

Good

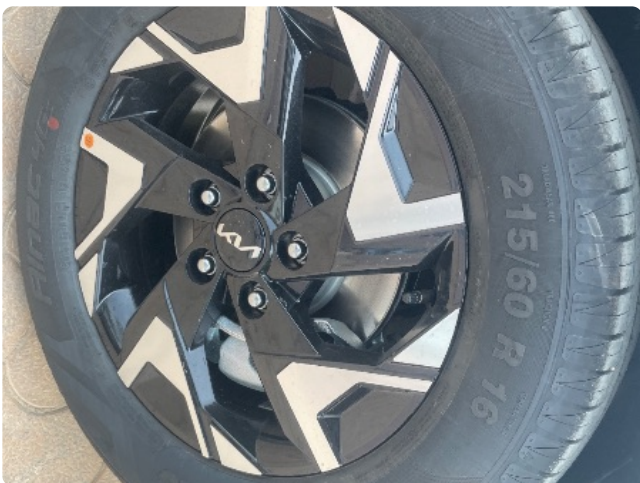
spare tyre

Spare Tyre

80%-100%

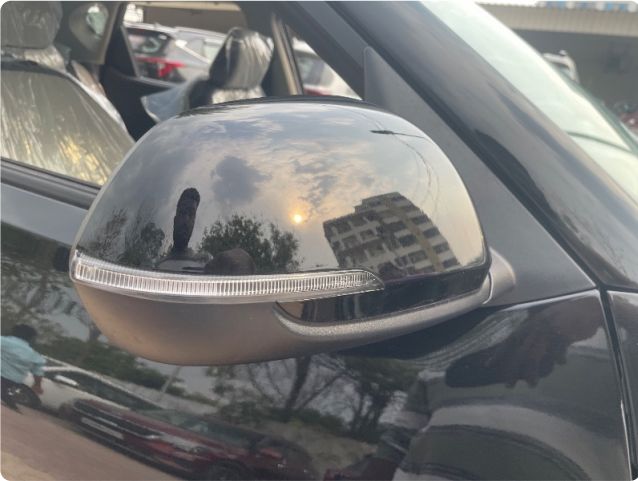
orvm mirror

Orvm Mirror

Good

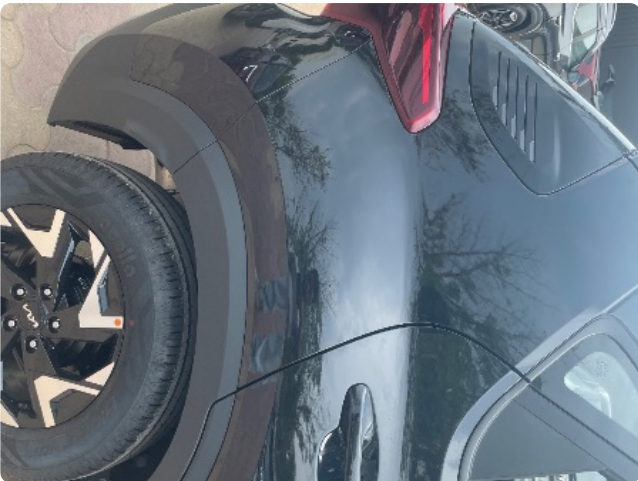
quarter panel

Quarter Panel

Good

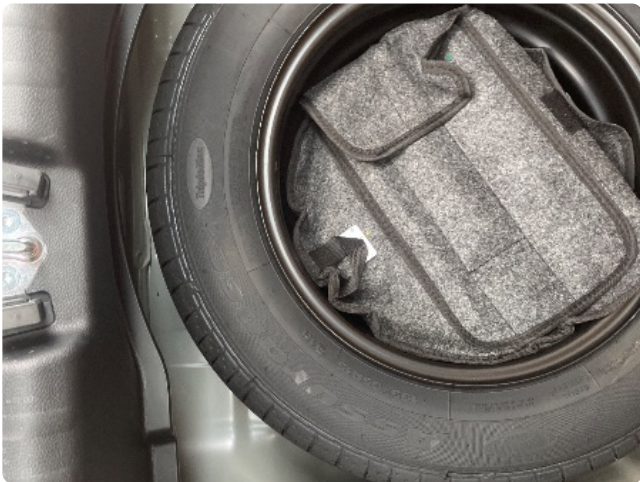
boot floor

| Component | Condition | Status |
|---|---|---|
| Boot Floor | Good | ● |

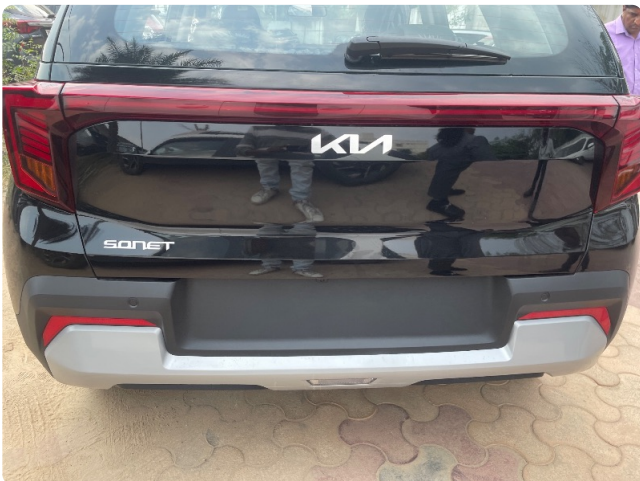
dicky door

| Dicky Door | Good | ● |

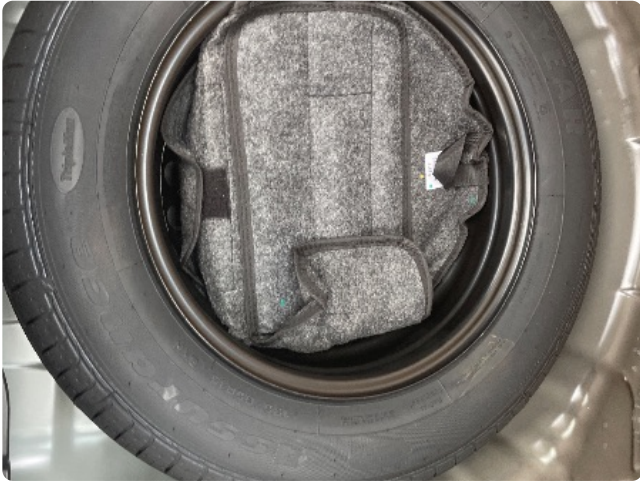
spare tyre

Spare Tyre

80%-100%

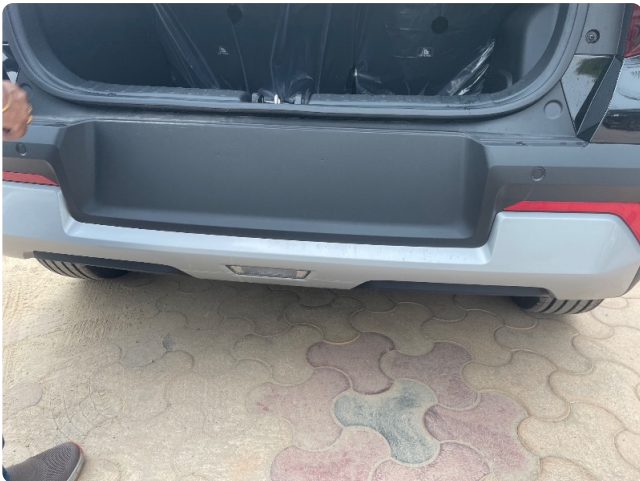
rear bumper

Rear Bumper

Good

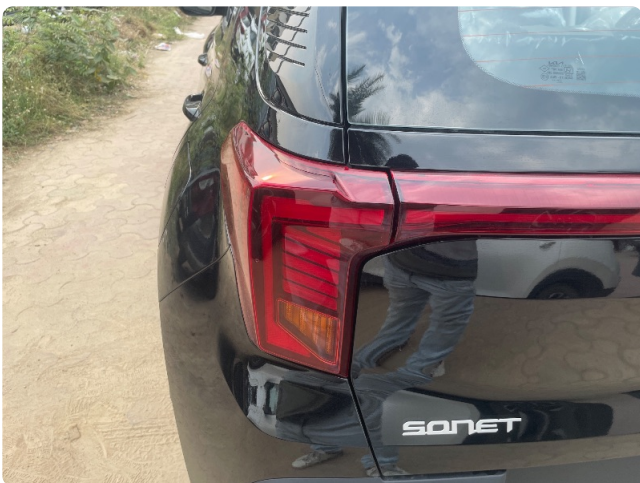
tail light lh

Tail Light Lh

Good

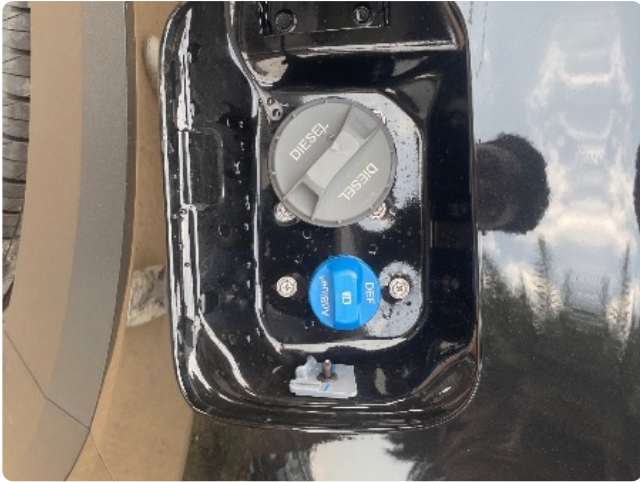
fuel tank

| Component | Condition | Status |
|---|---|---|
| Fuel Tank | Good | ● |

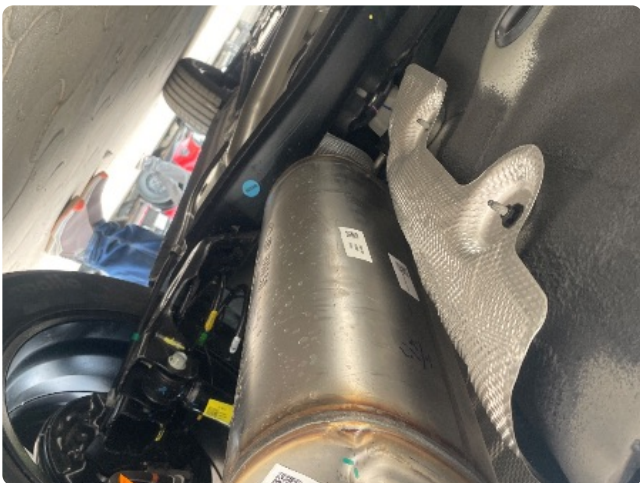
exhaust pipe

Exhaust Pipe

Good

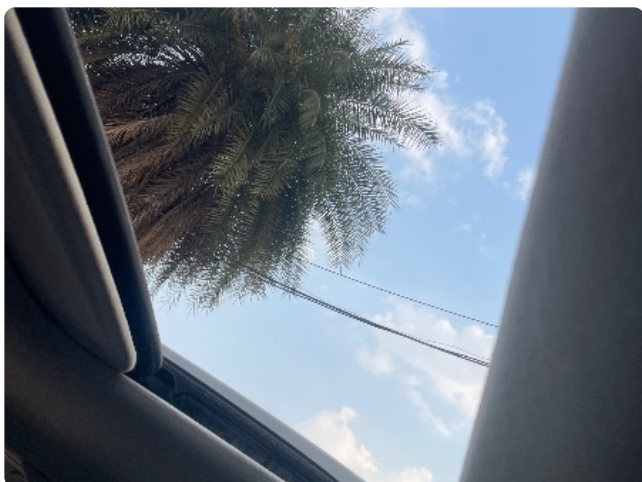
sun roof

| Component | Condition | Status |
|---|---|---|
| Sun Roof | Good | ● |

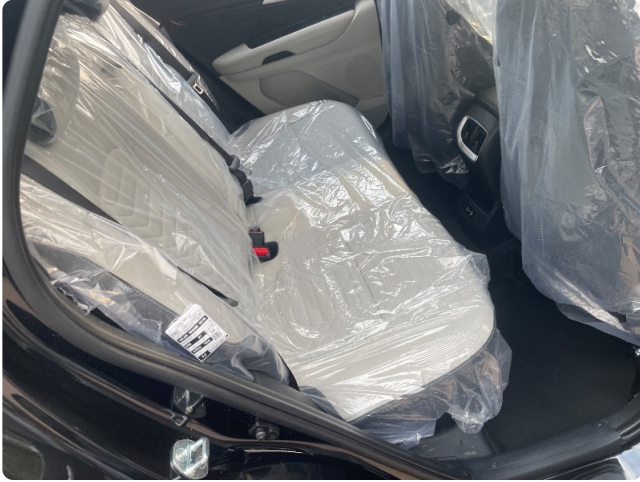
rear seats

| Rear Seats | Good | ● |

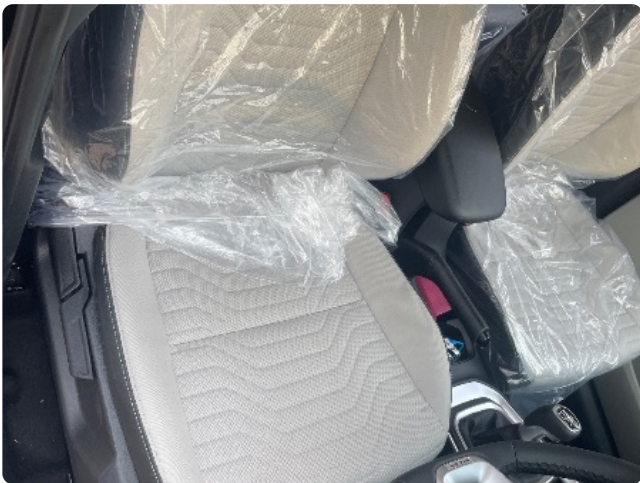
driver seat

| Driver Seat | Good | ● |

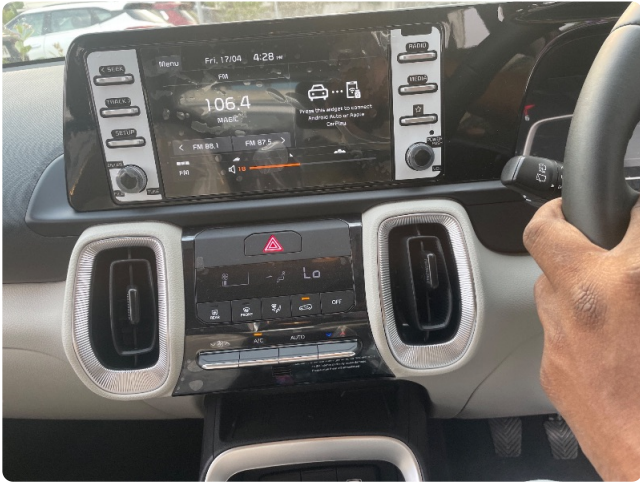
infotainment

Infotainment

Working

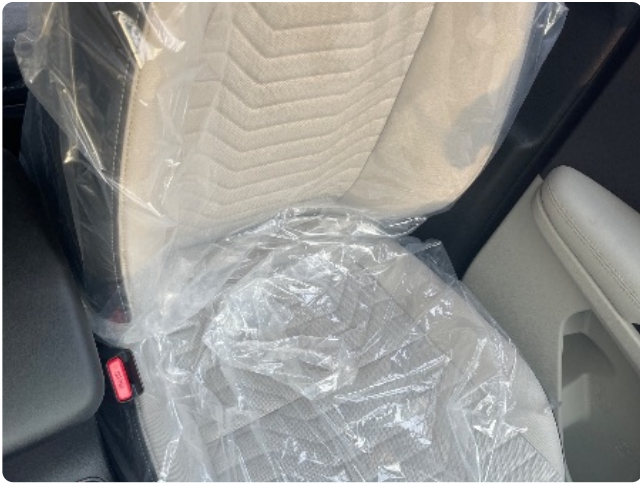
passenger seat

Passenger Seat

Good

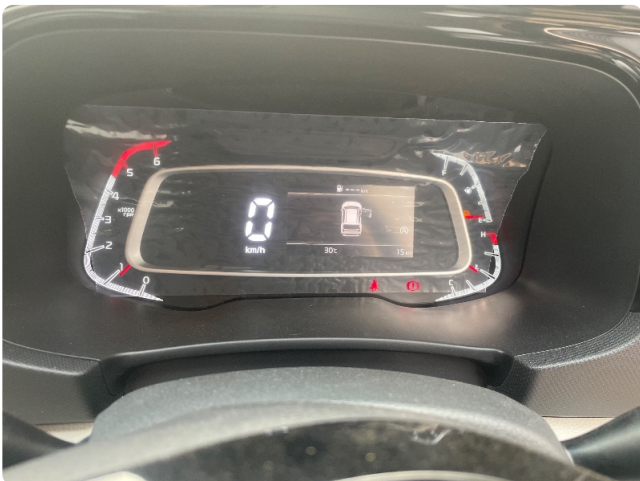
instrument cluster

Instrument Cluster

Working

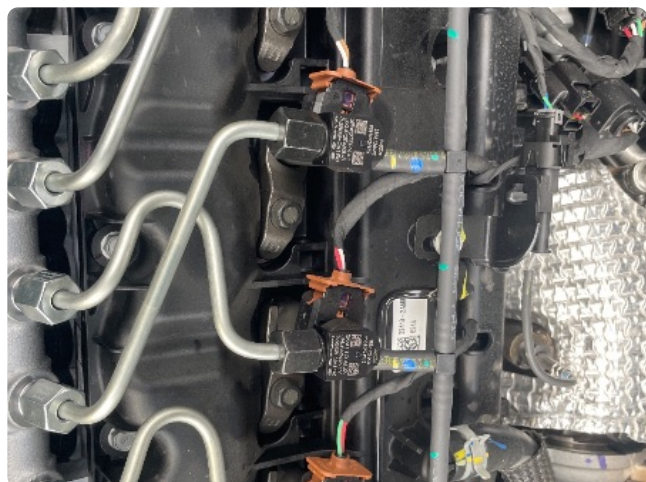
injector

| Component | Condition | Status |
|---|---|---|
| Injector | Good | ● |

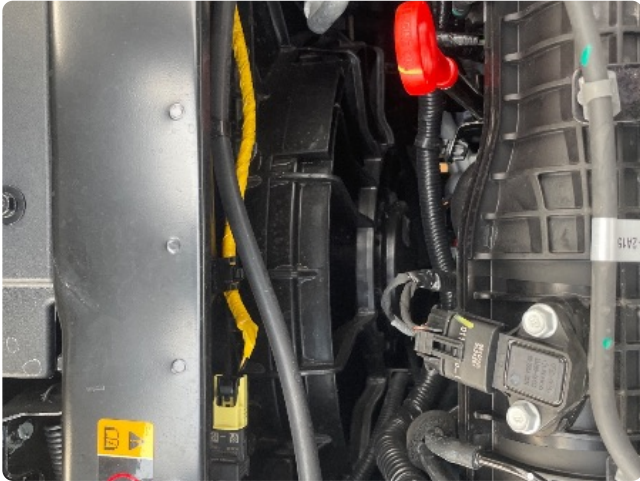
radiator

Radiator

Good

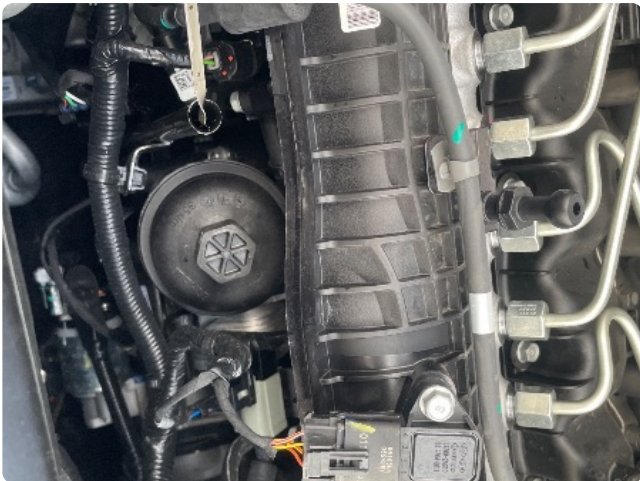
engine oil

Engine Oil

Clean

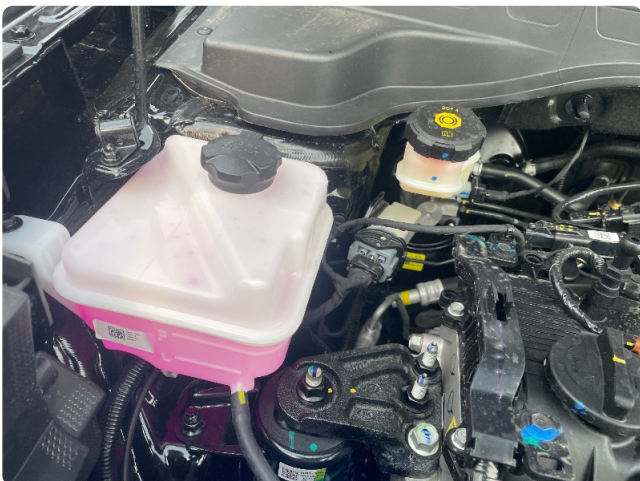
coolant level

Coolant Level

Full
