# 360° Car Inspection Report

Report ID: e52a873a

Date: 2026-08-26

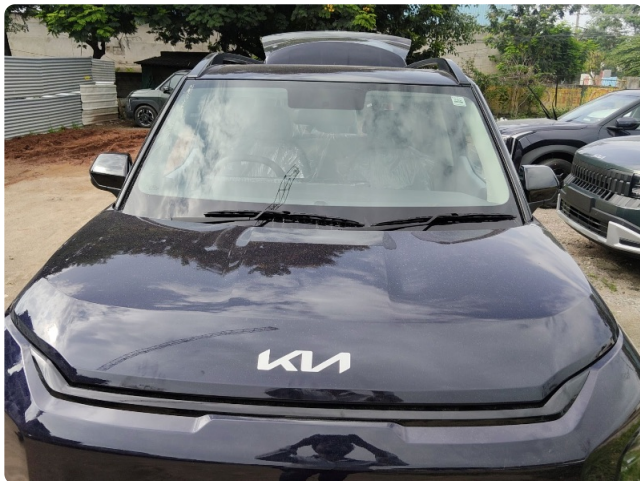
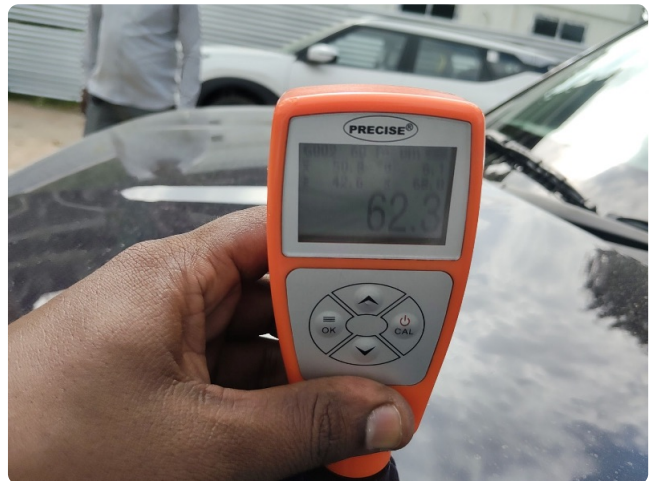
| Component | Condition | Status |
|---|---|---|
| Bonnet | Good | <span style="color: green;">●</span> |

bonnet

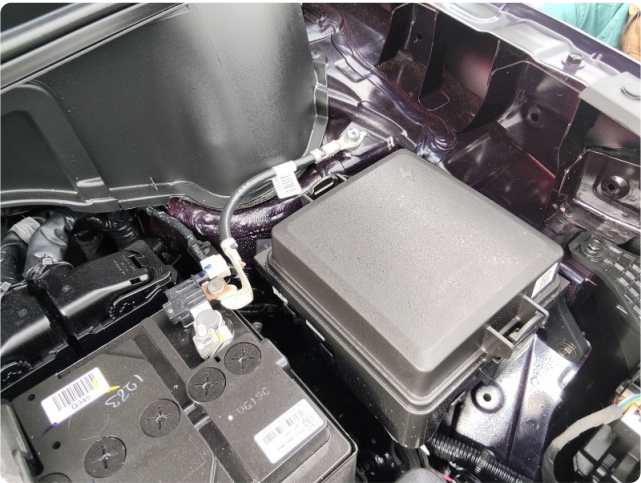
Lh Apron

Good

lh apron

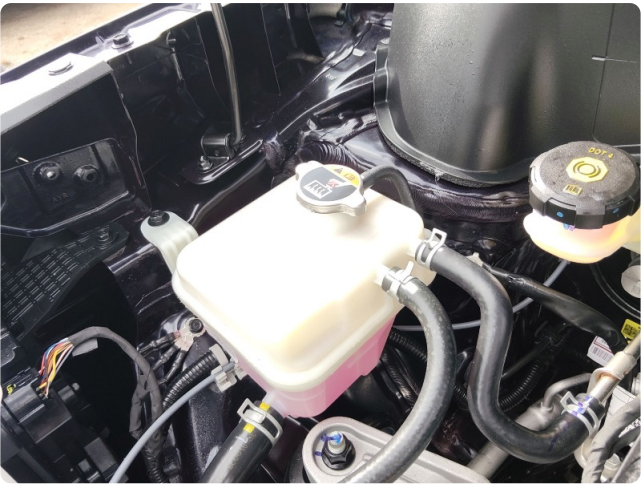
Rh Apron

Good

rh apron

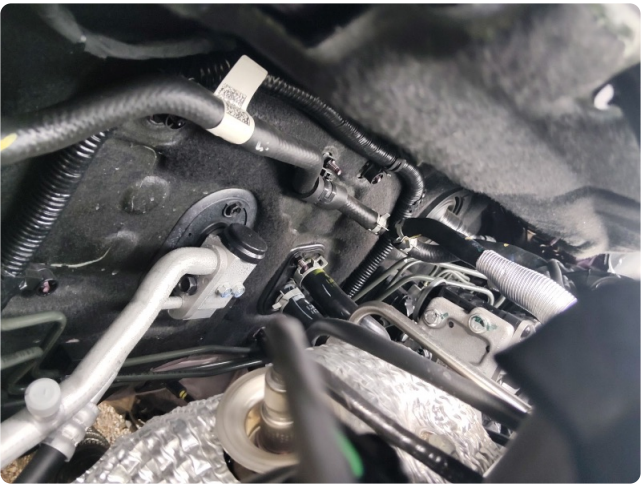
Fire Wall

Good

fire wall

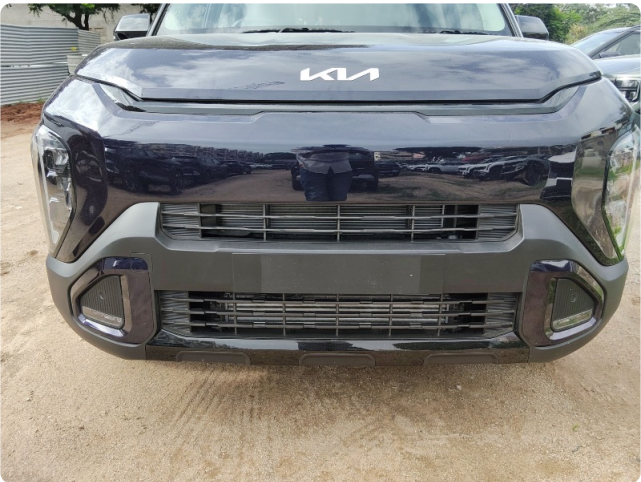
Front Grille

Good

front grille

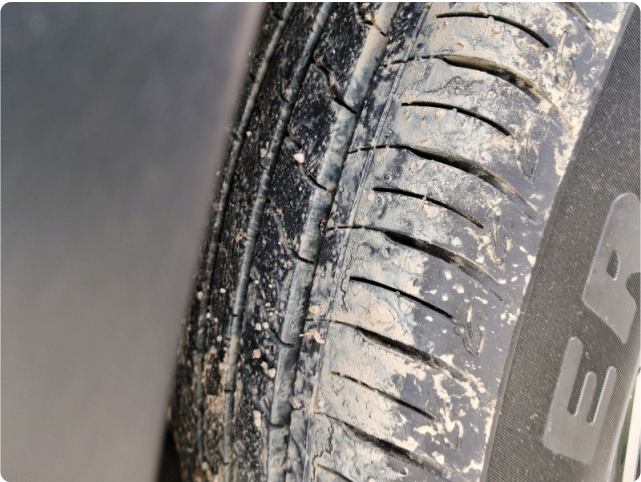
Rear Tyre

80%-100%

rear tyre

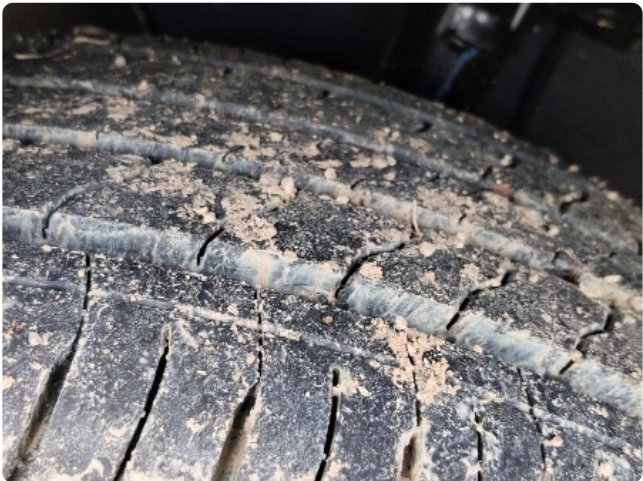
Spare Tyre

80%-100%

spare tyre

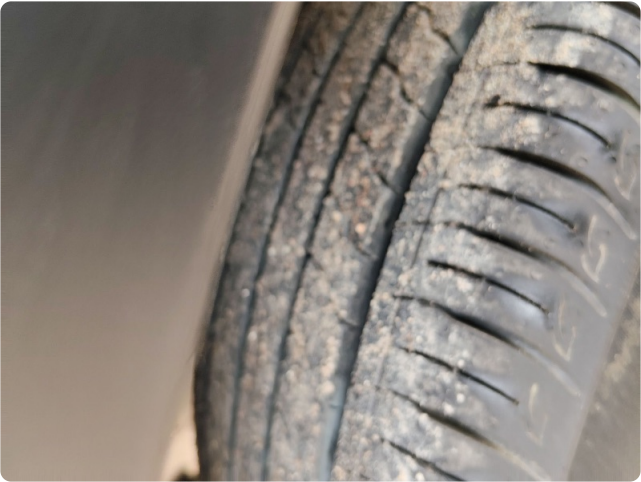
Rear Tyre

80%-100%

rear tyre

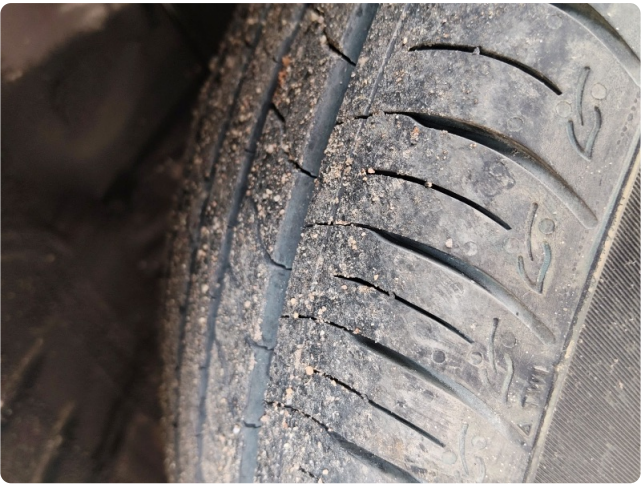
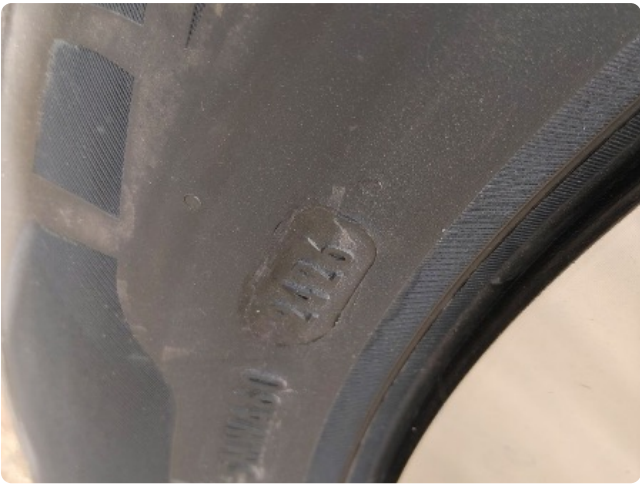
Front Tyre

80%-100%

front tyre

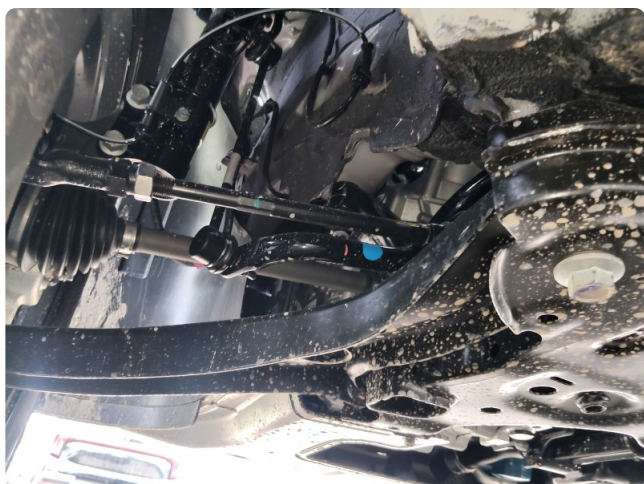
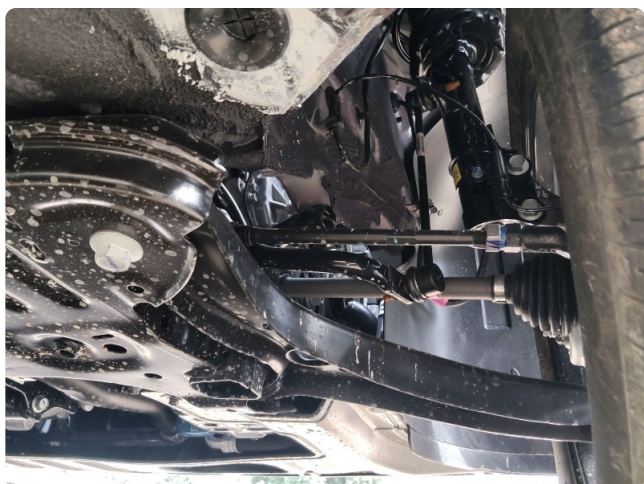
| Component | Condition | Status |
|---|---|---|
| Chassis | Good | <span style="color: green;">●</span> |

chassis

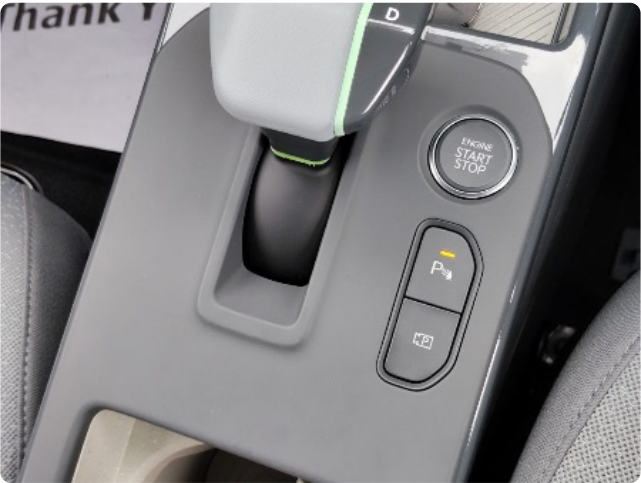
Handbrake

Working

handbrake

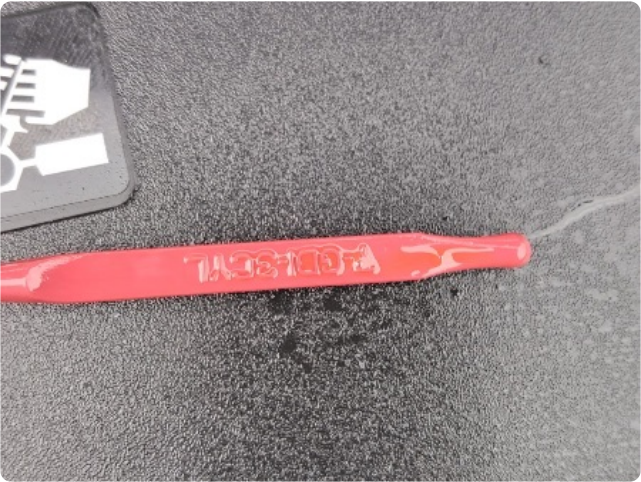
Engine Oil

Clean

engine oil

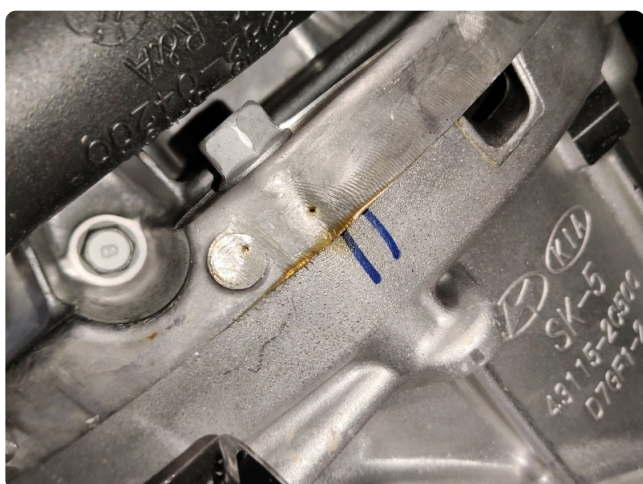
transmission

| Component | Condition | Status |
|---|---|---|
| Transmission | Gear Box Oil Leakage | ● |

Gear box side oil leakage
