# 360° Car Inspection Report

Report ID: ca2f493f

Date: 2026-08-25

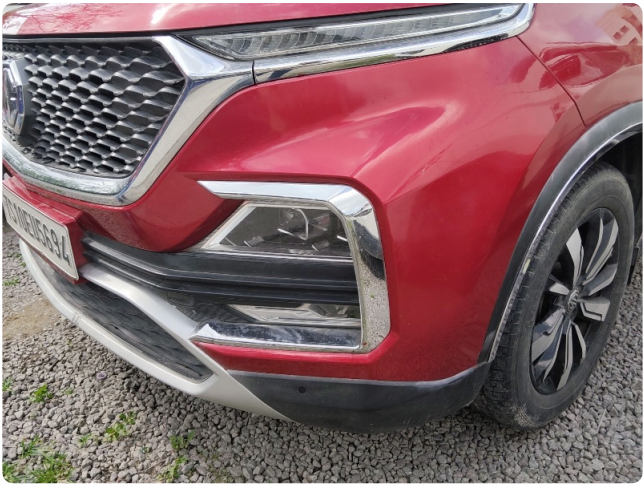
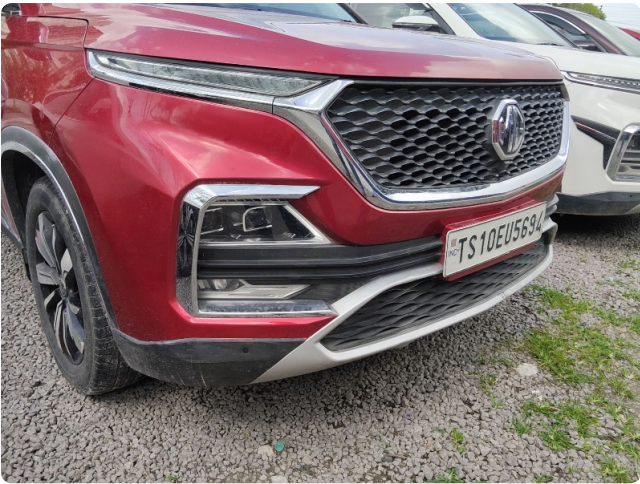
Front Bumper

Repaint

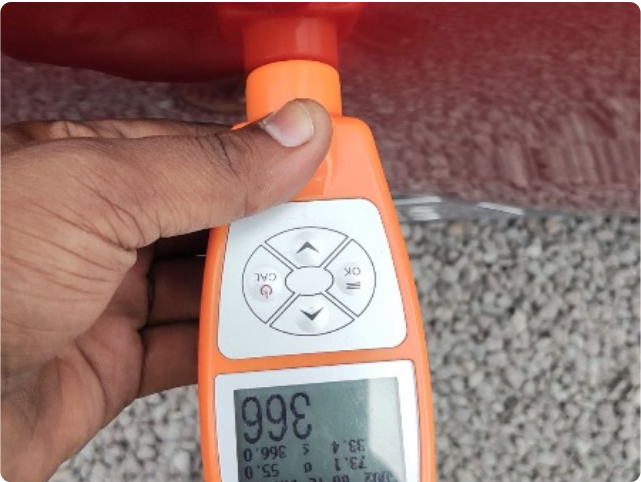
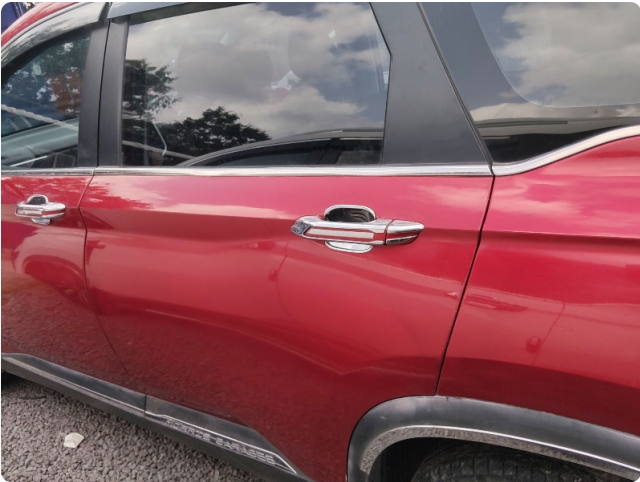
Rear Door

Repaint

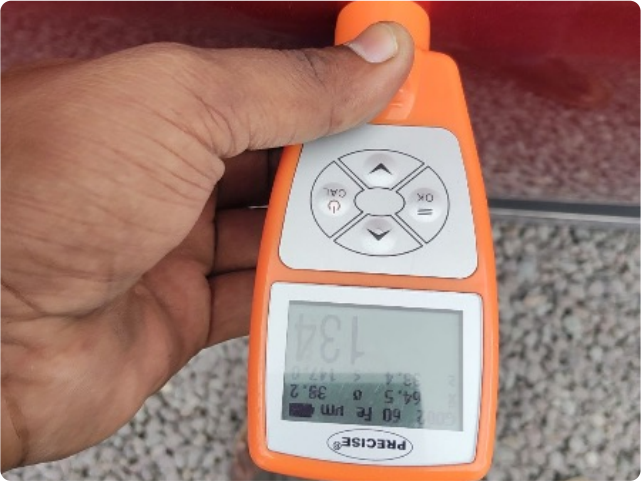
Front Door

Repaint

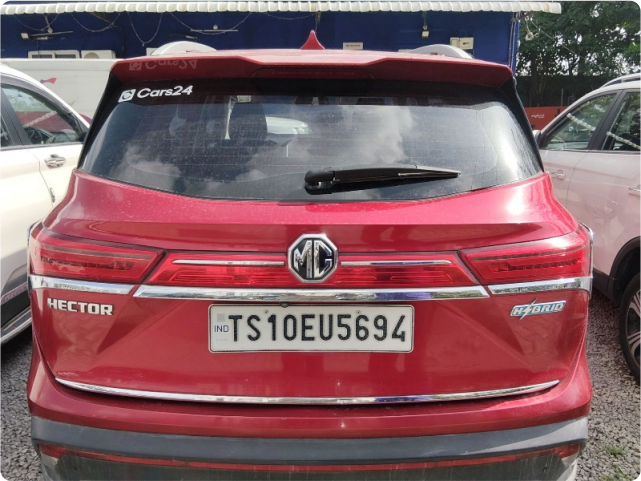
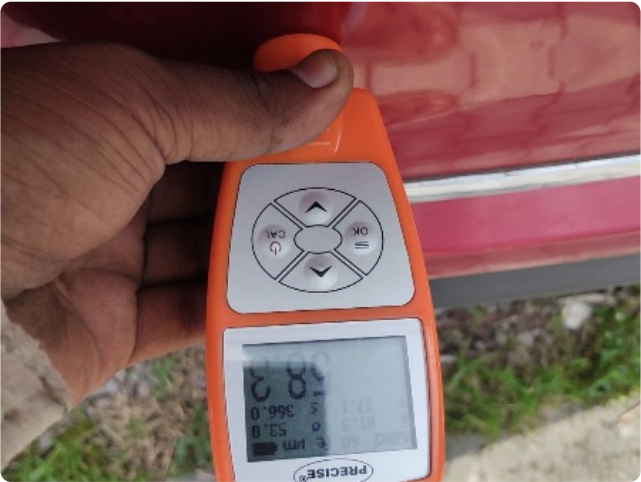
Dicky Door

Scratches

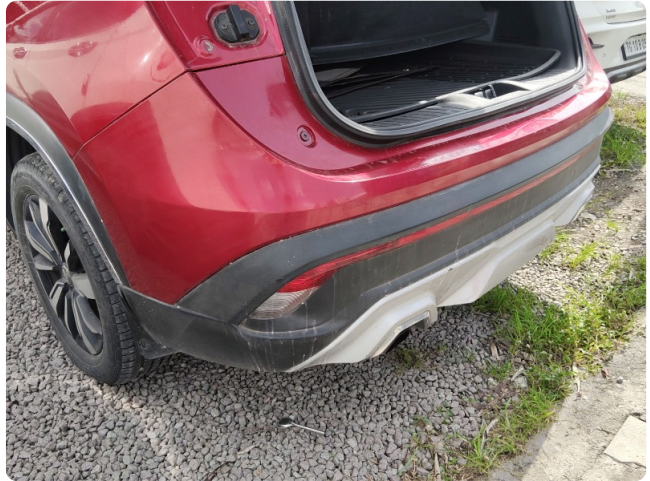
Rear Bumper

Repaint

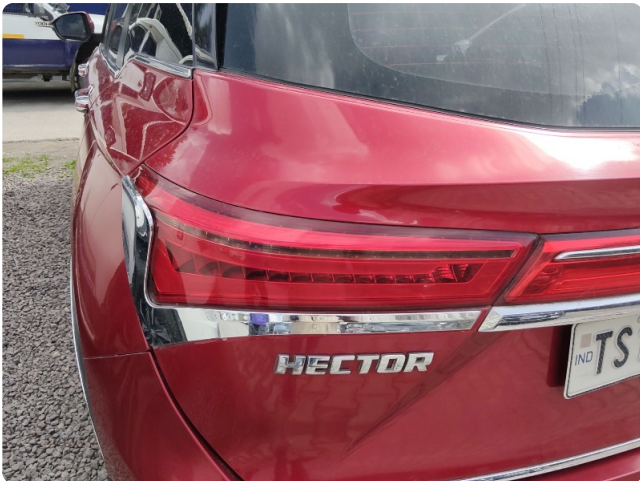
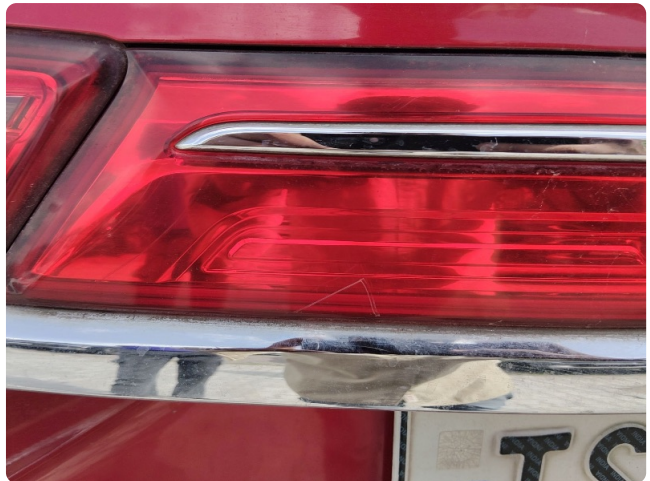
Tail Light Lh

Cracked

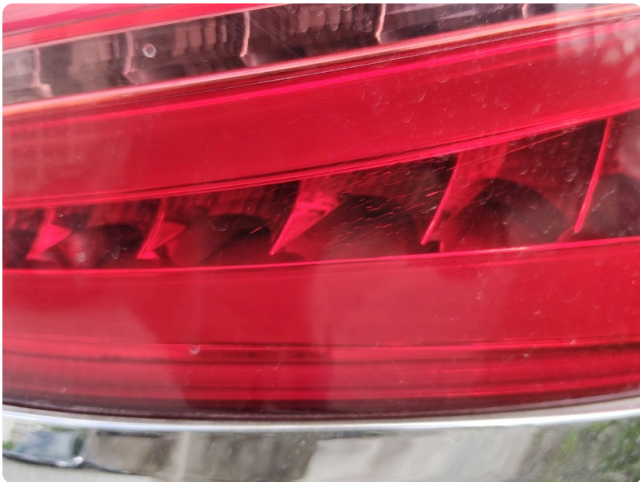
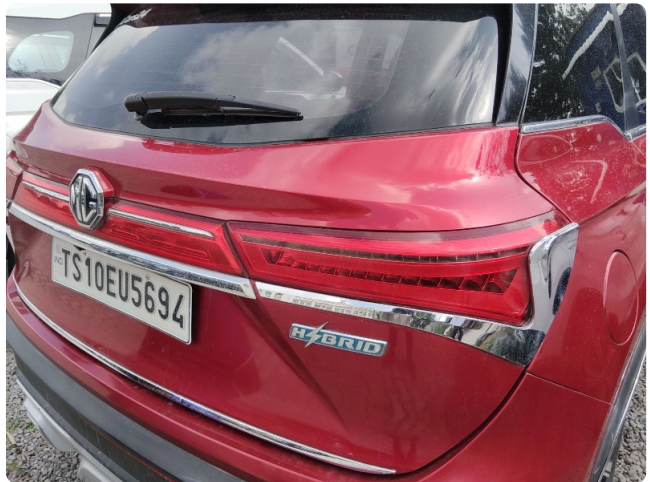
Tail Light Rh

Cracked

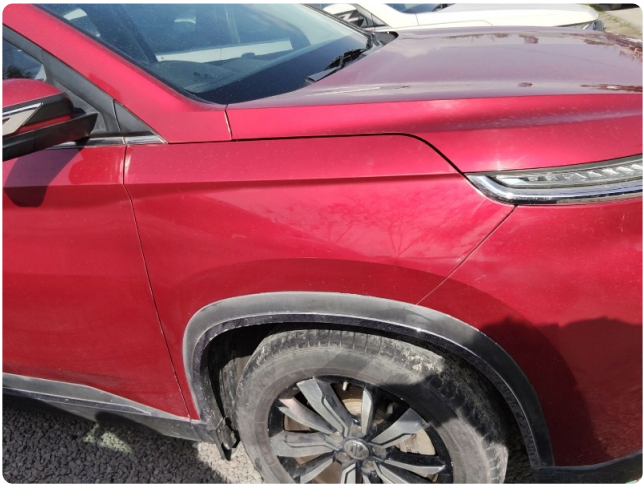
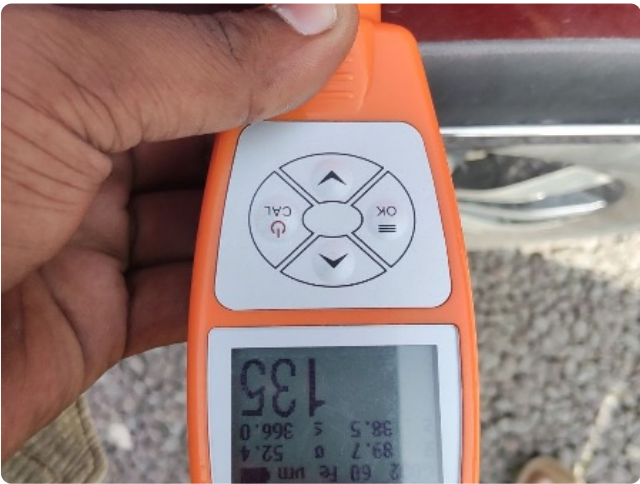
| Component | Condition | Status |
|---|---|---|
| Fender | Repaint | <div></div> |

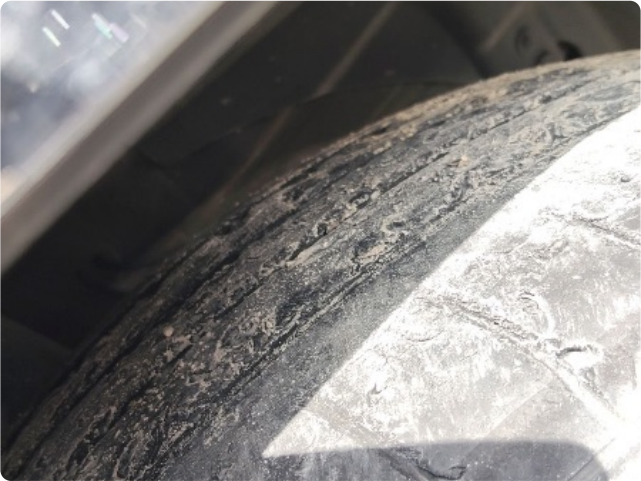
Front Tyre

Worn out

Clutch hard  
Gear shifting hard  
Need to replace all tyres

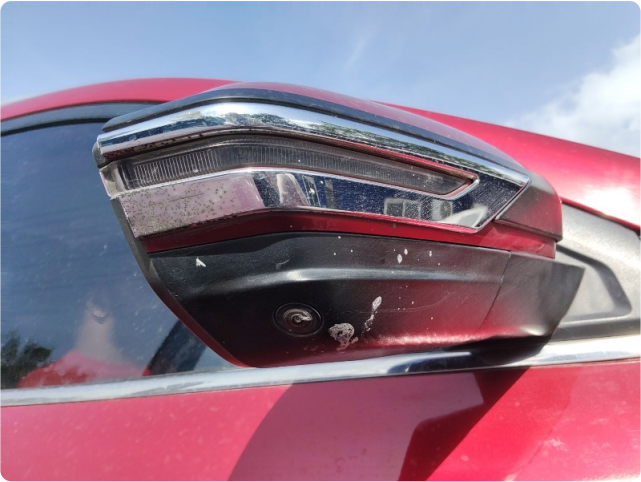
Orvm Mirror

Scratches
