# 360° Car Inspection Report

Professional Vehicle Assessment

Report ID: 46b59250

Date: 2026-08-27

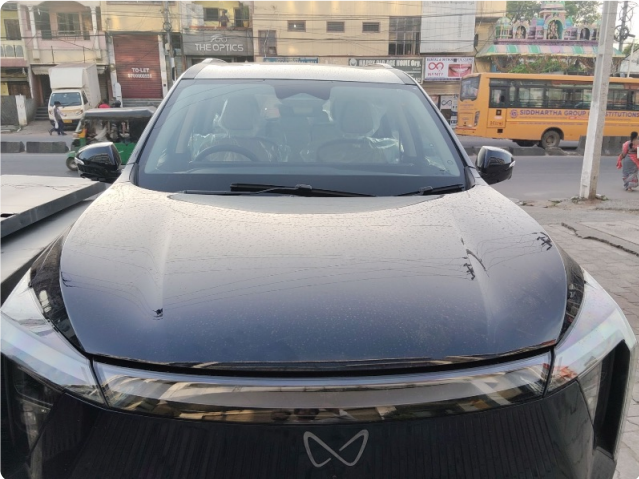
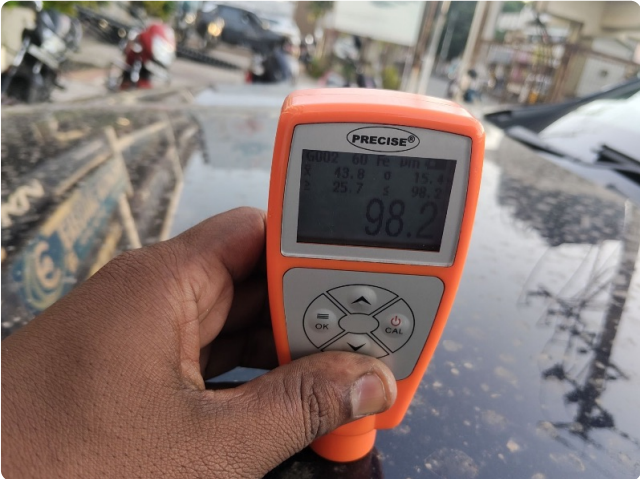
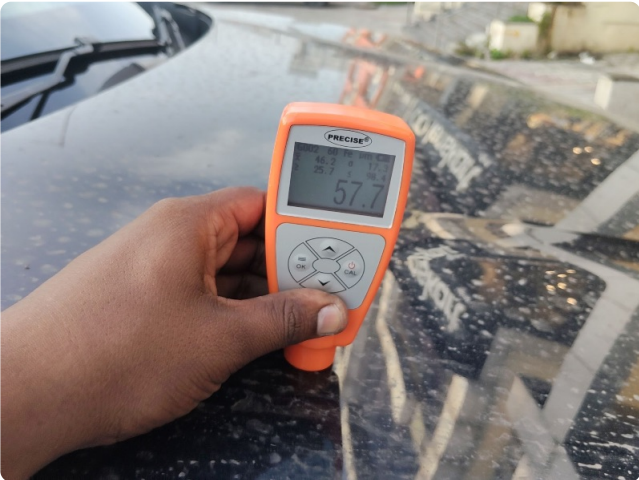
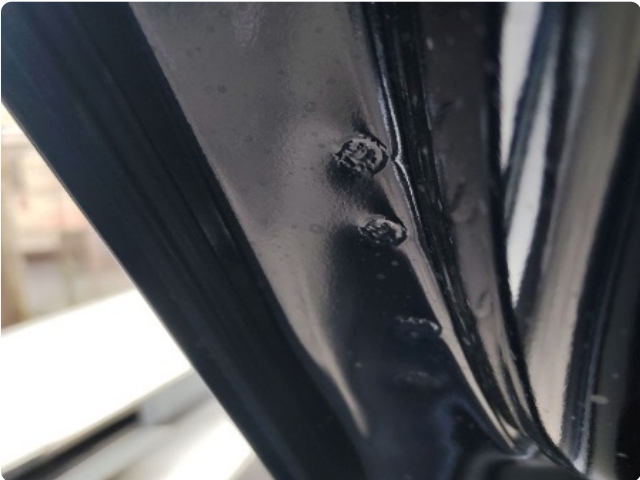
bonnet

Good

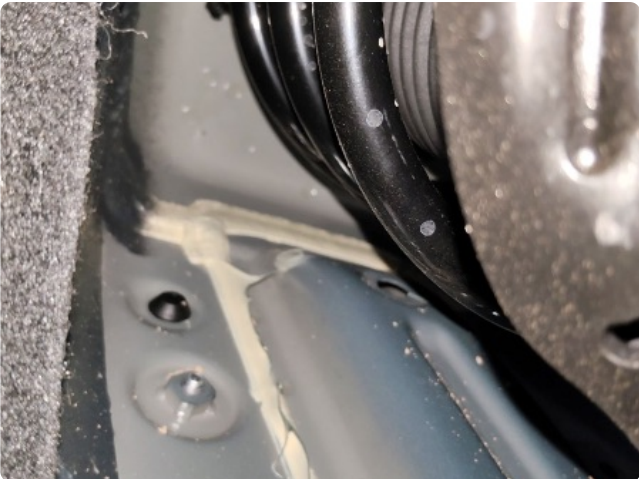
lh apron

Good

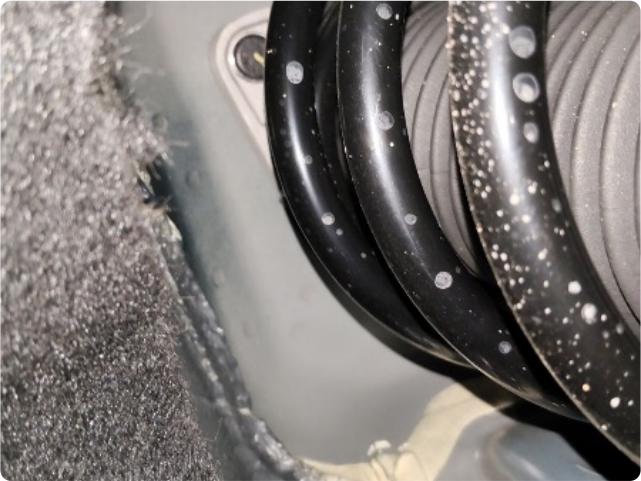
rh apron

Good

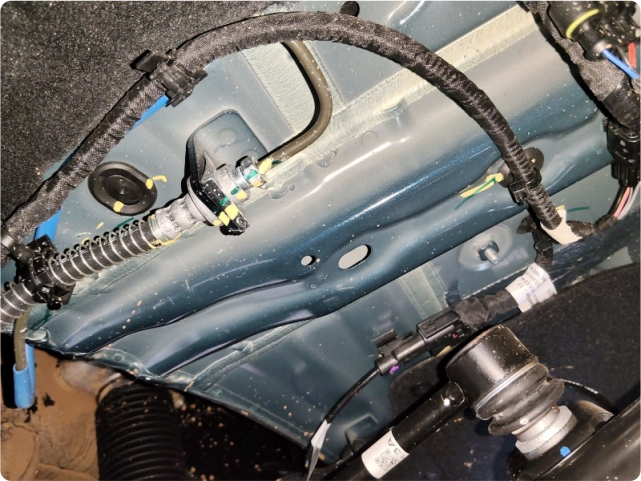
rh leg member

Good

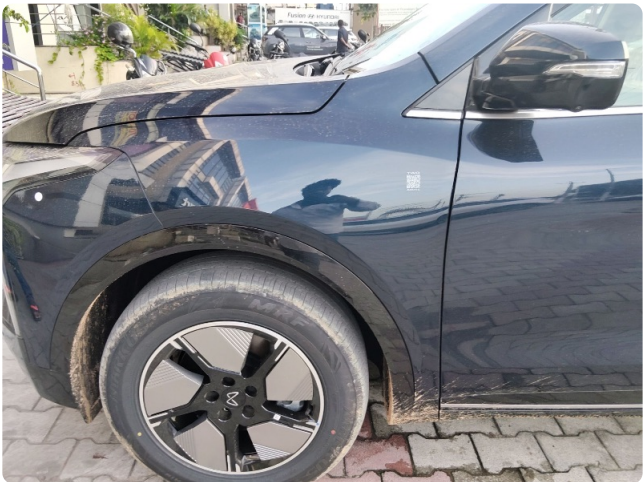
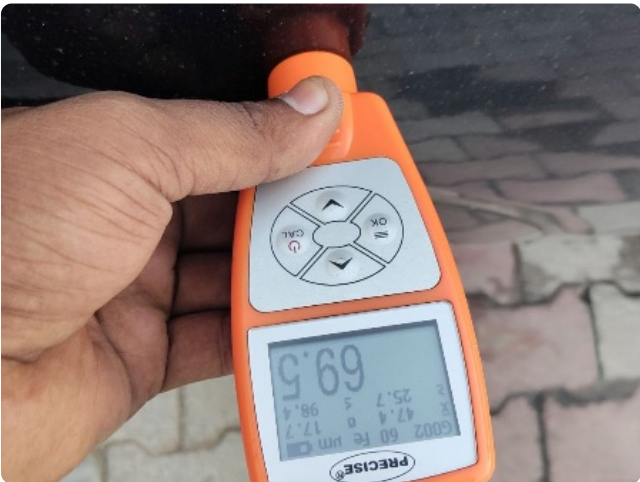
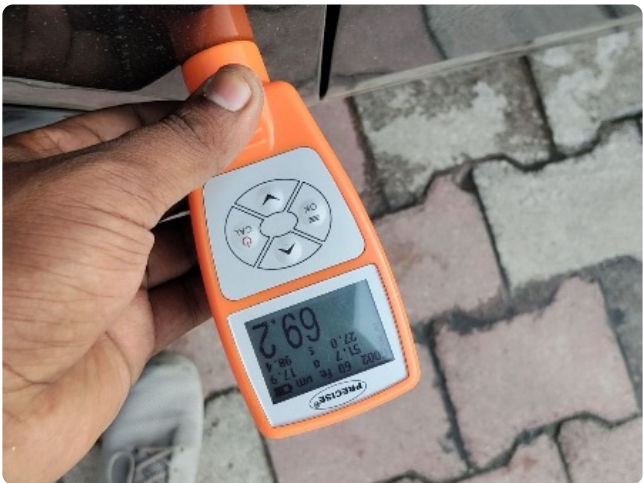
fender

| Component | Condition | Status |
|---|---|---|
| Fender | Good | <div></div> |

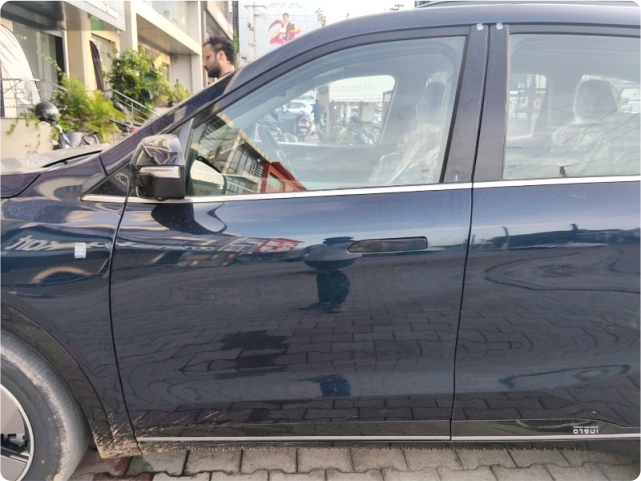
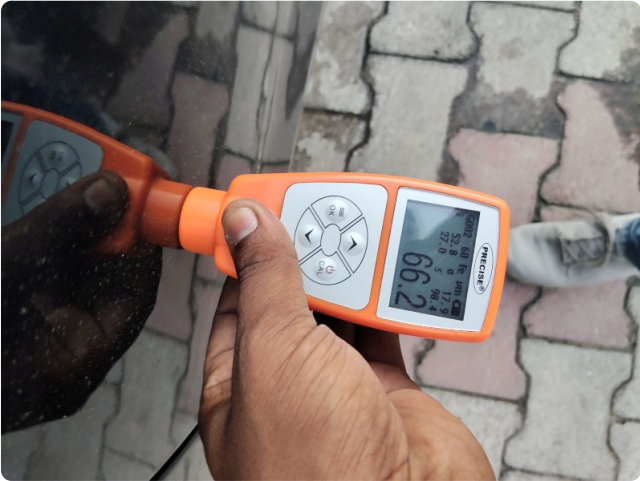
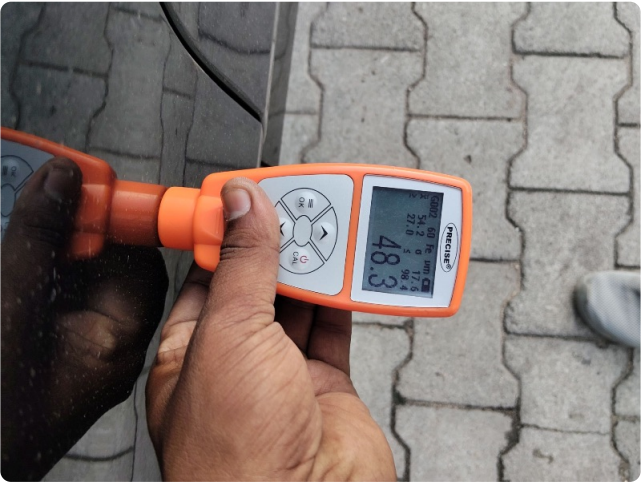
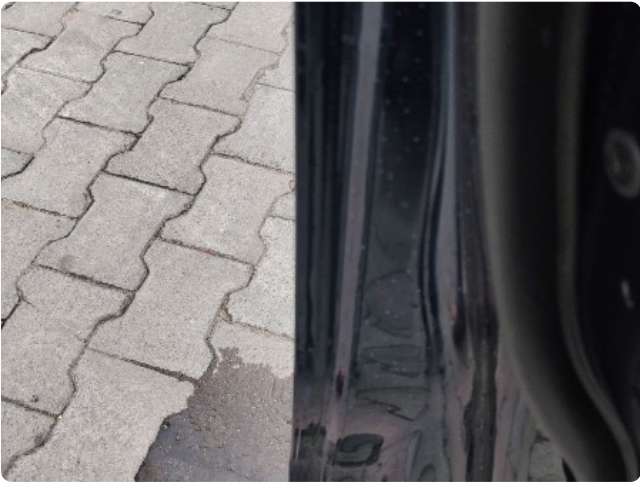
front door

Good

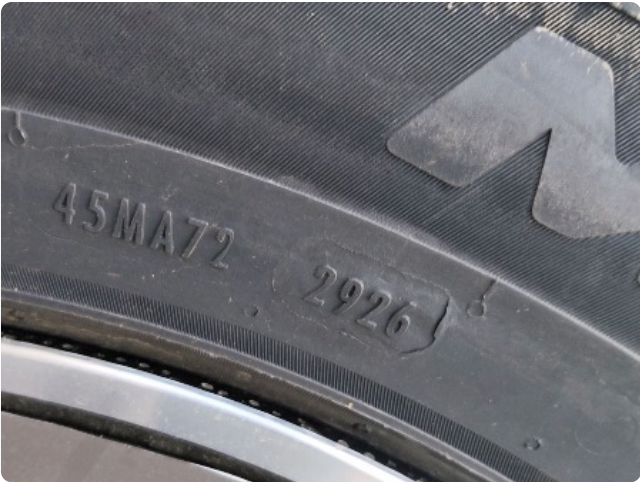
rear tyre

80%-100%

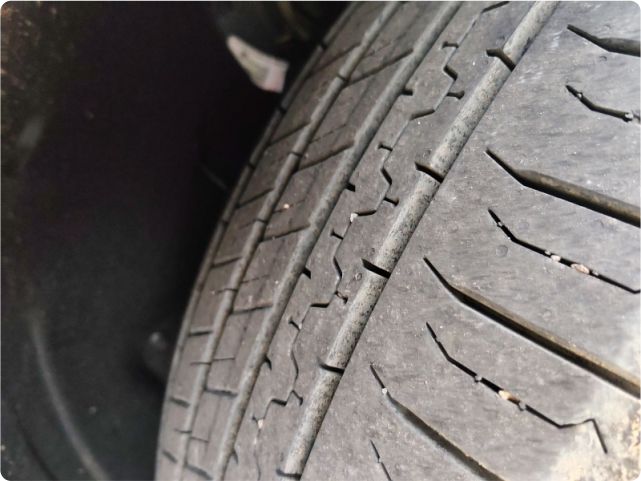
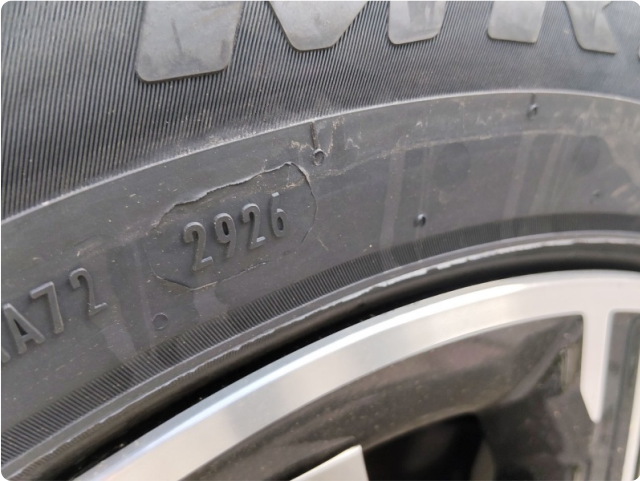
spare tyre

80%-100%

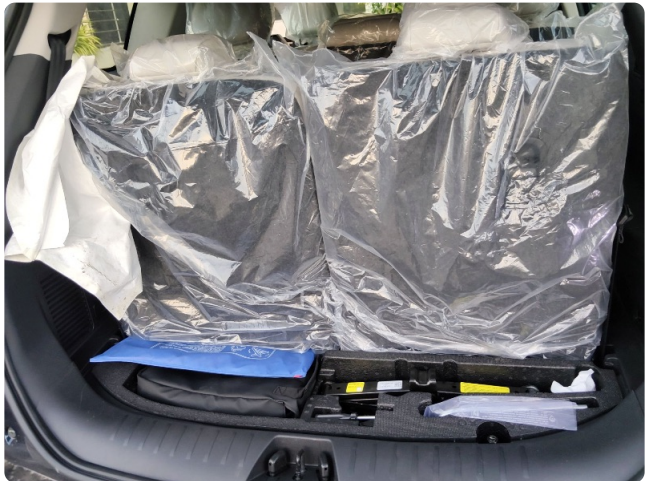
boot floor

| Component | Condition | Status |
|---|---|---|
| Boot Floor | Good | <div></div> |

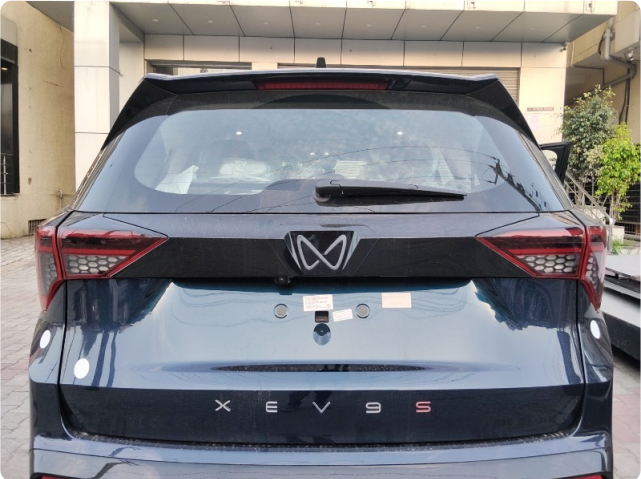
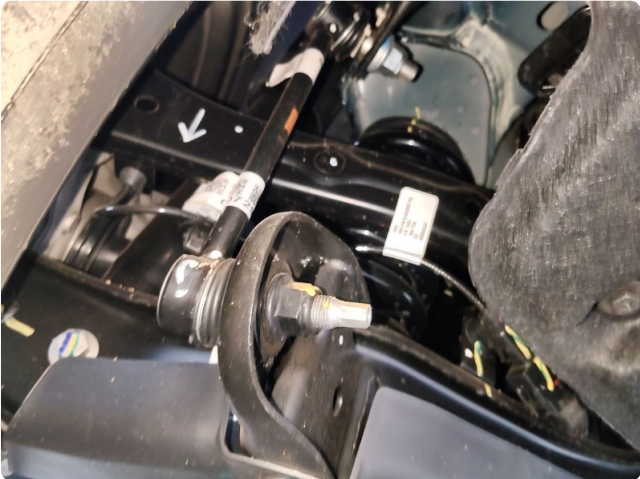
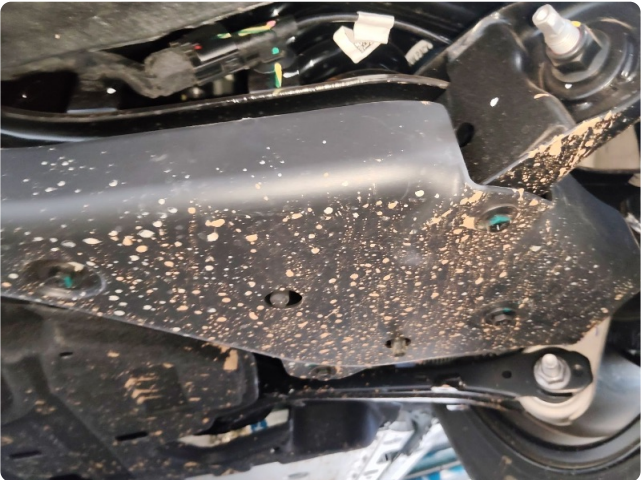
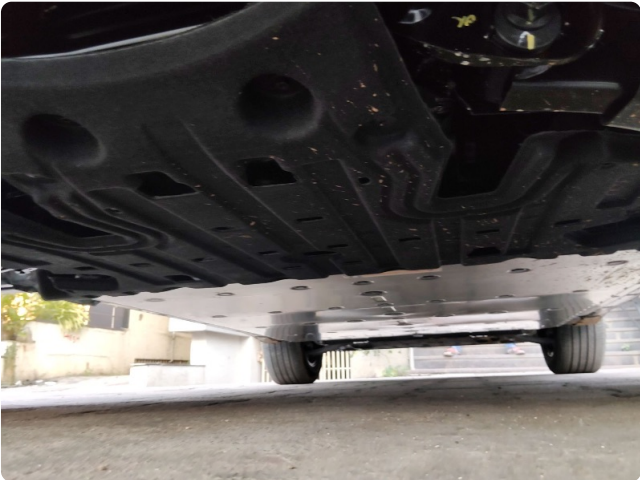
dicky door

Dicky Door

Good

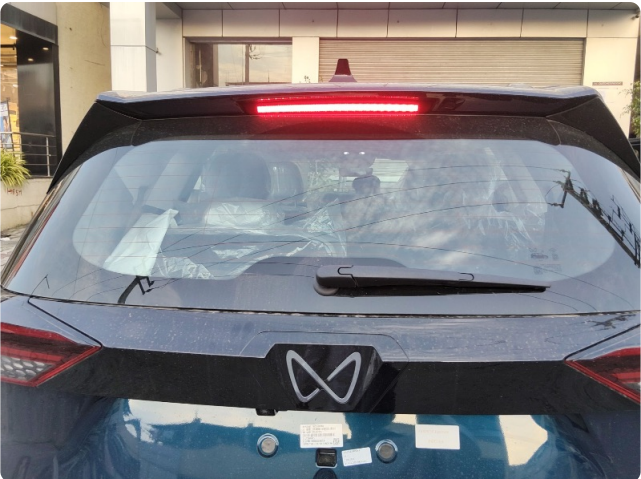
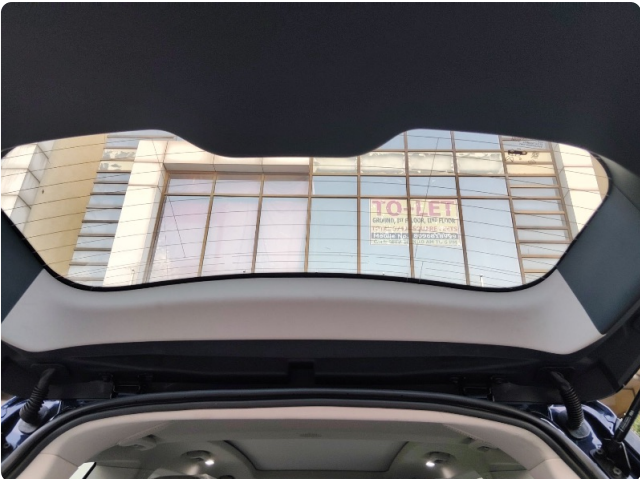
rear glass

Rear Glass

Good

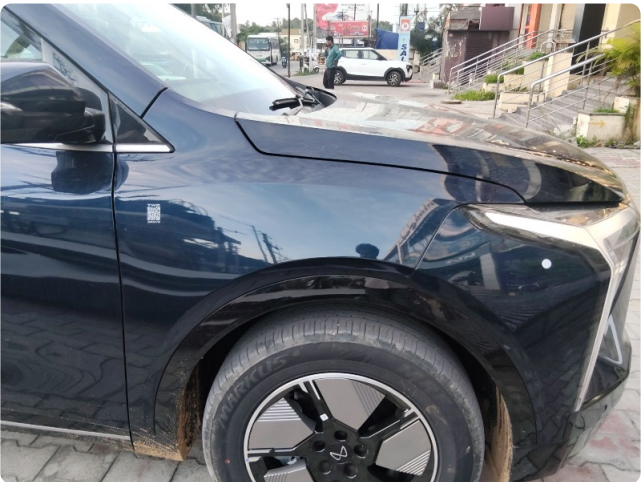
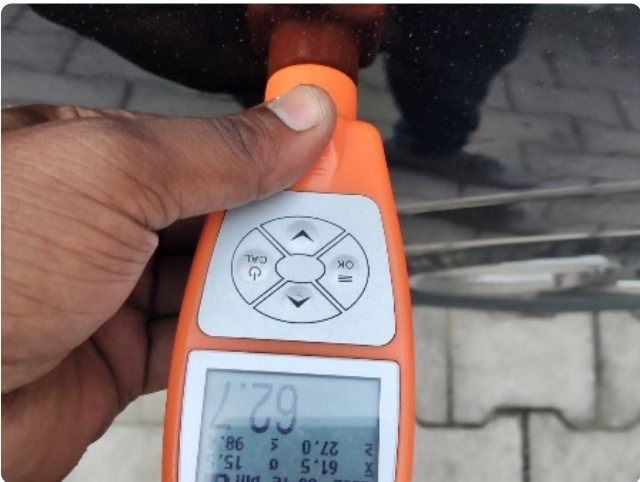
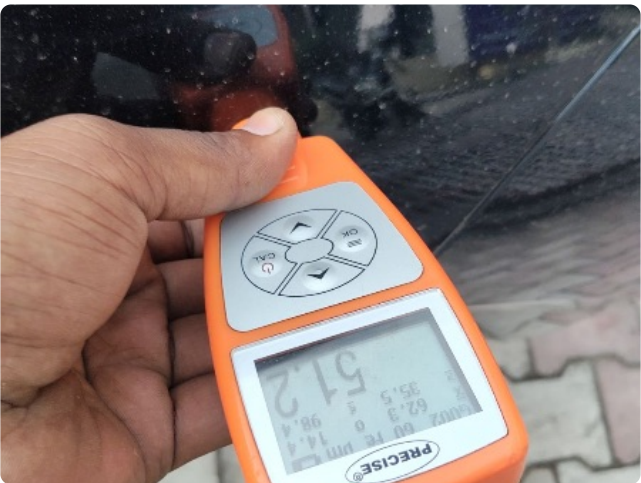
fender

| Component | Condition | Status |
|---|---|---|
| Fender | Good | <div></div> |

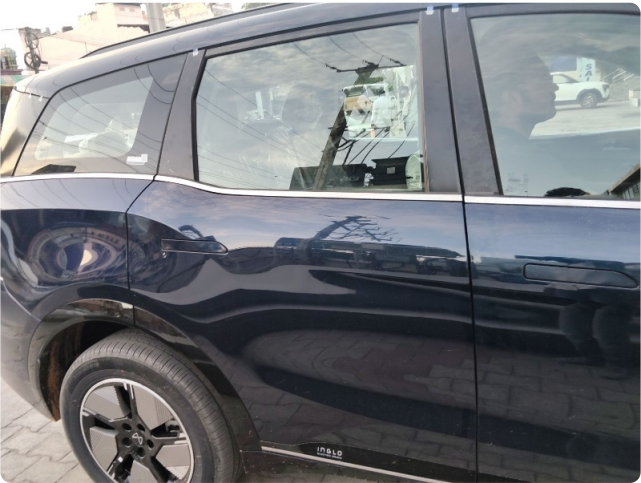
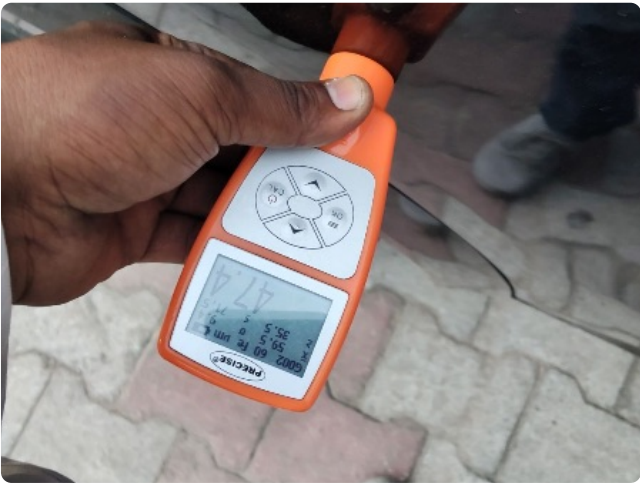
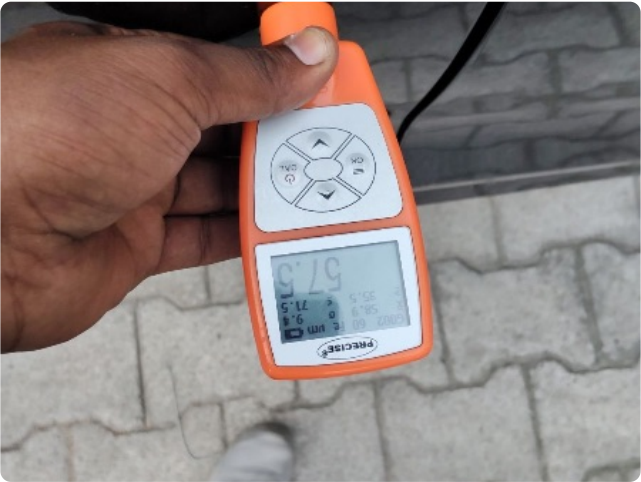
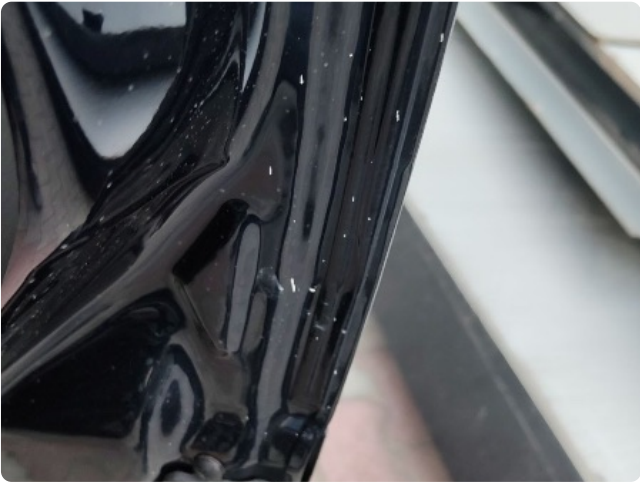
rear door

Rear Door

Good

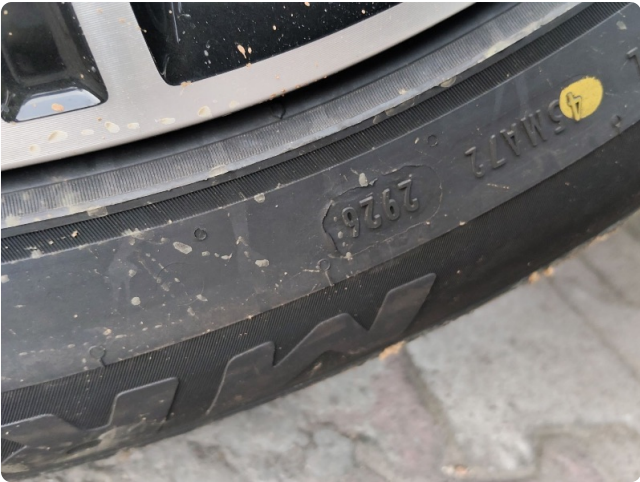
rear tyre

Rear Tyre

80%-100%

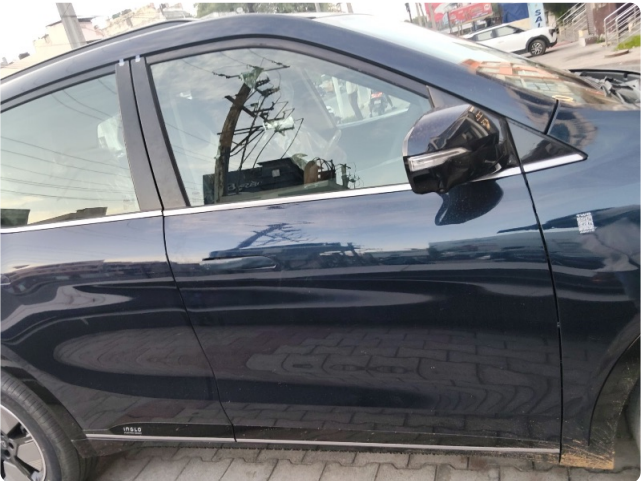
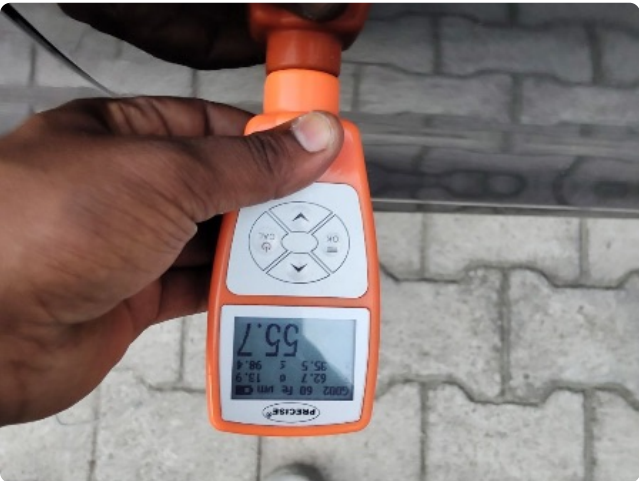
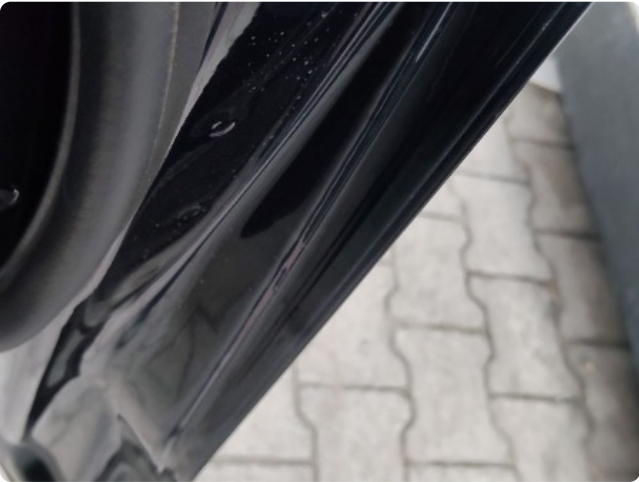
front door

Front Door

Good

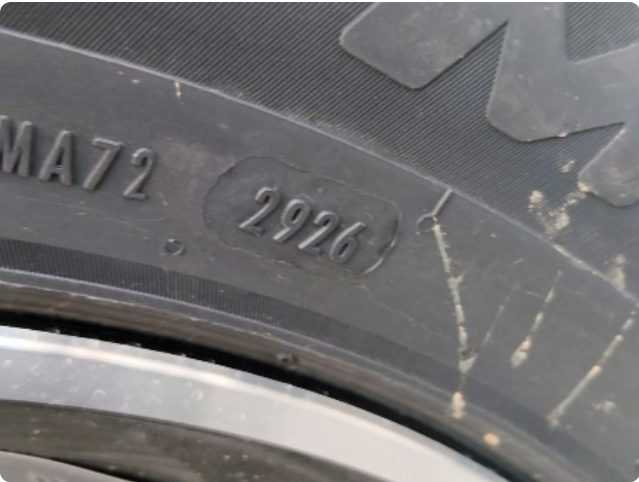
front tyre

Front Tyre

80%-100%

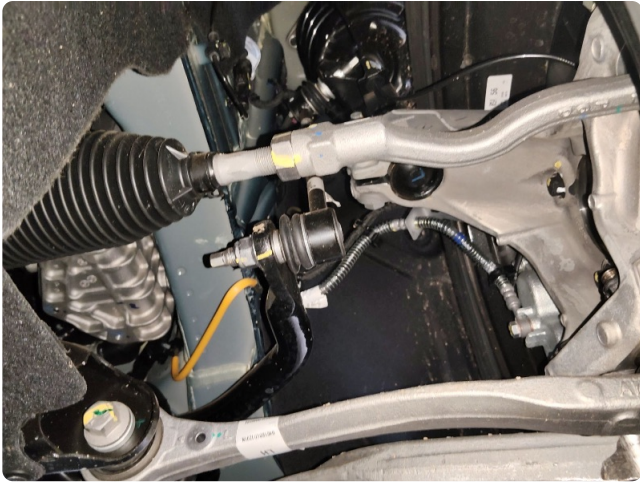
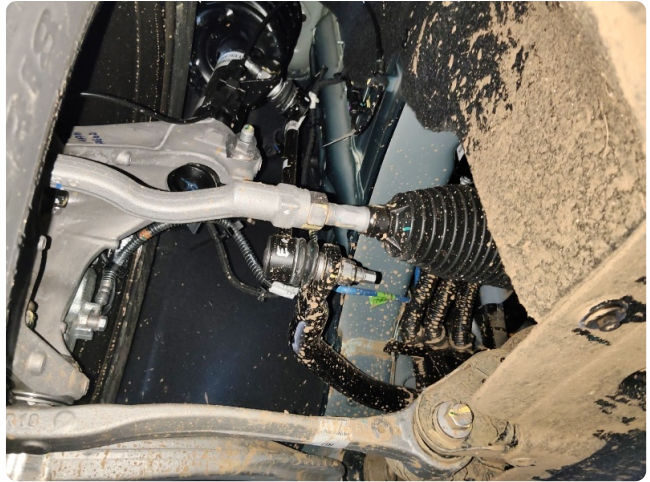
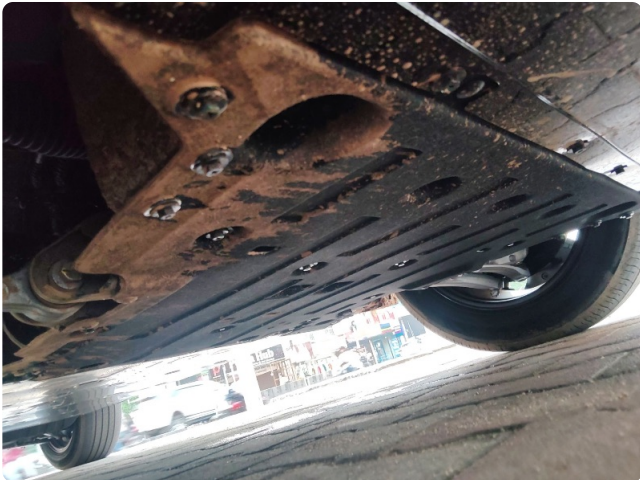
| Component | Condition | Status |
|---|---|---|
| Chassis | Good | <span></span> |

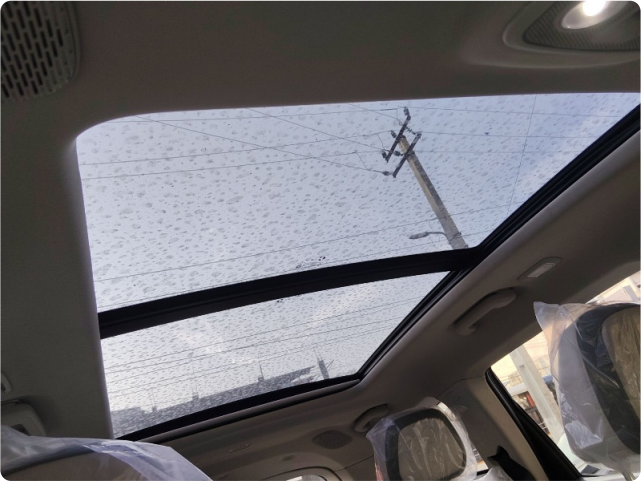
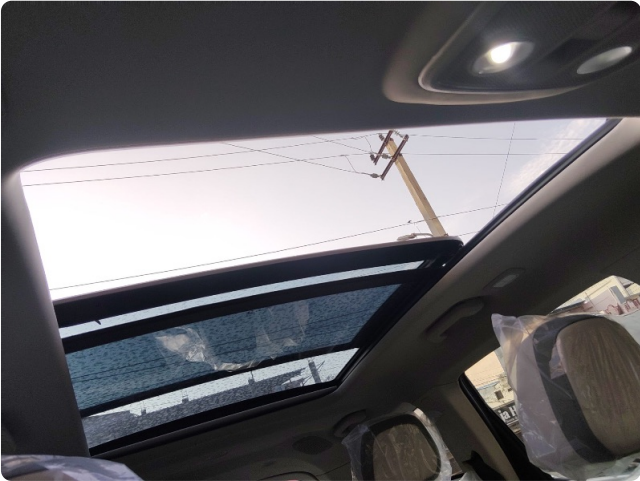
sun roof

Sun Roof

Good

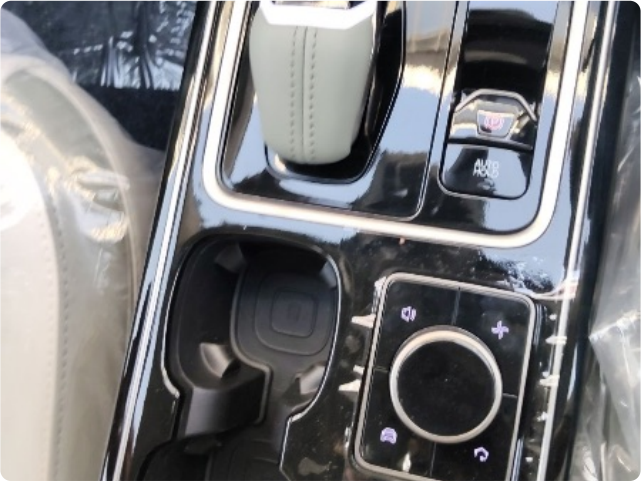
gear knob

Gear Knob

Good

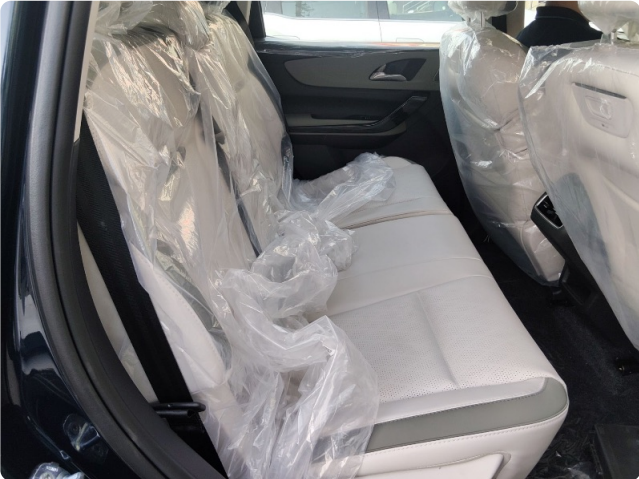
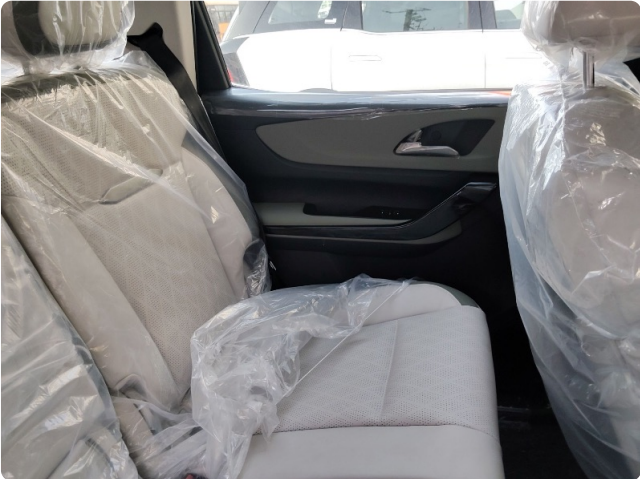
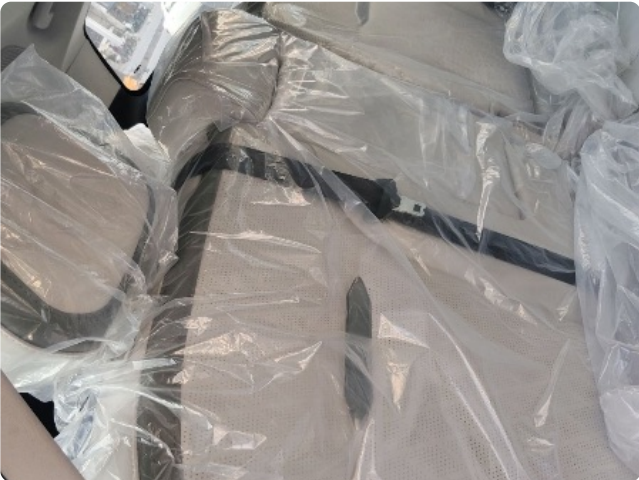
rear seats

Rear Seats

Good

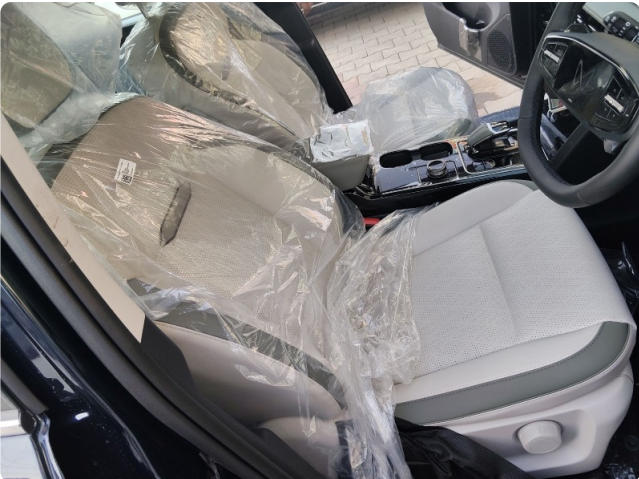
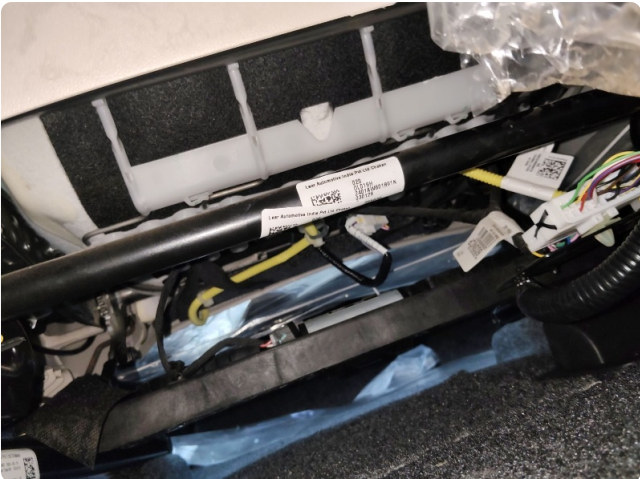
driver seat

Driver Seat

Good

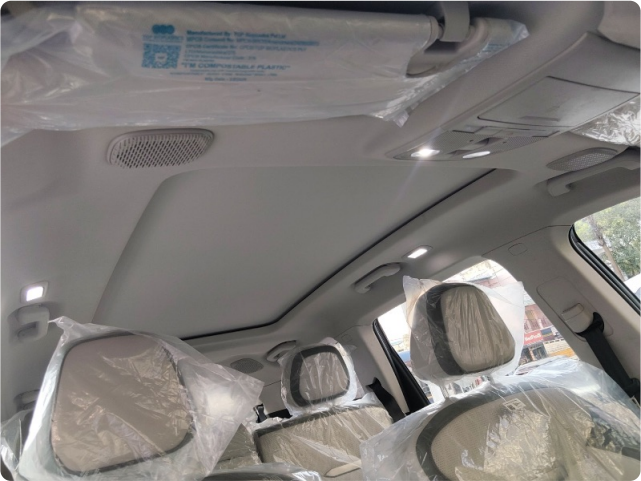
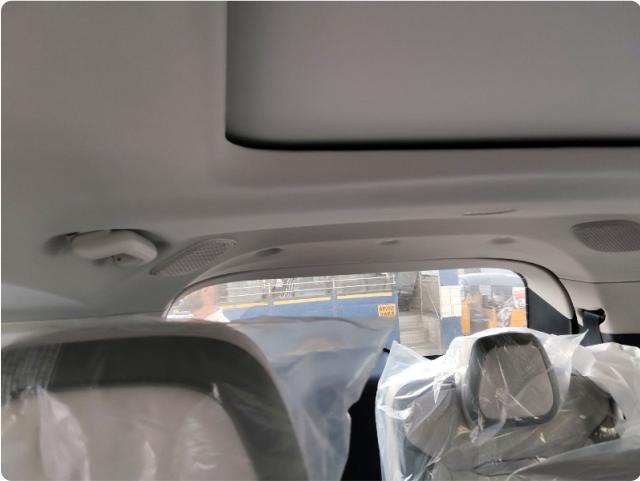
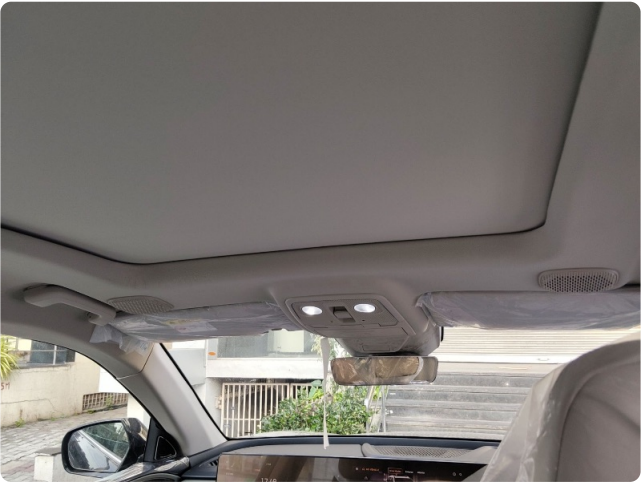
roof lining

Roof Lining

Good

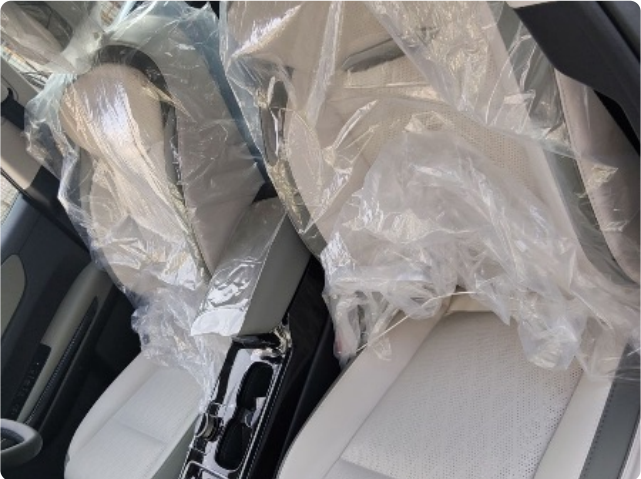
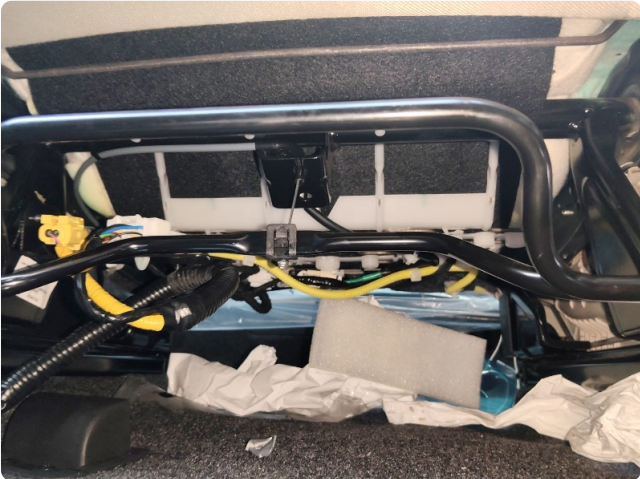
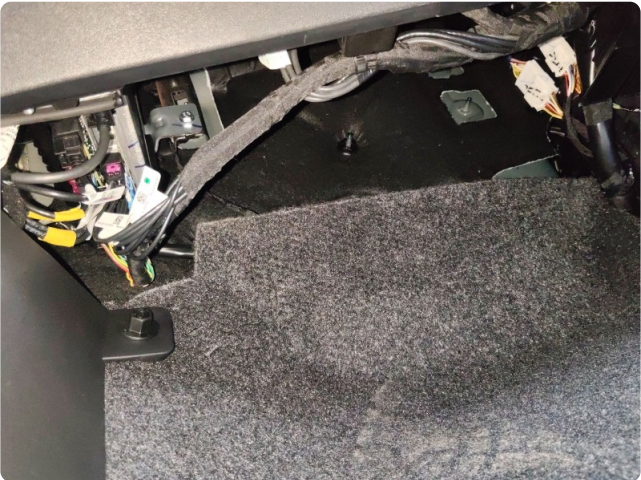
passenger seat

Passenger Seat

Good

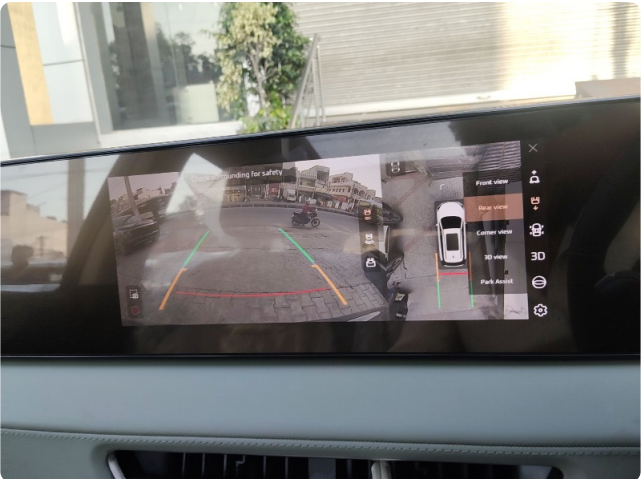
reverse camera

Reverse Camera

Working

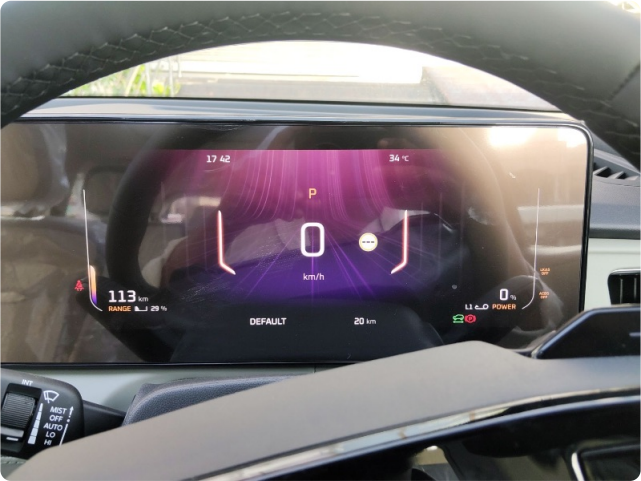
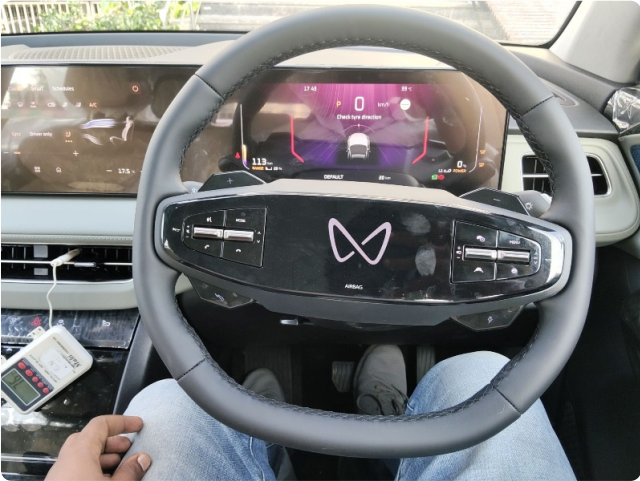
instrument cluster

Warning Lights

Yes

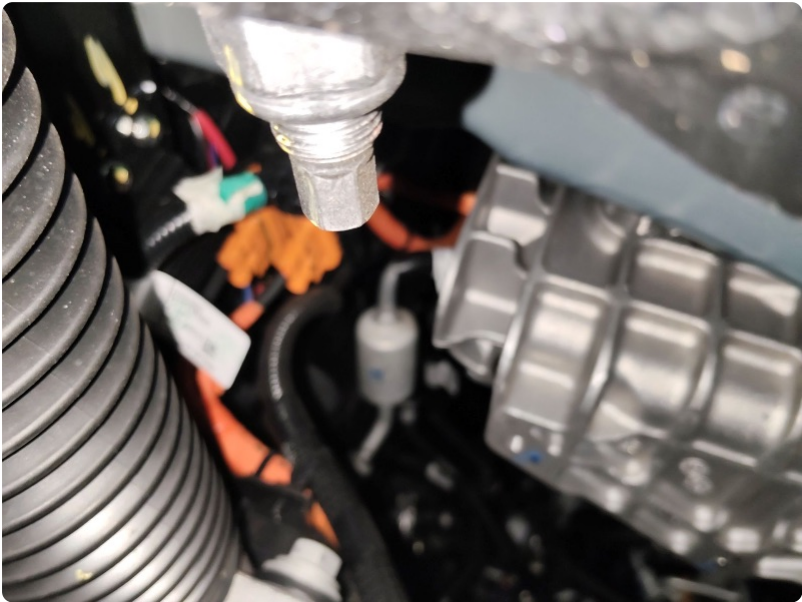
motor photo

| Motor Condition | Good | ● |

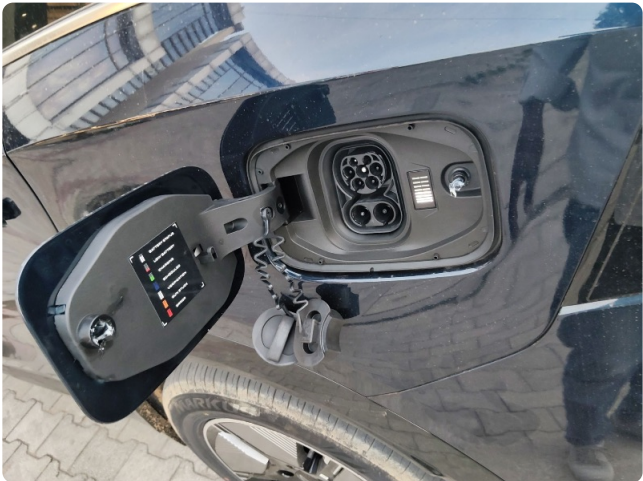
charging port

| Component | Condition | Status |
|---|---|---|
| Charging Port | Good | <div></div> |

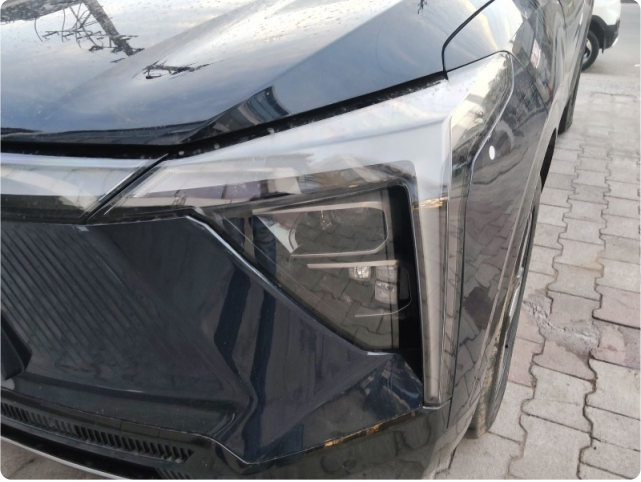
| Lh head light | | |

| Lh Head Light | Good | ● |

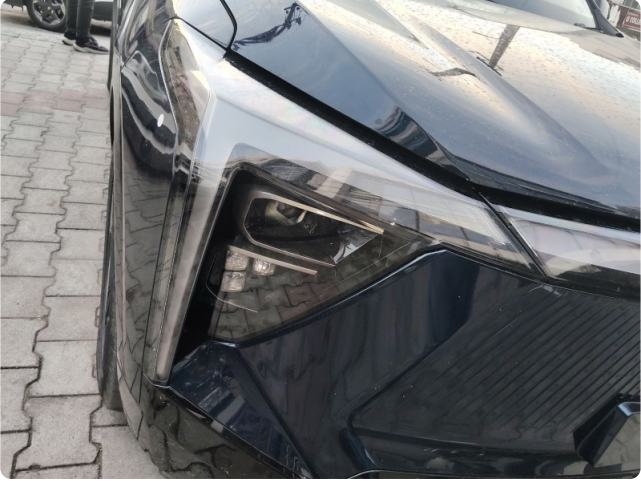
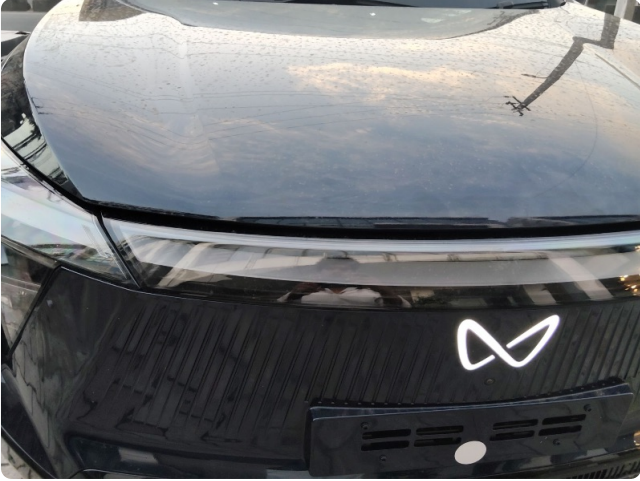
| rh head light | rh head light | |

| Rh Head Light | Good | ● |
