# 360° Car Inspection Report

Report ID: e52a873a

Date: 2026-08-26

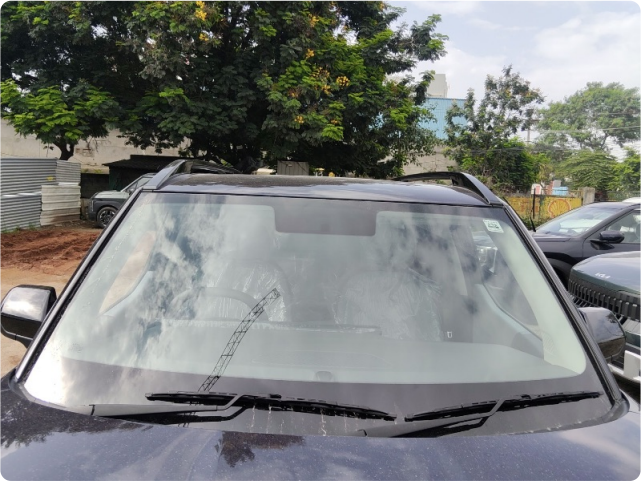
windshield

Good

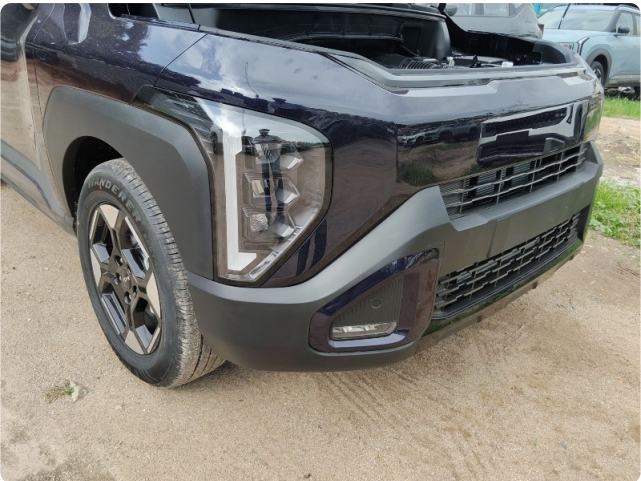
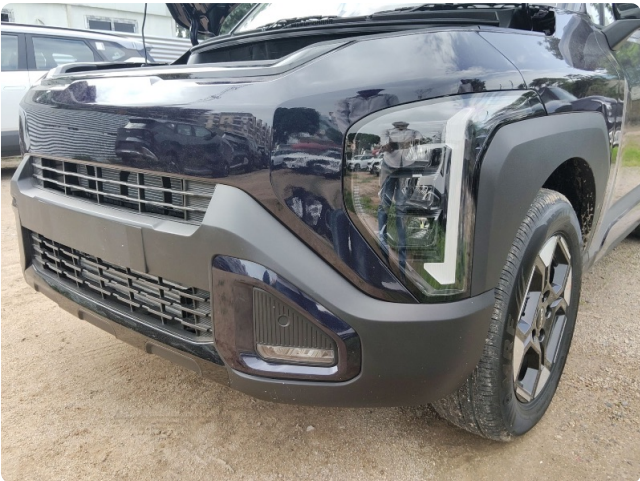
front bumper

Good

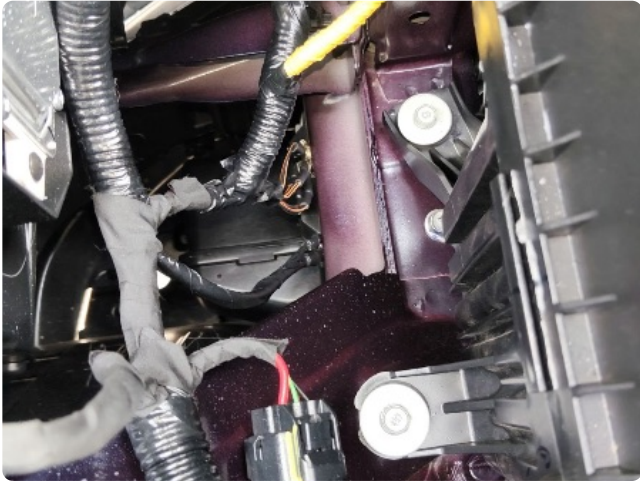
lh leg member

Good

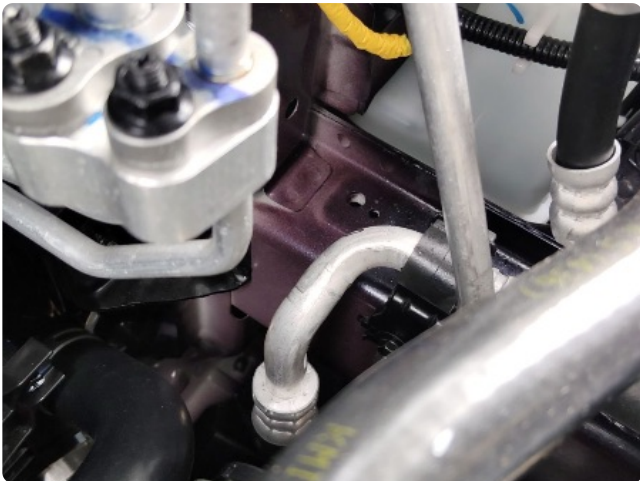
rh leg member

Good

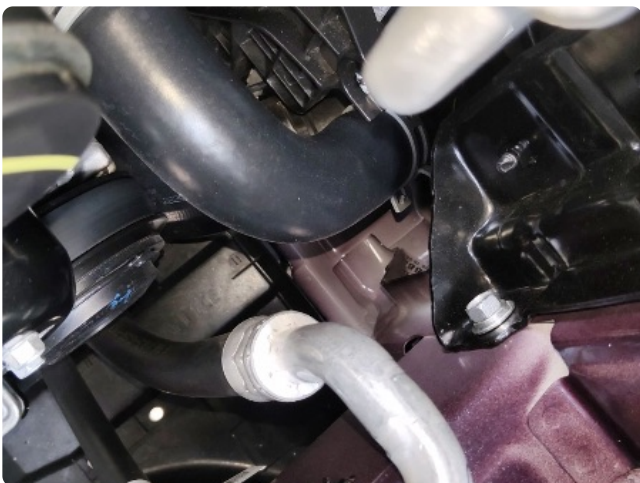
lower cross member

Good

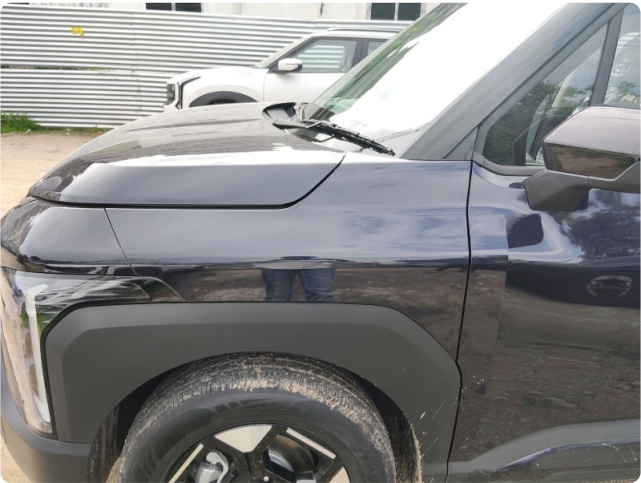
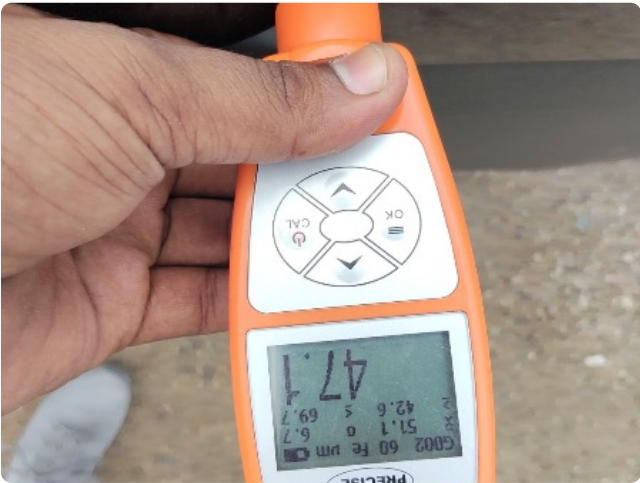
fender

Good

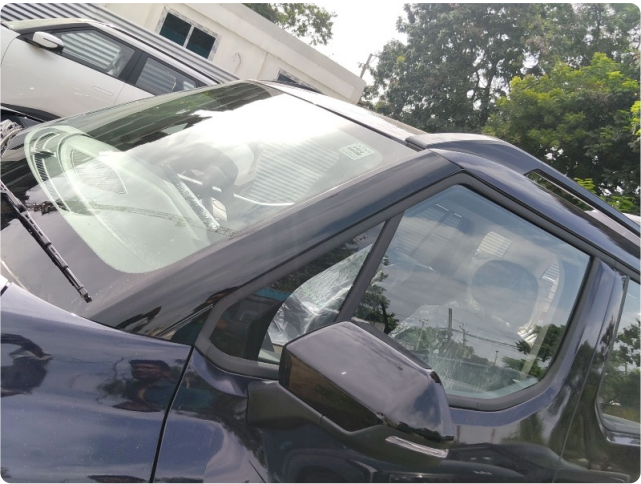
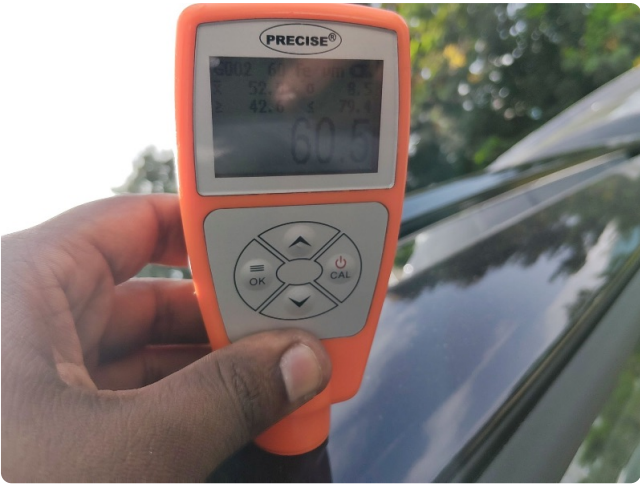
a pillar

Good

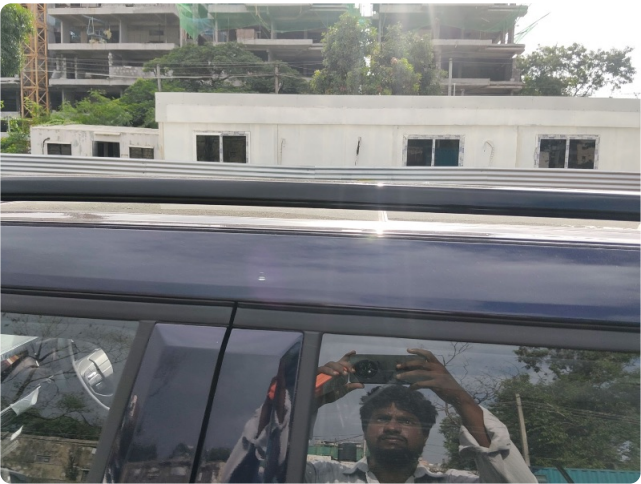
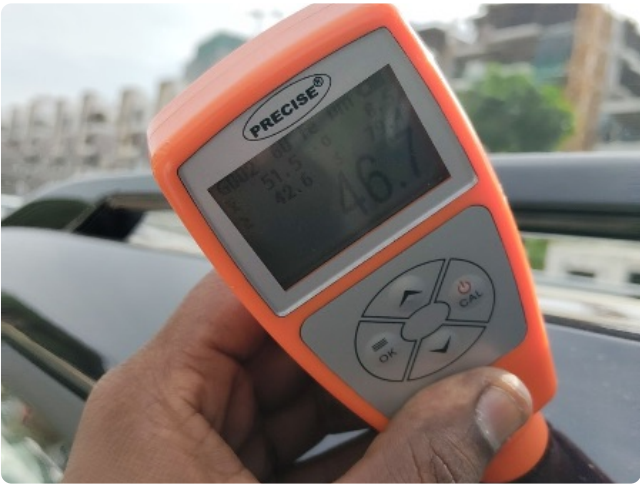
b pillar

Good

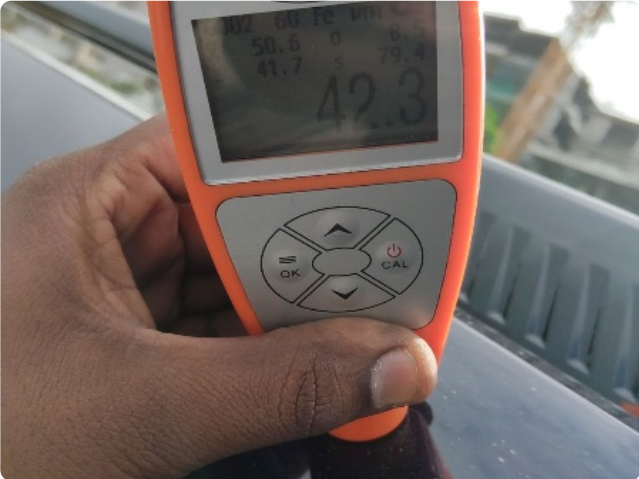
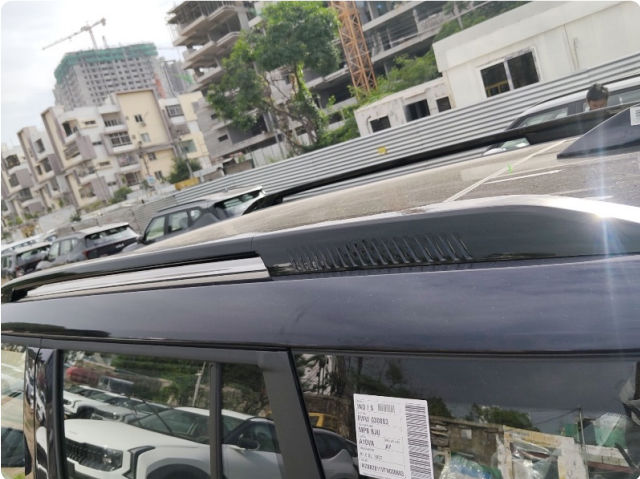
c pillar

Good

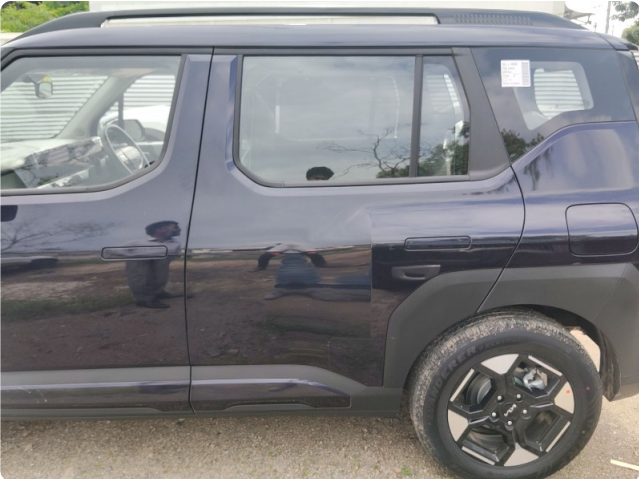
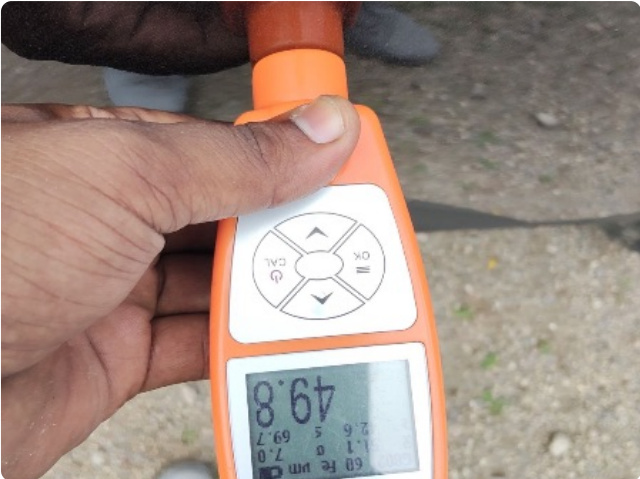
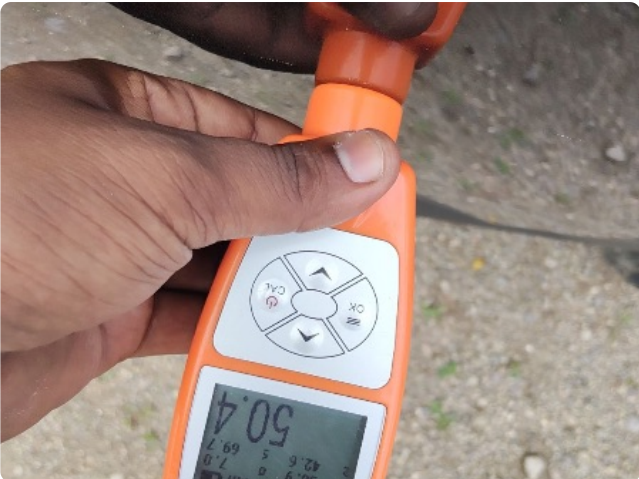
rear door

Good

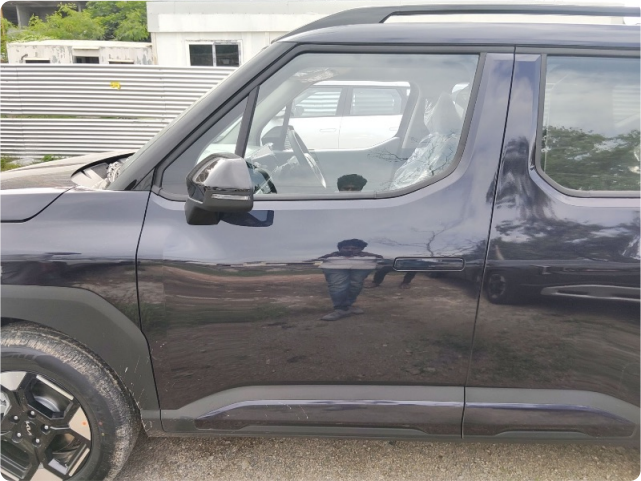
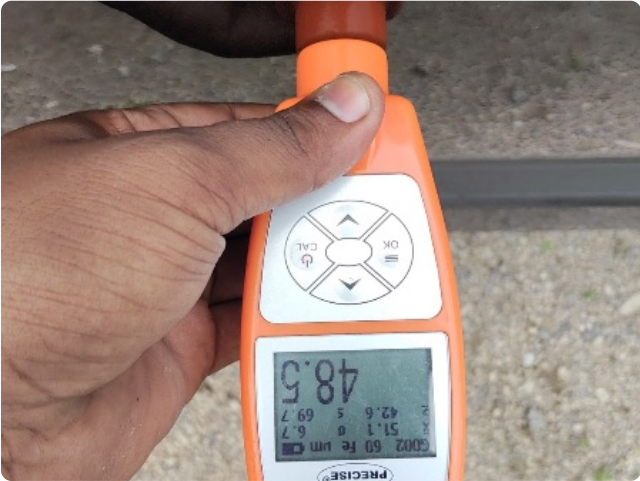
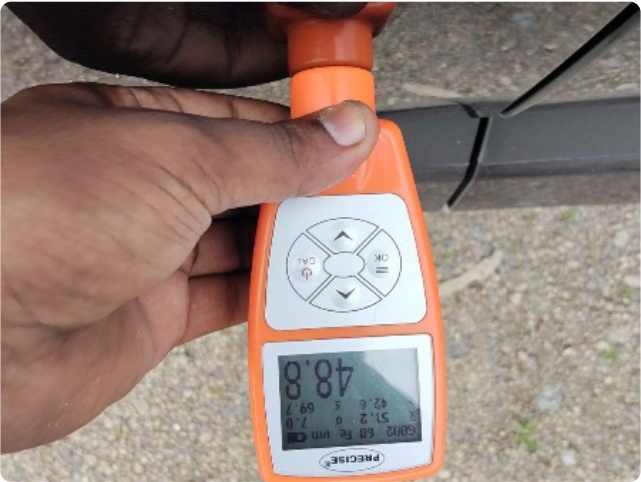
front door

Good

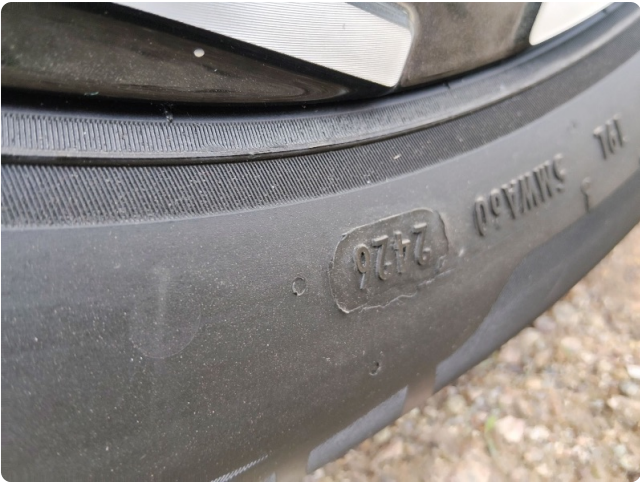
rear tyre

80%-100%

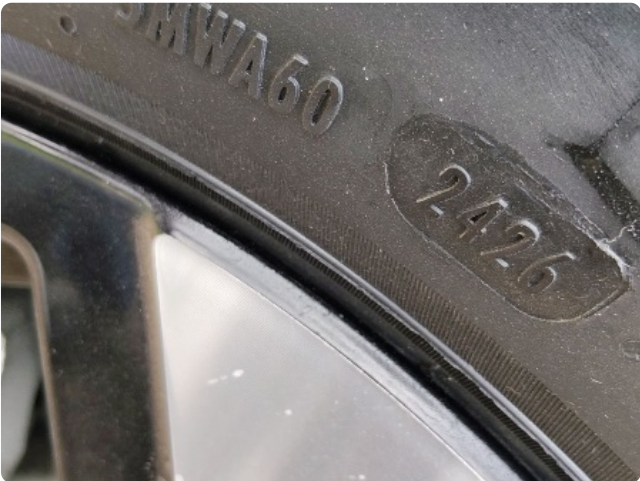
spare tyre

80%-100%

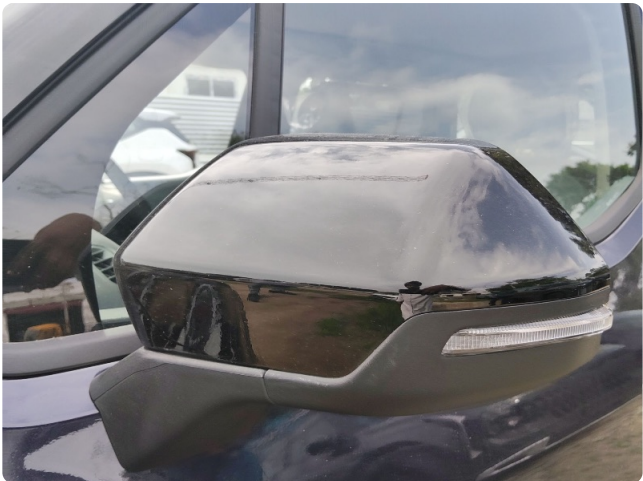
orvm mirror

Good

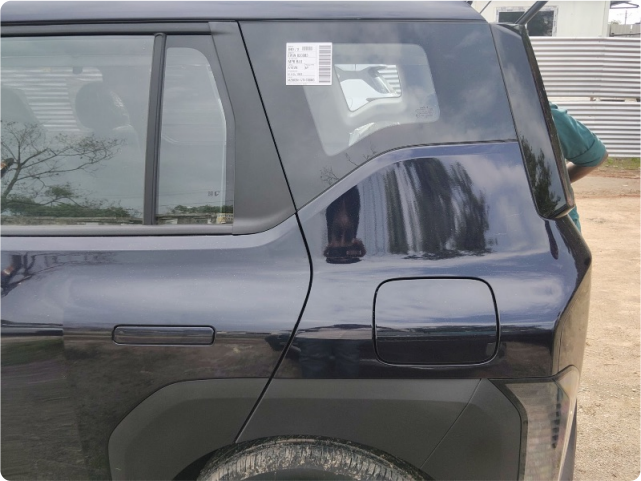
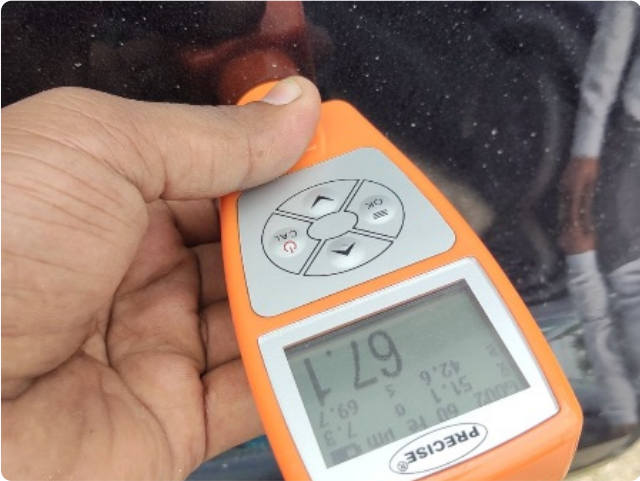
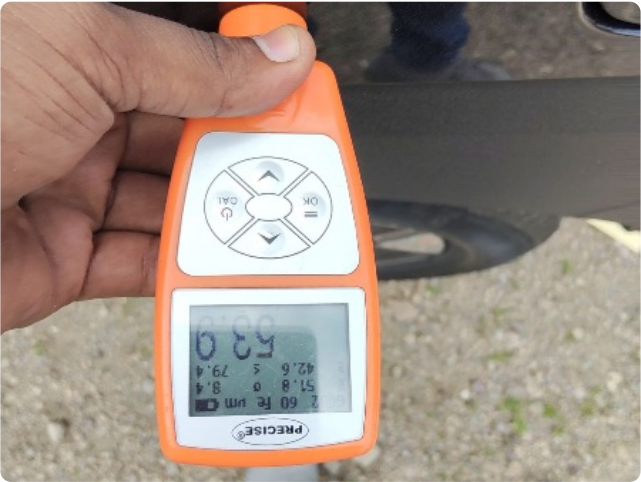
quarter panel

Good

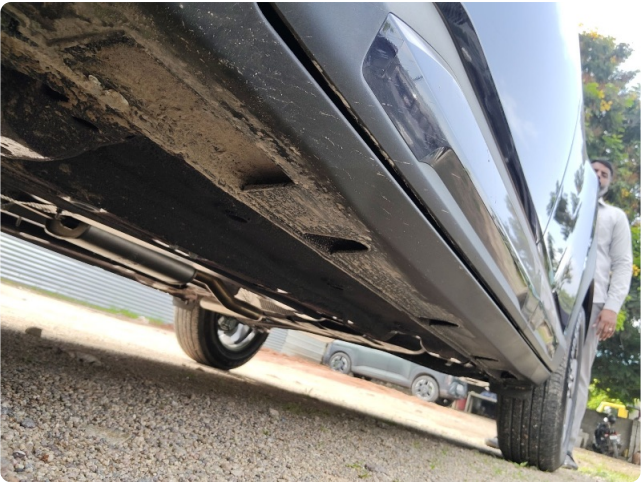
running board

Good

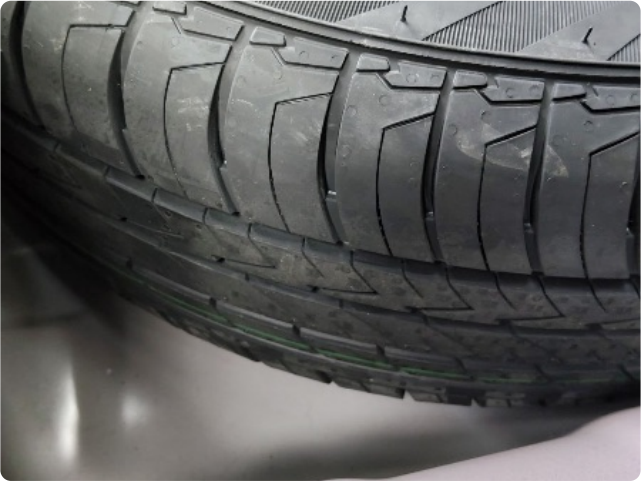
spare tyre

80%-100%

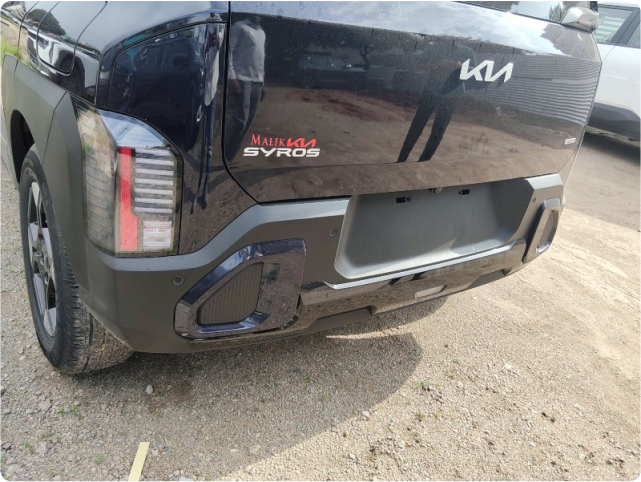
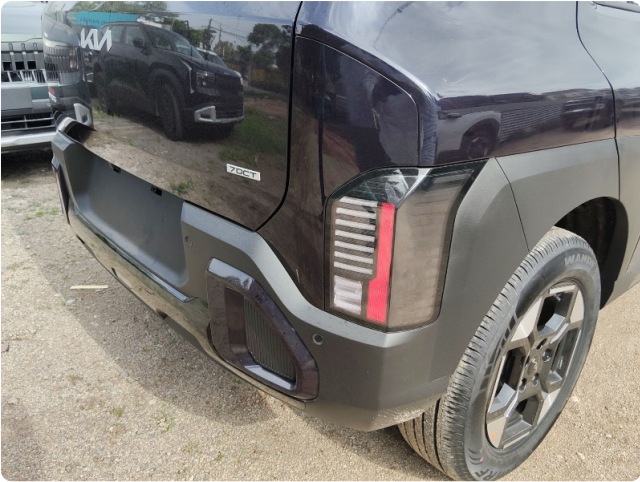
rear bumper

Good

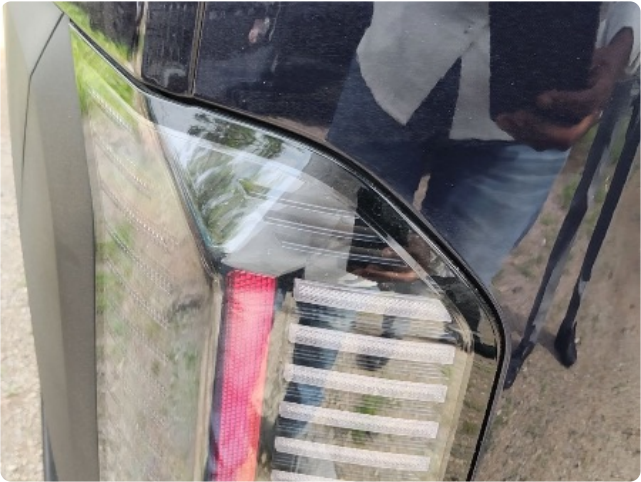
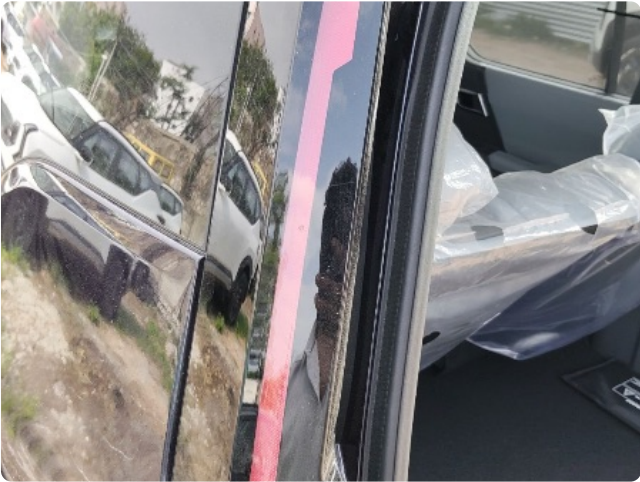
tail light lh

Good

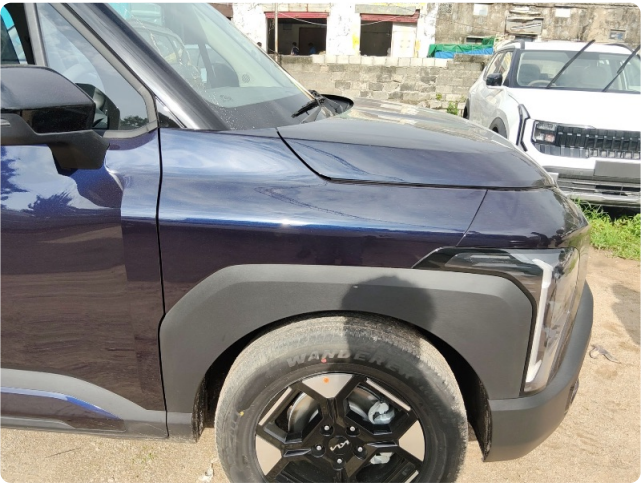
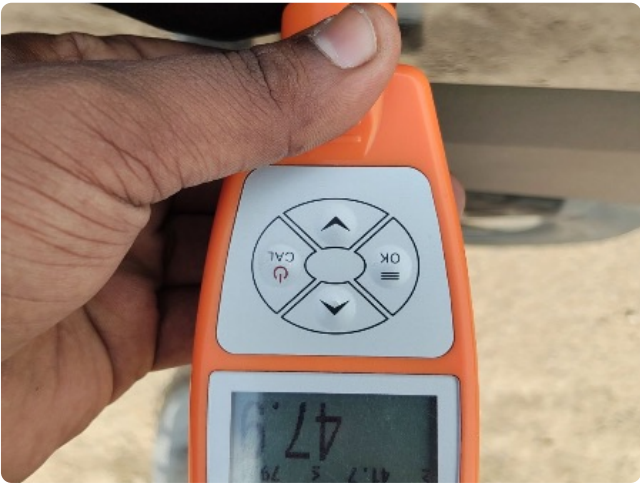
fender

Good

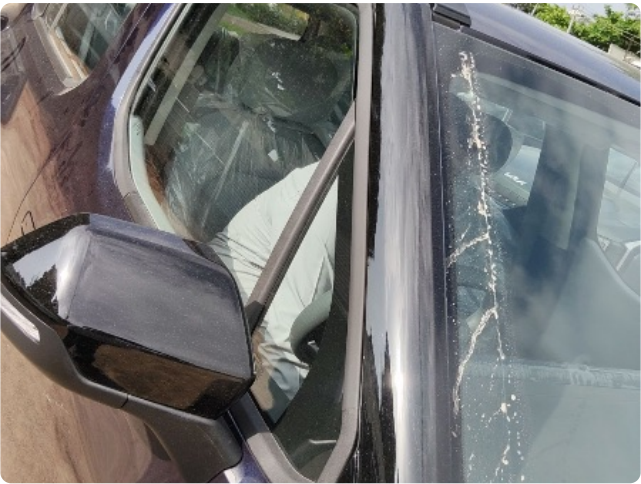
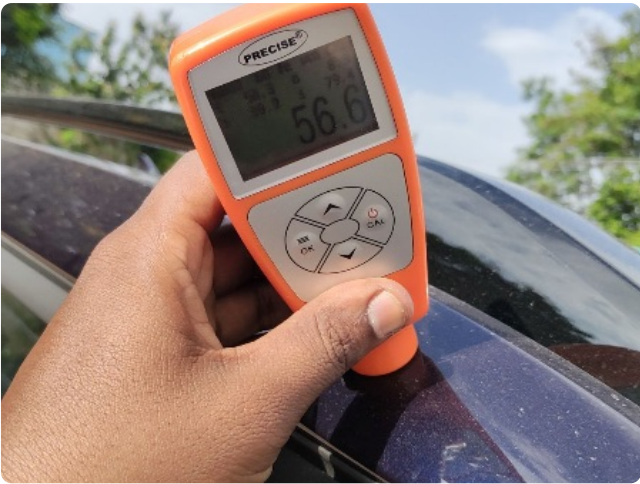
a pillar

Good

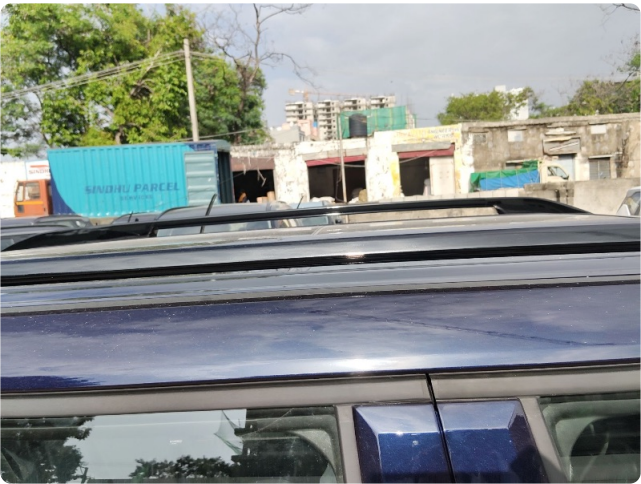
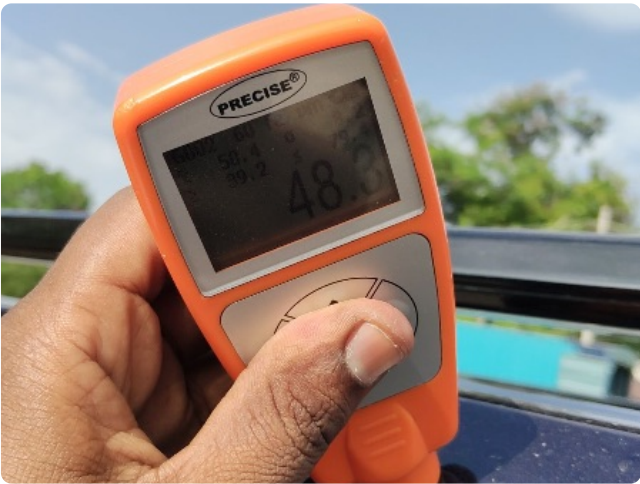
b pillar

Good

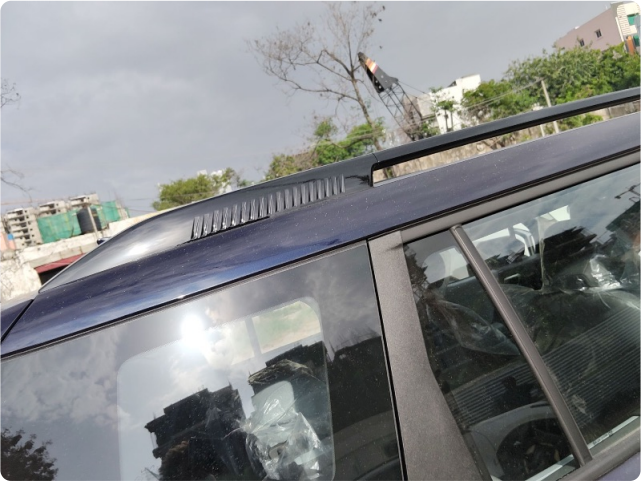
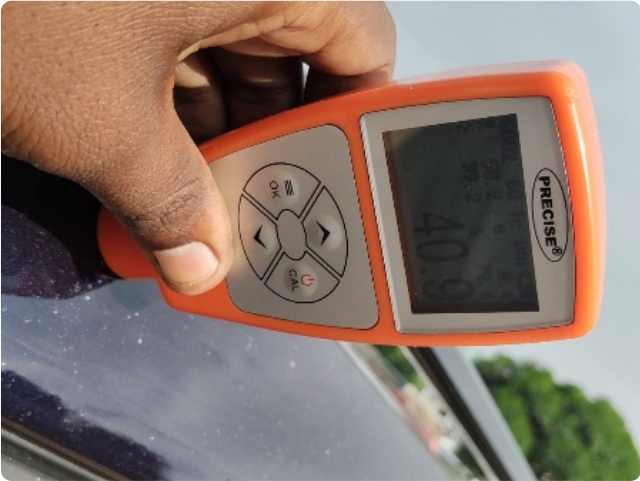
c pillar

Good

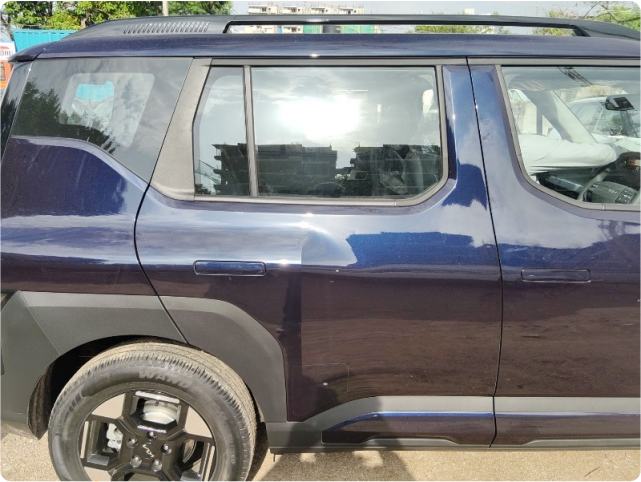
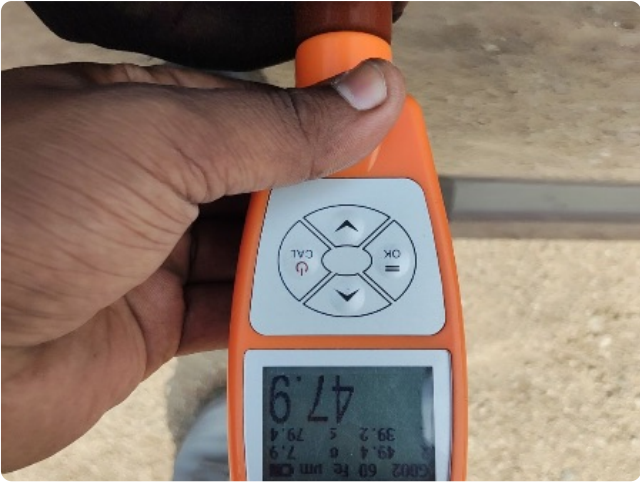
rear door

Good

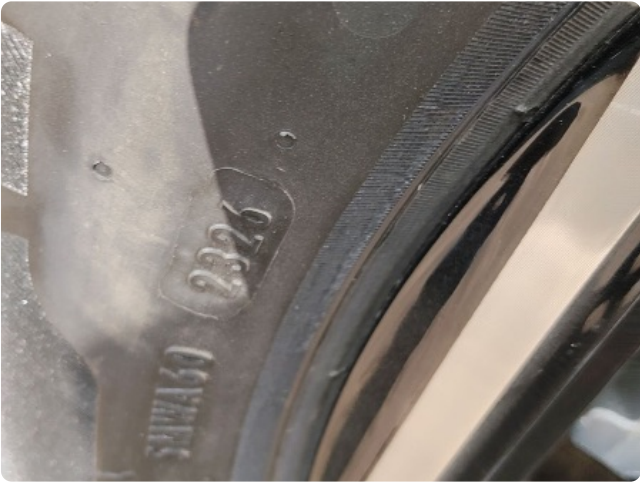
rear tyre

80%-100%

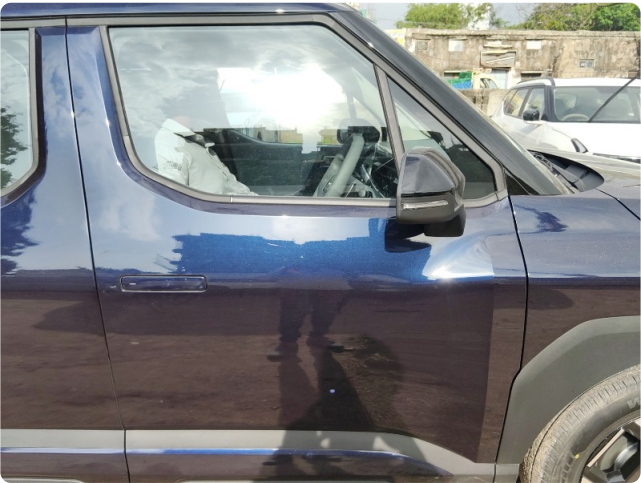
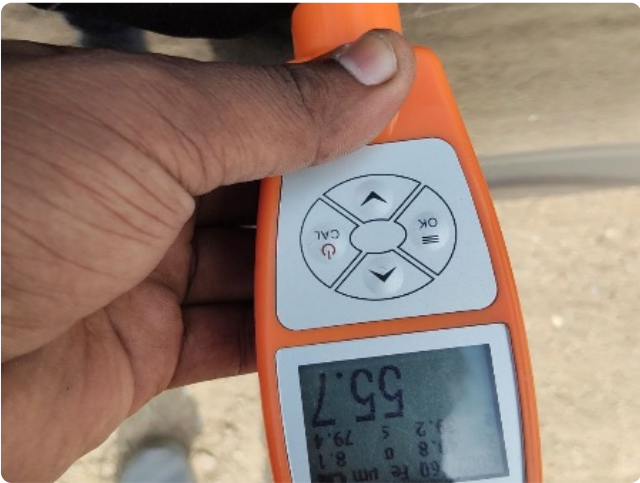
front door

Good

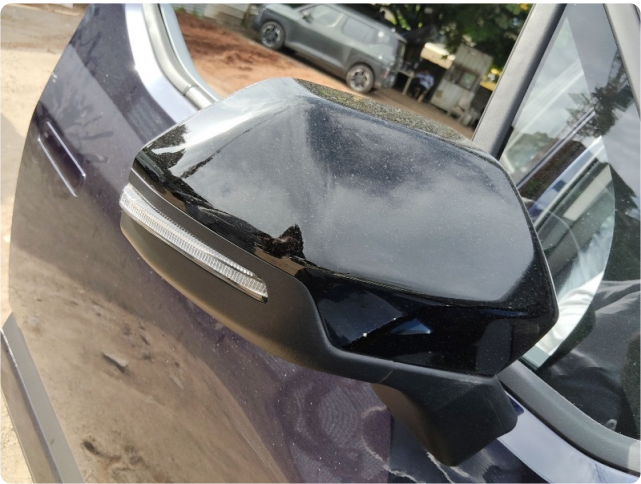
orvm mirror

Good

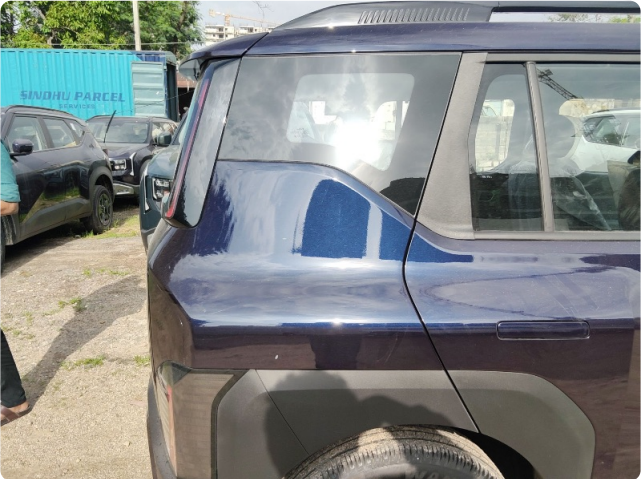
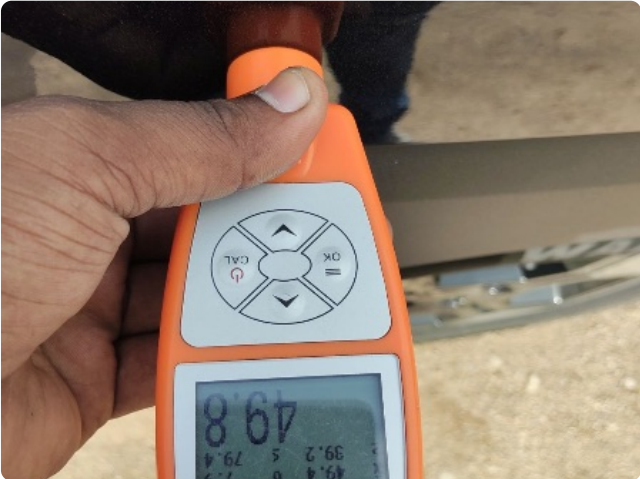
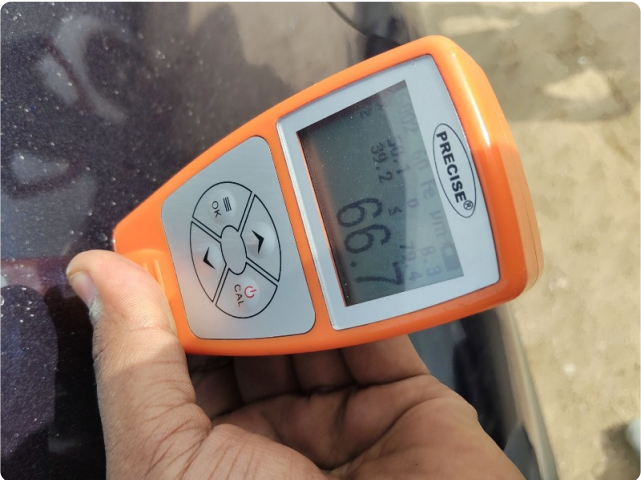
quarter panel

Good

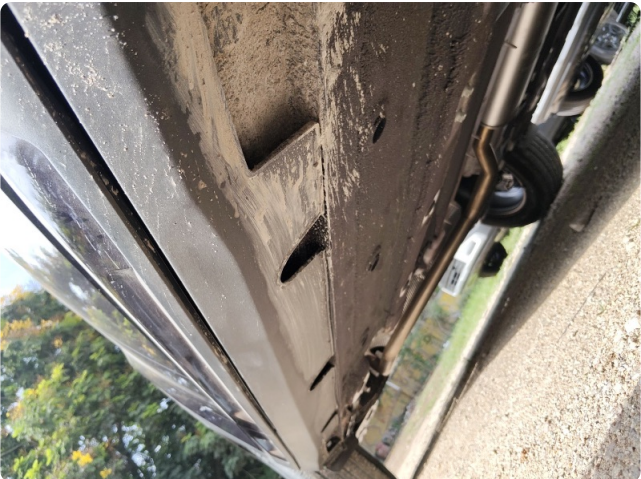
running board

Good

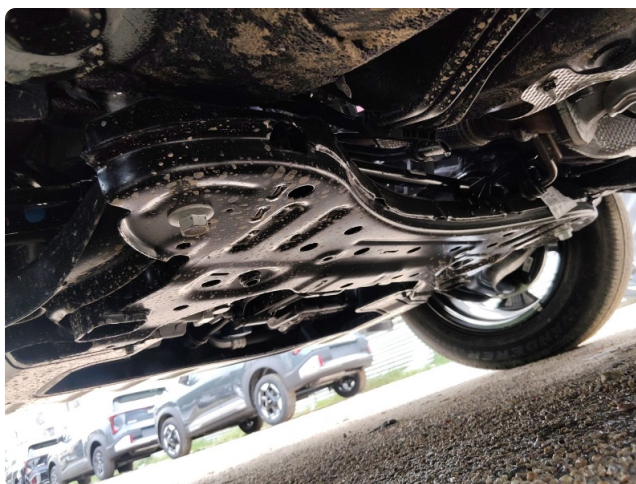
chassis

| Component | Condition | Status |
|---|---|---|
| Chassis | Good | <span style="color: green;">●</span> |

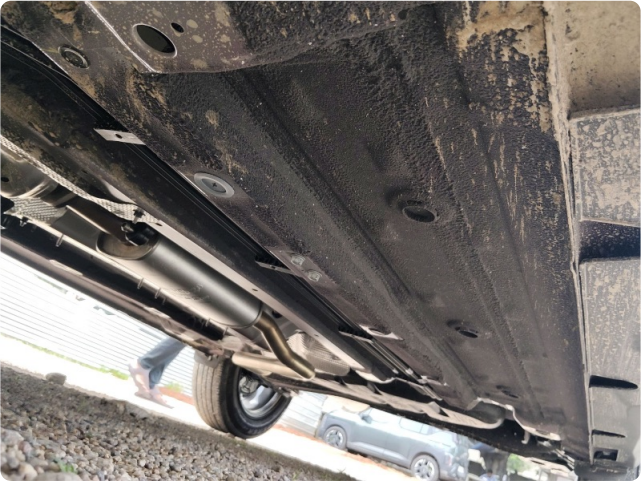
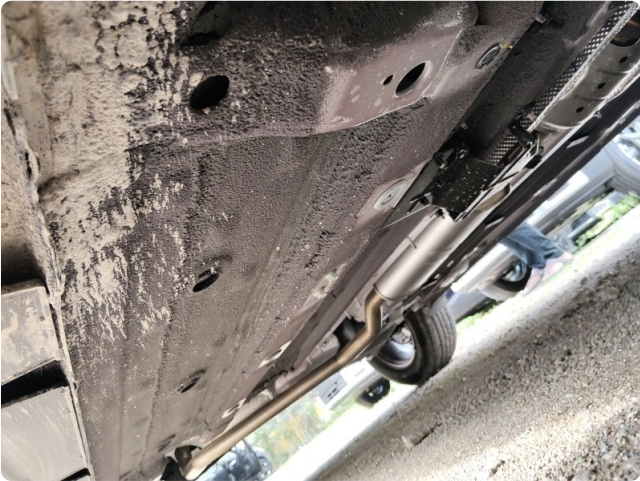
floor pan

Good

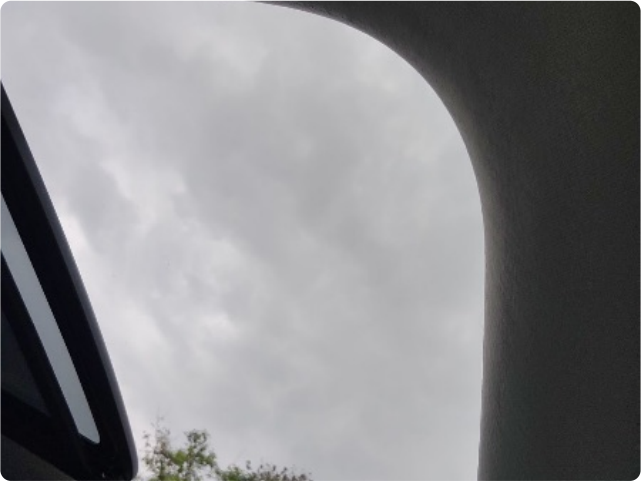
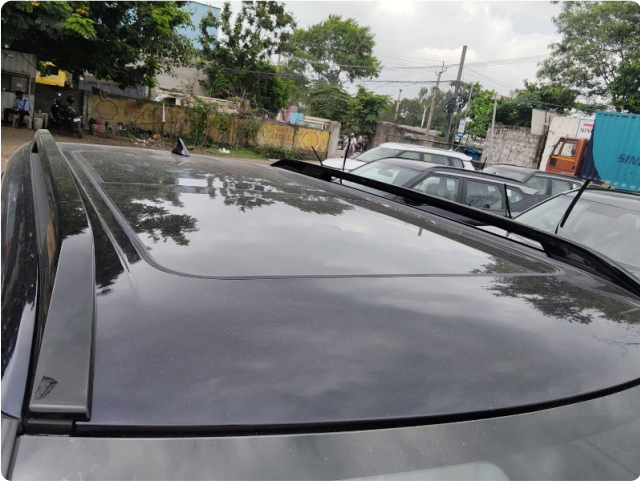
sun roof

Good

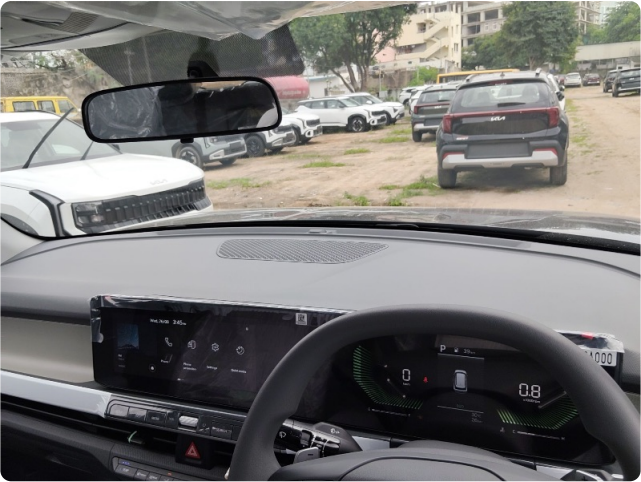
dashboard

Good

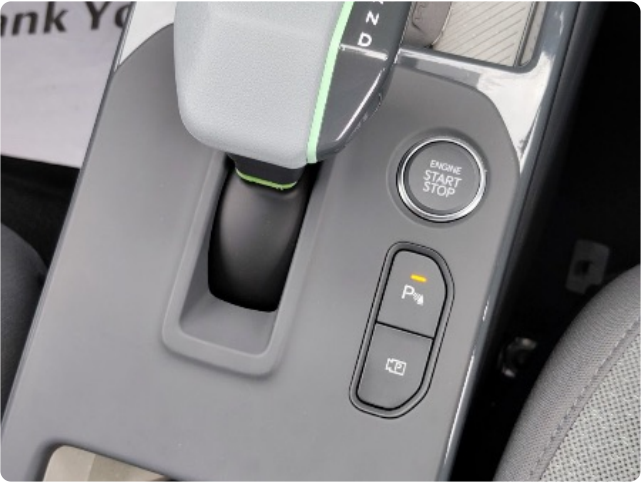
gear knob

Gear Knob

Good

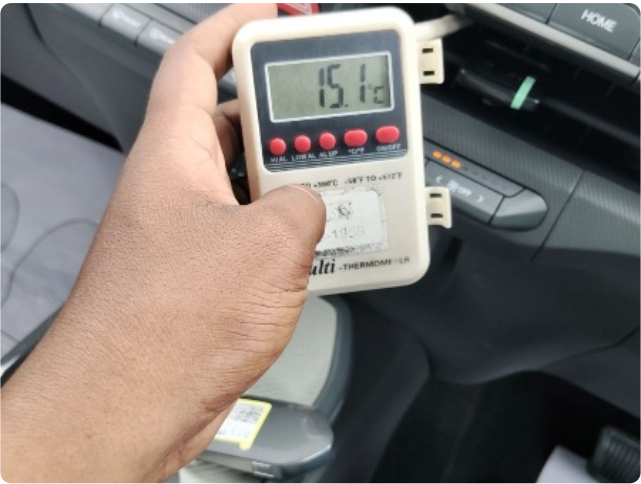
ac cooling

Ac Cooling

Excellent

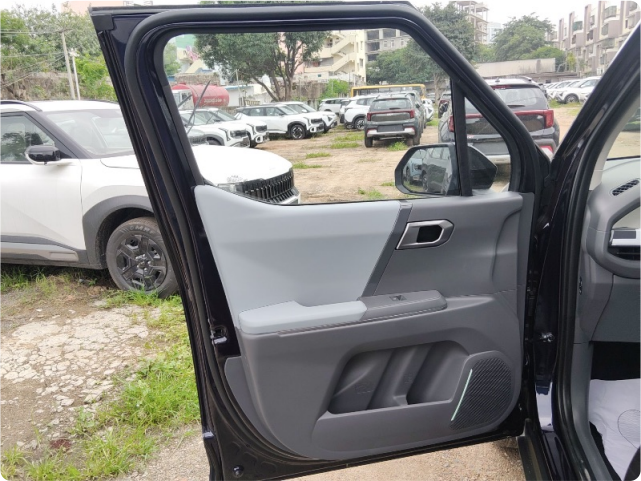
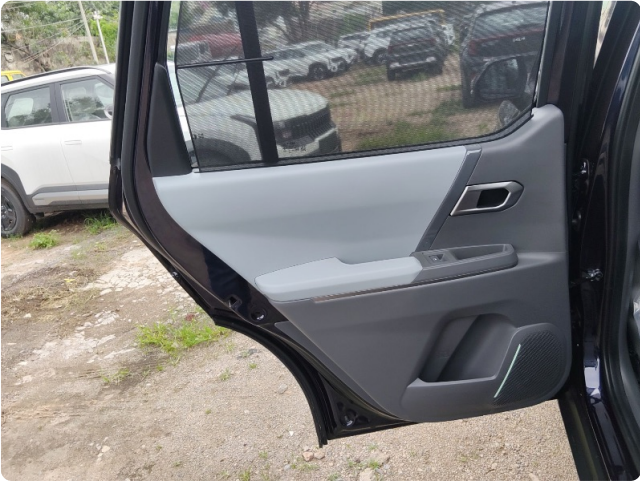
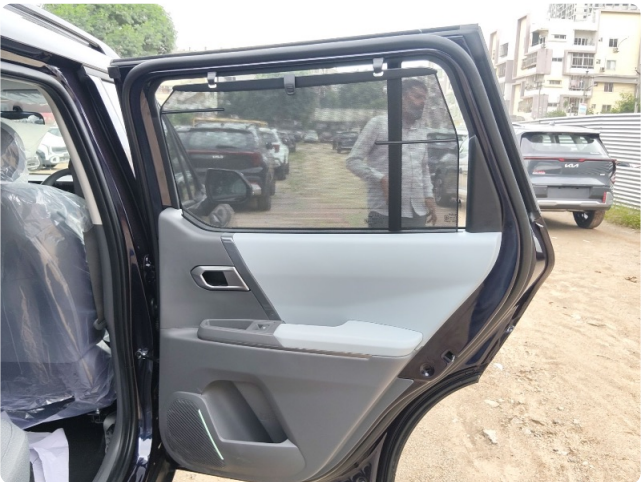
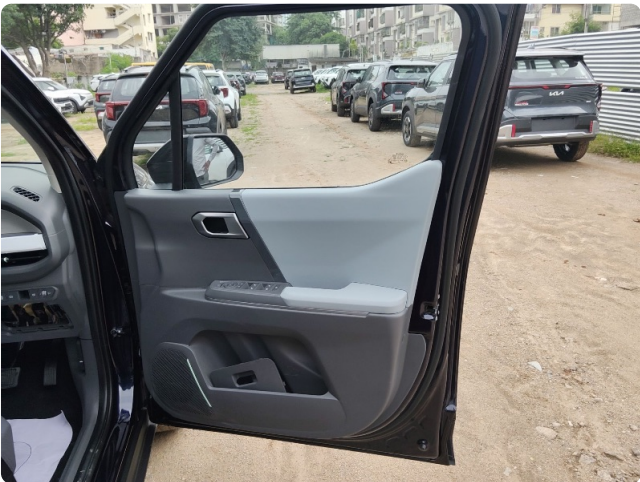
door trims

Door Trims

Good

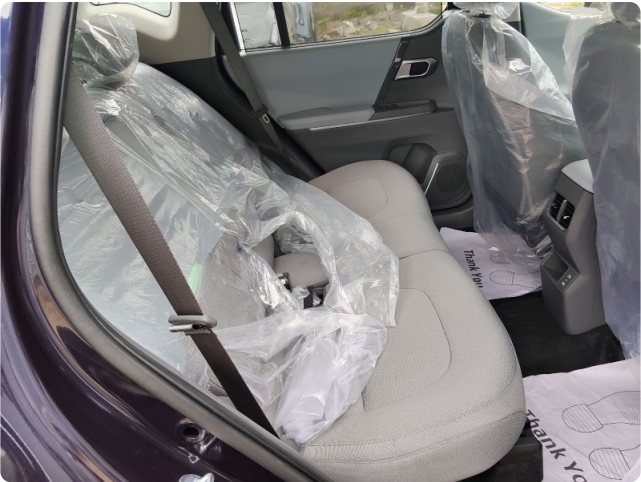
rear seats

Rear Seats

Good

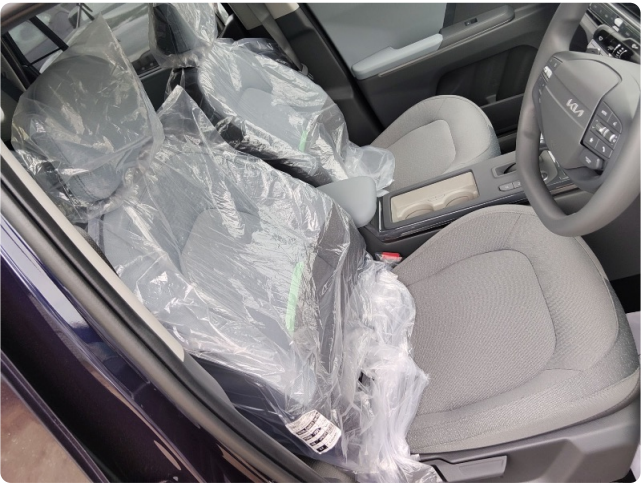
driver seat

Driver Seat

Good

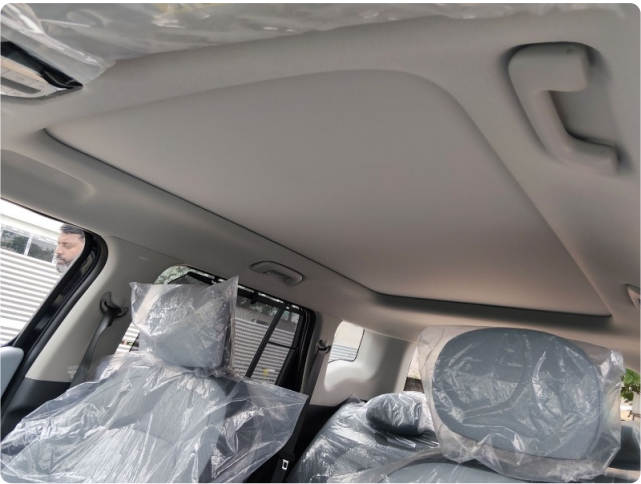
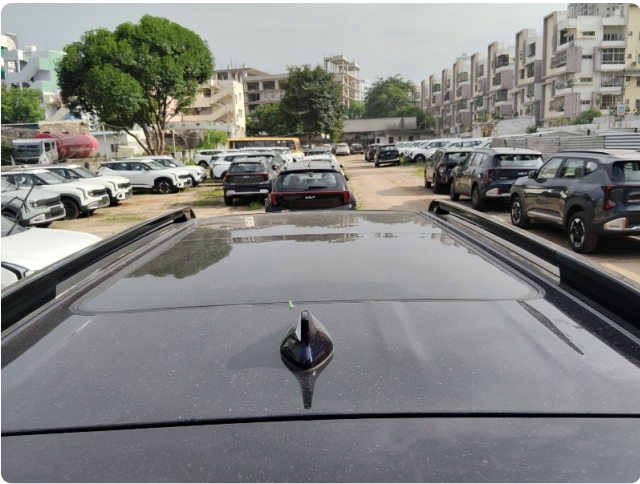
roof lining

Roof Lining

Good

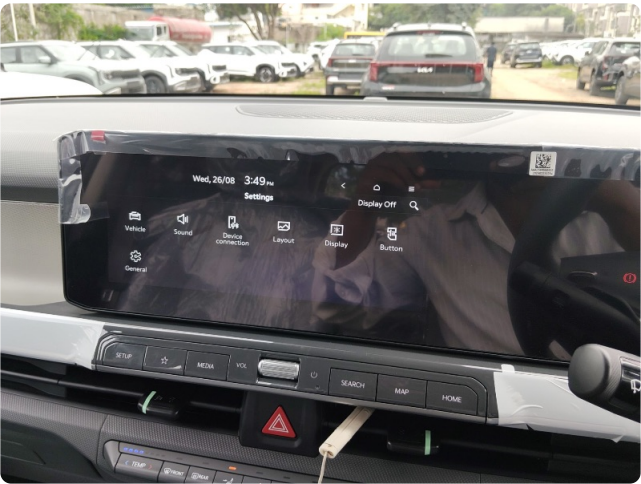
infotainment

Infotainment

Working

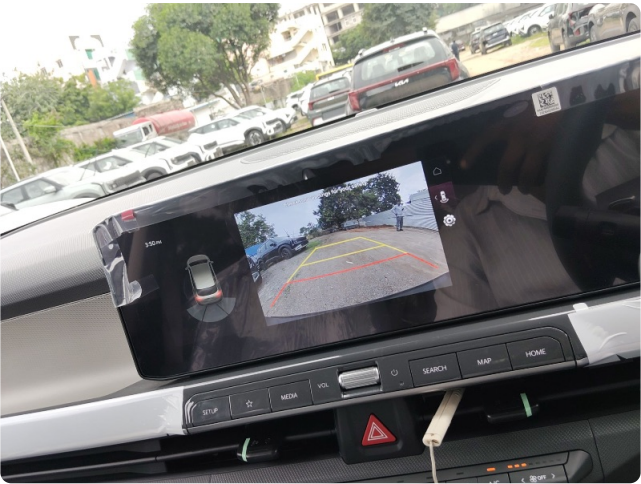
reverse camera

Reverse Camera

Working

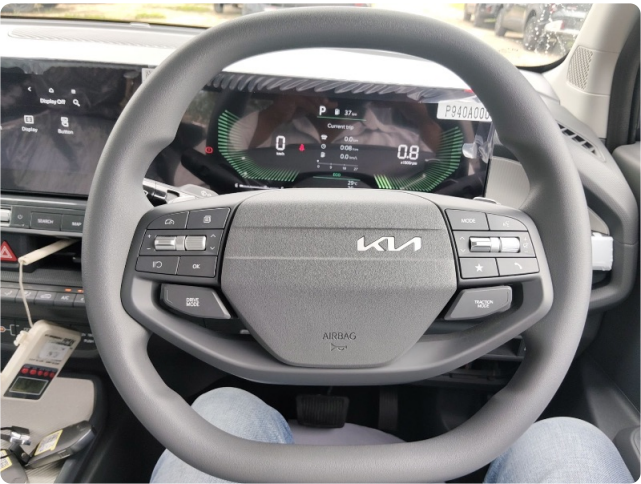
steering wheel

Steering Wheel

Good

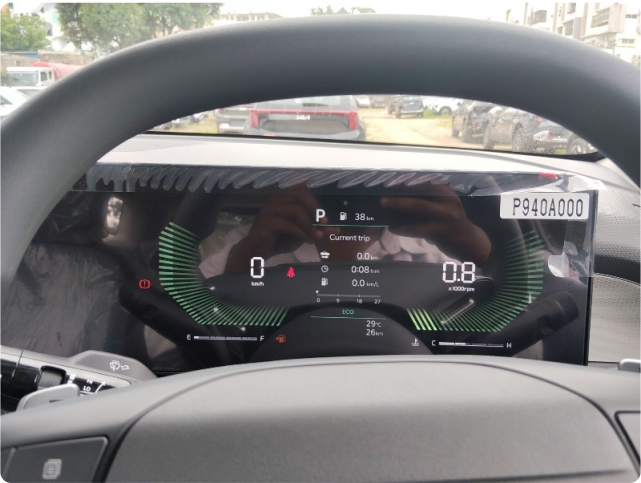
instrument cluster

Warning Lights

Yes

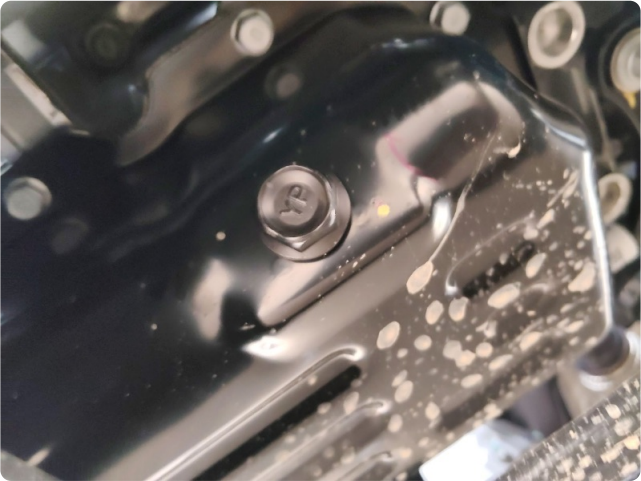
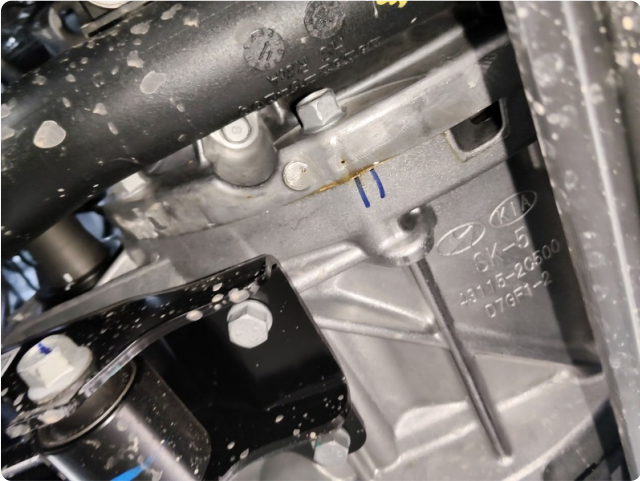
sump

Sump

Good

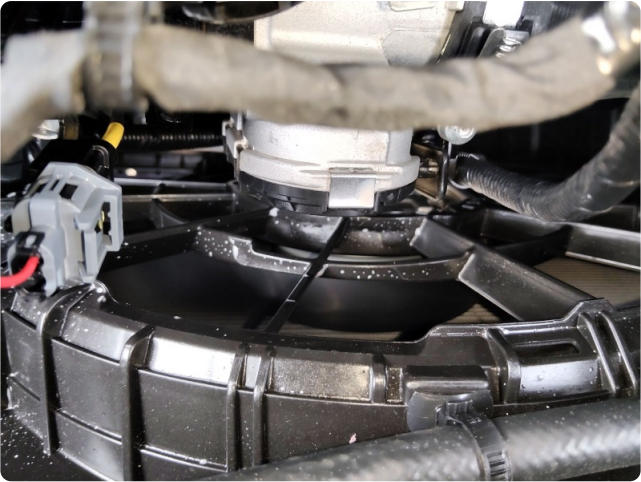
radiator

Radiator

Good

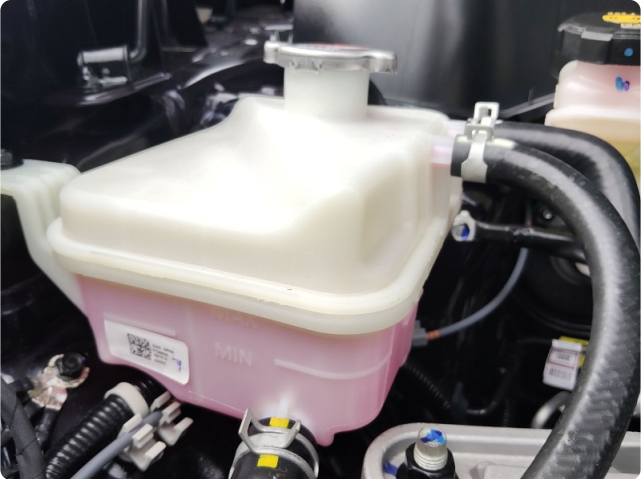
coolant color

| Coolant Color | Green/Normal | ● |
