# 360° Car Inspection Report

Report ID: e52a873a

Date: 2026-08-26

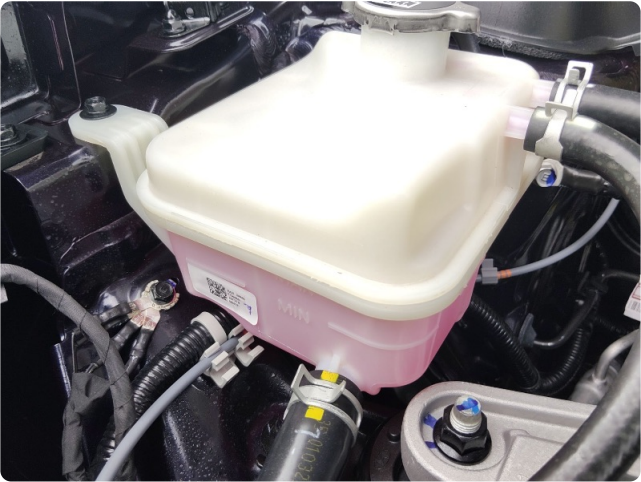
coolant level

| Coolant Level | Full | ● |

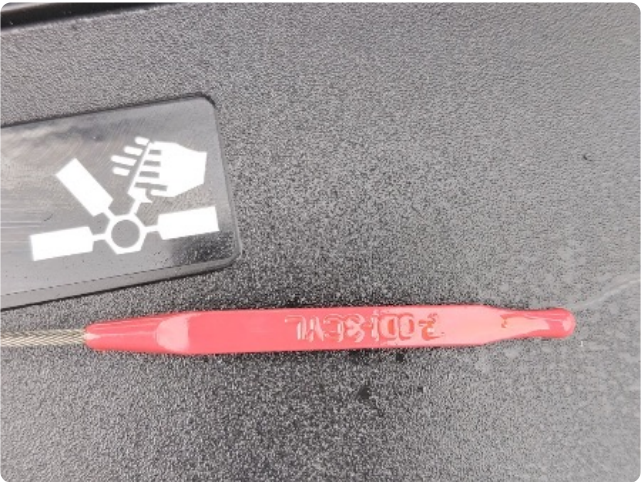
engine oil level

| Engine Oil Level | Full | ● |

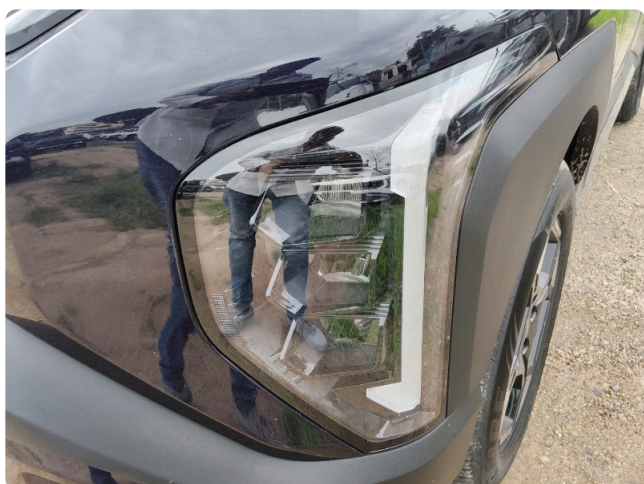
Lh head light

| Component | Condition | Status |
|---|---|---|
| Lh Head Light | Good | ● |

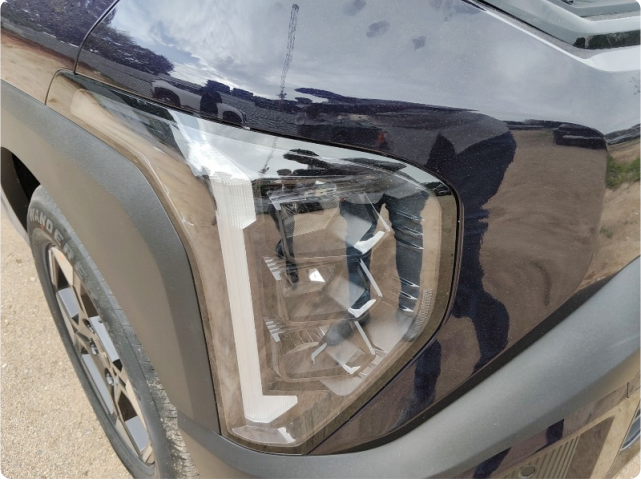
| rh head light | | |

| Rh Head Light | Good | ● |
