# 360° Car Inspection Report

Report ID: ca2f493f

Date: 2026-08-25

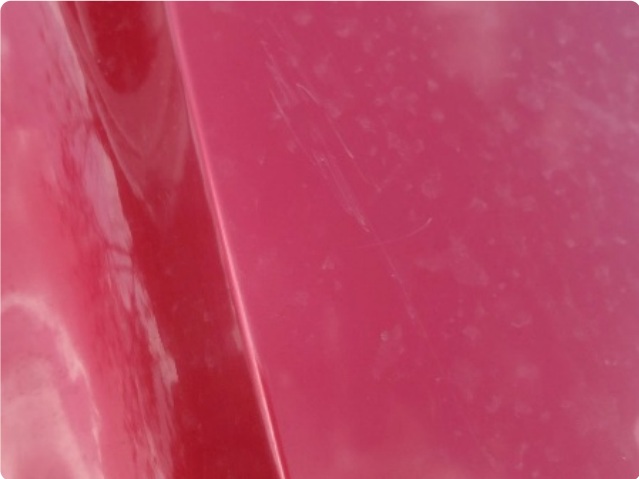
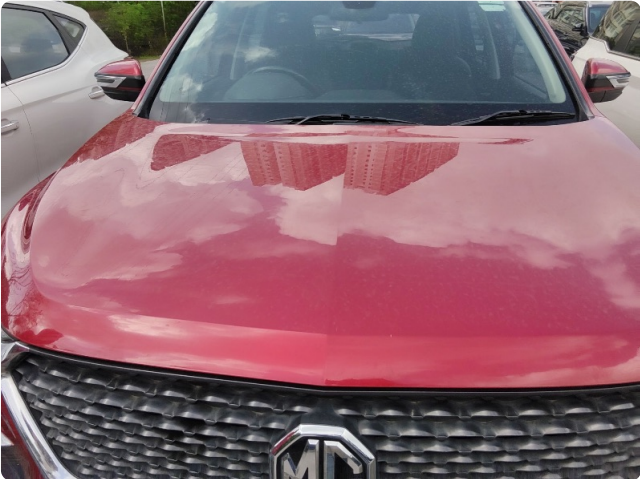
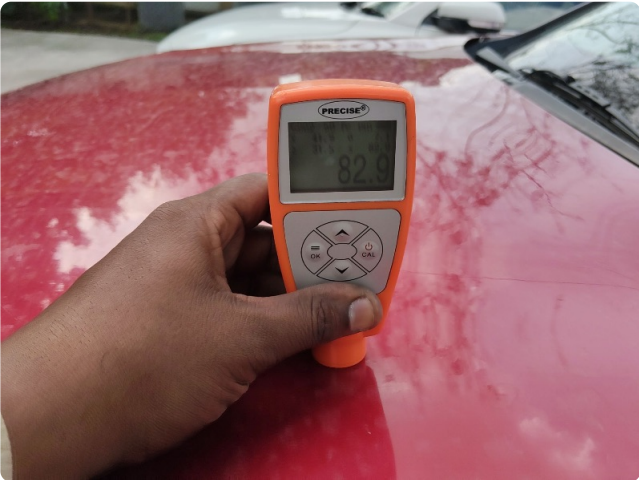
Bonnet

Scratch

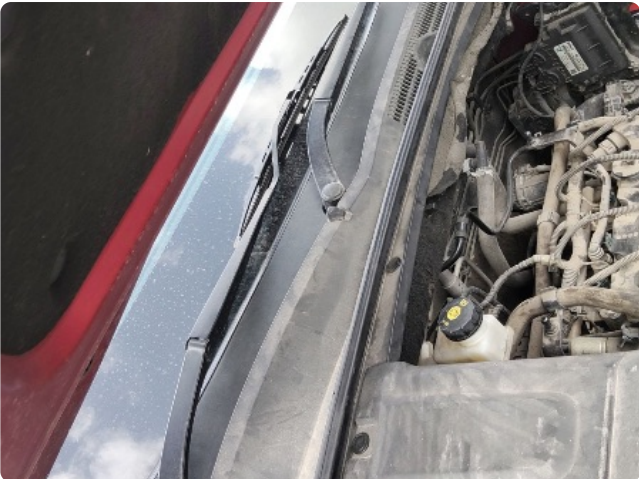
Clow Top

Good

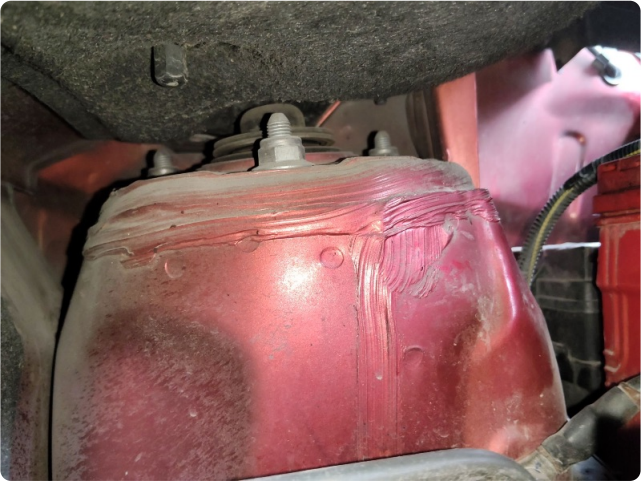
Lh Apron

Good

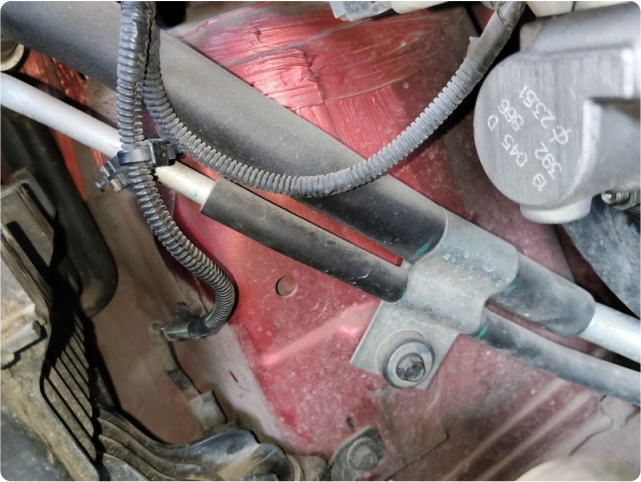
Rh Apron

Good

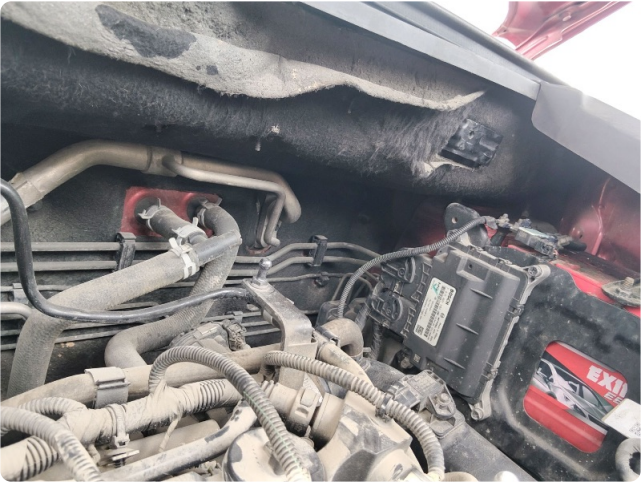
Fire Wall

Good

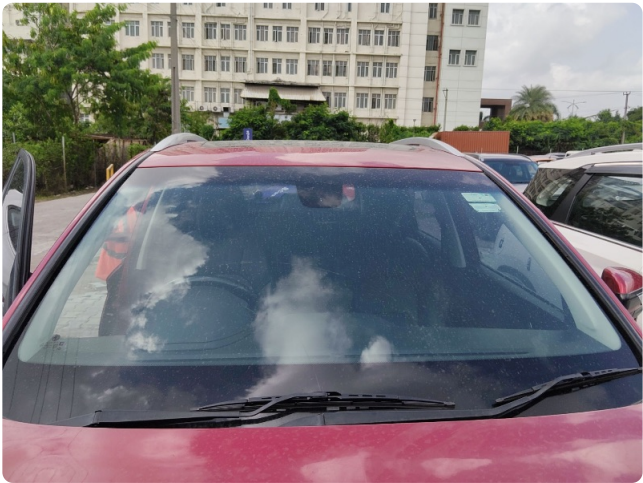
Windshield

Good

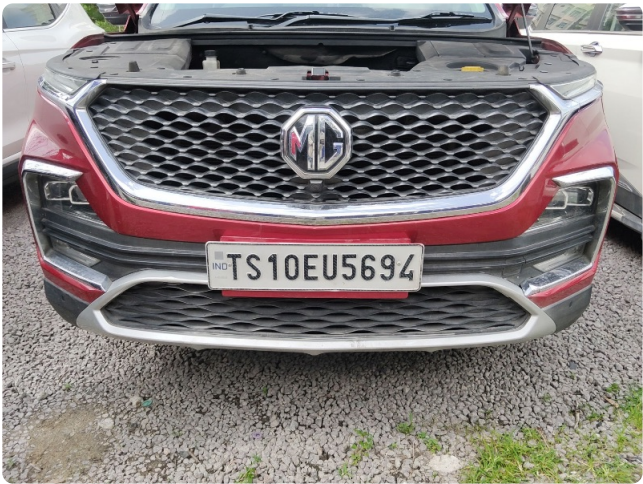
Front Grille

Good

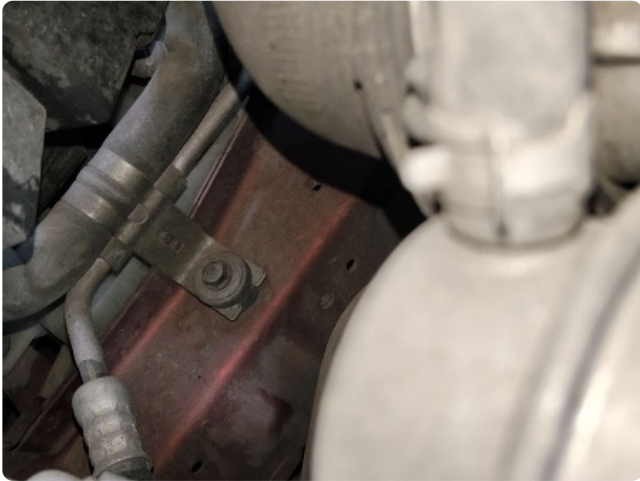
Lh Leg Member

Good

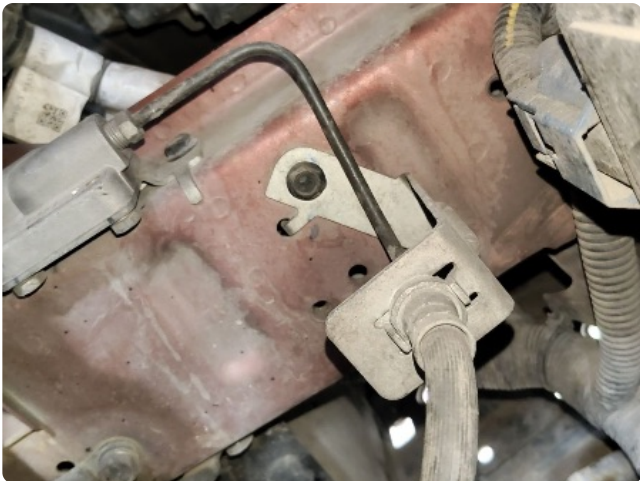
Rh Leg Member

Good

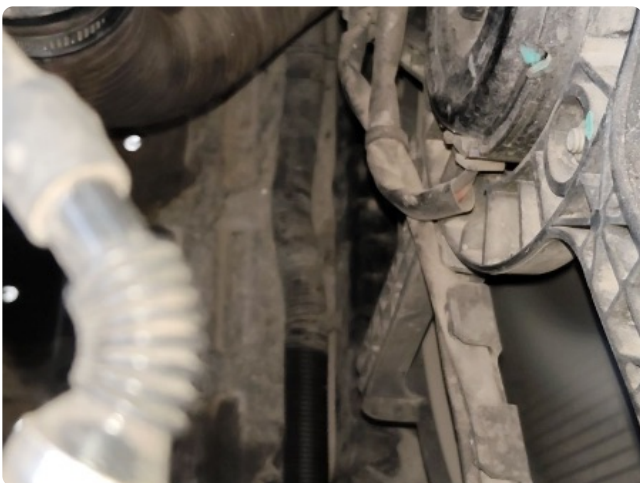
Lower Cross Member

Good

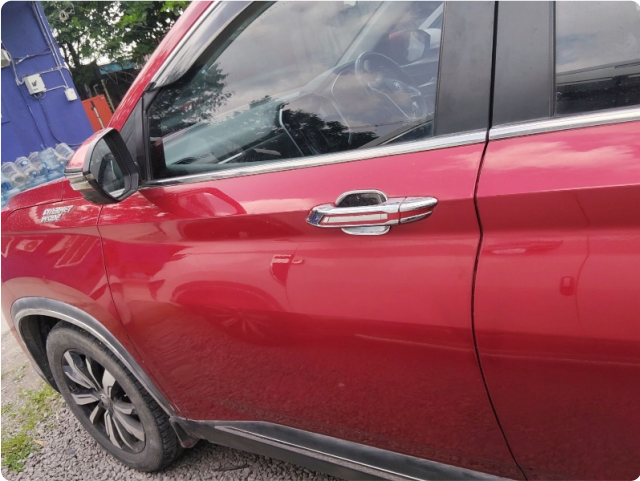
Front Door

Repaint

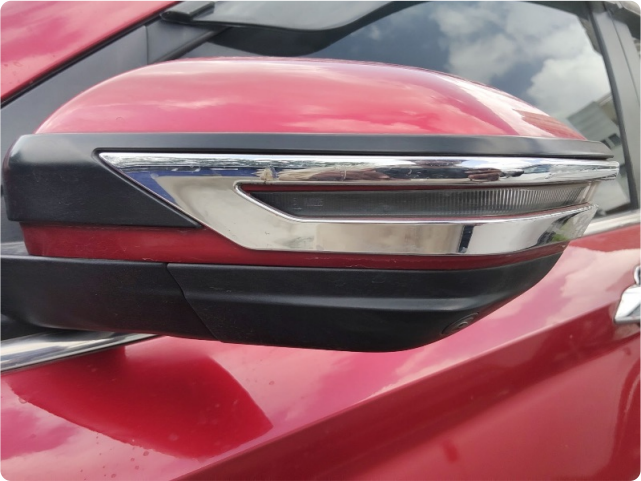
Orvm Mirror

Good

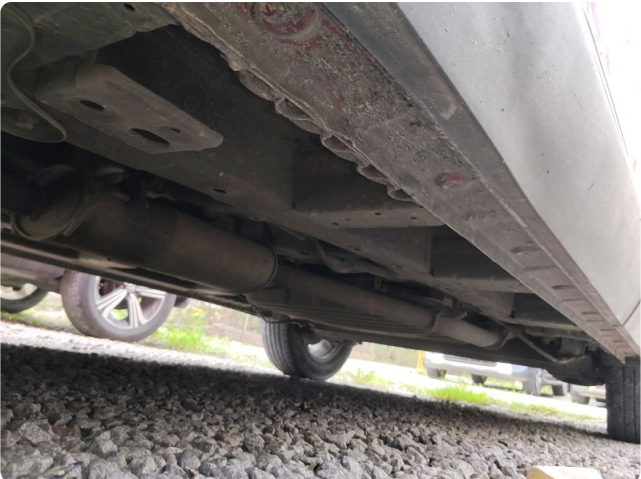
Running Board

Good

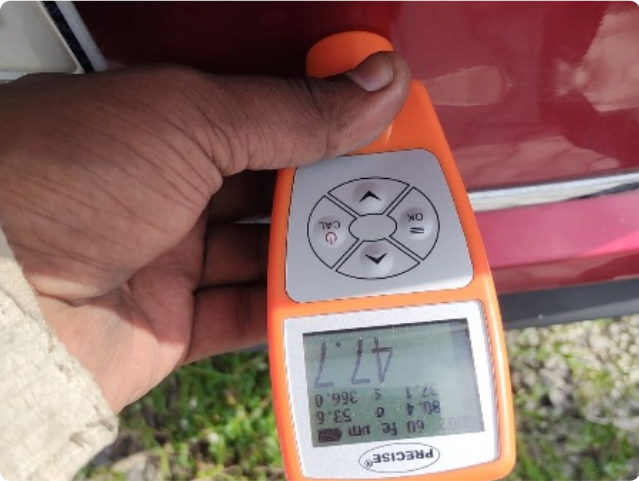
dicky door

Dicky Door

Scratches

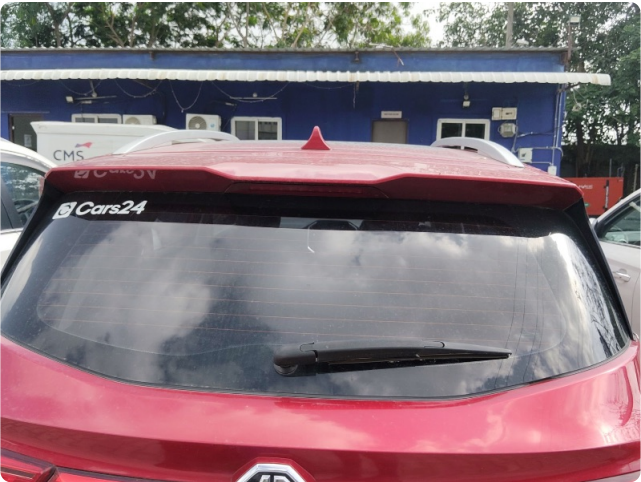
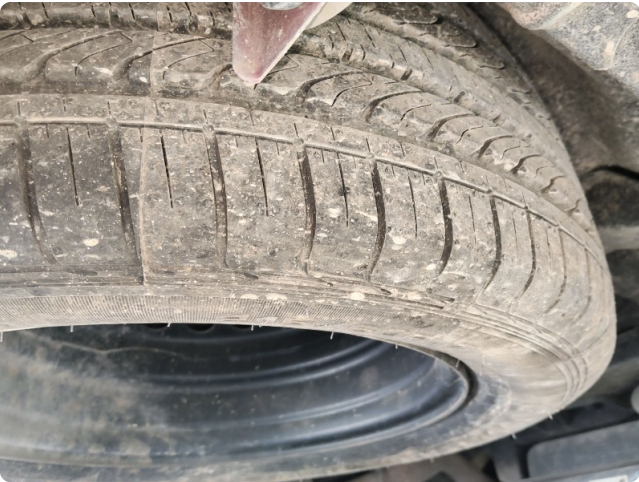
rear glass

Rear Glass

Good

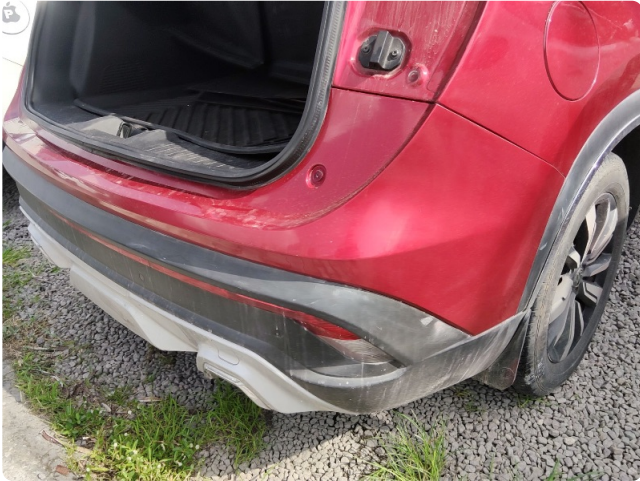
rear bumper

Rear Bumper

Repaint

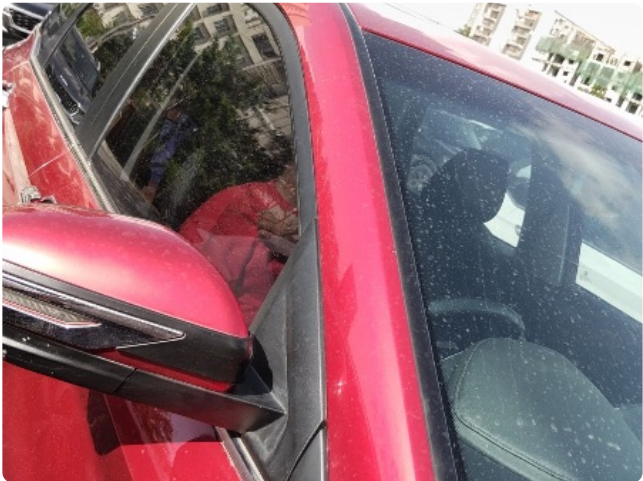
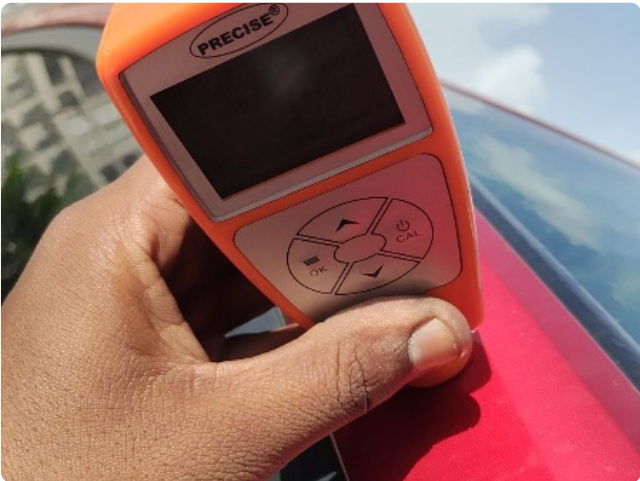
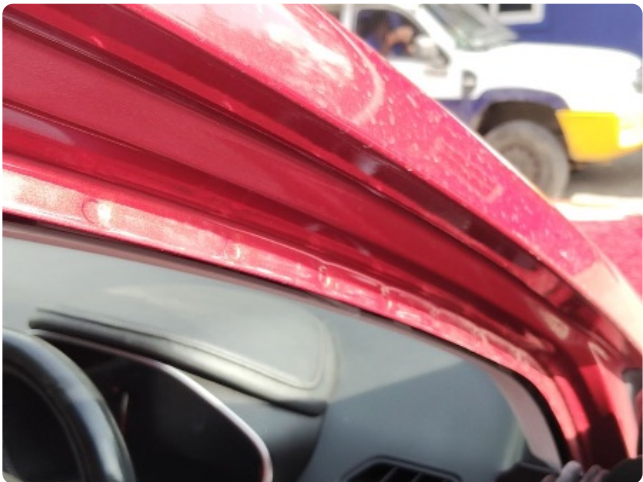
a pillar

A Pillar

Good

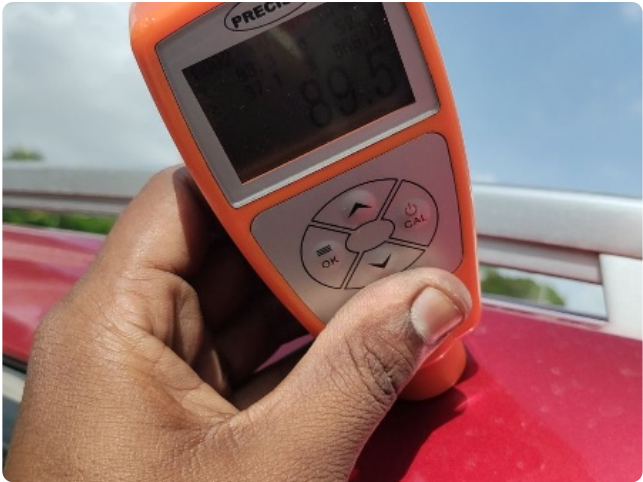
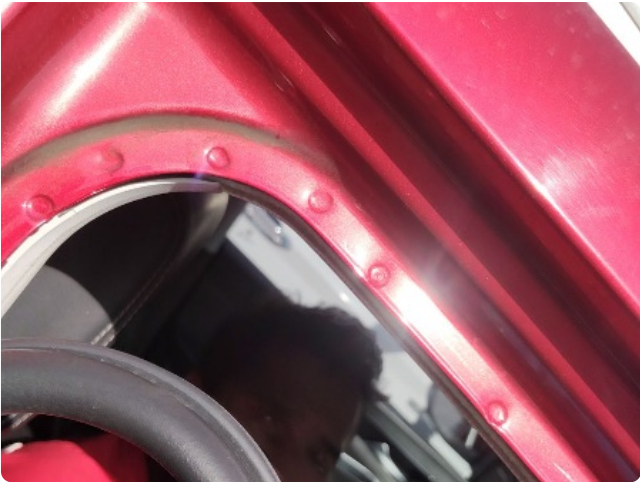
b pillar

B Pillar

Good

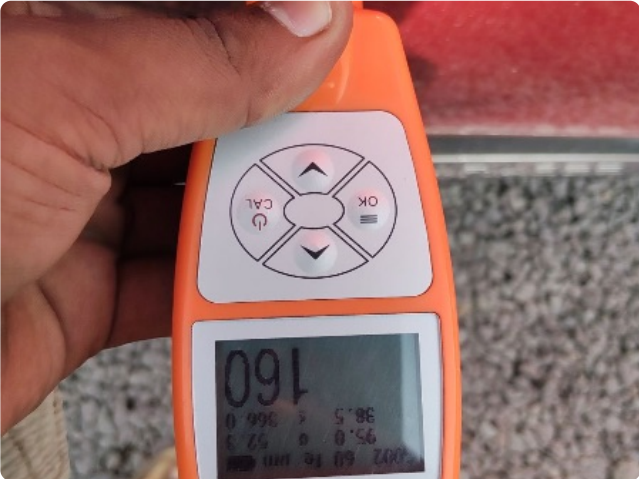
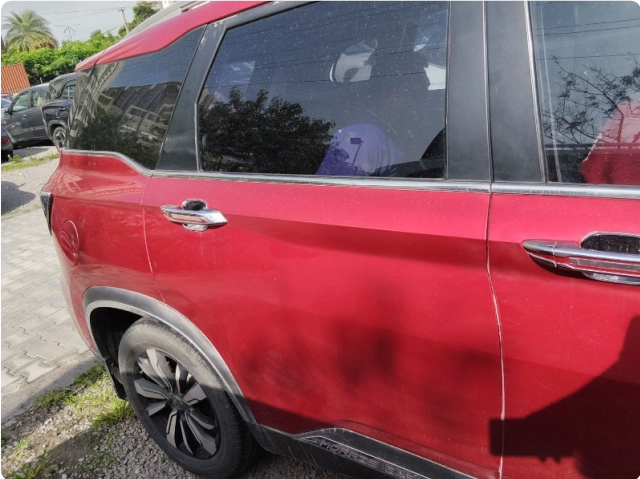
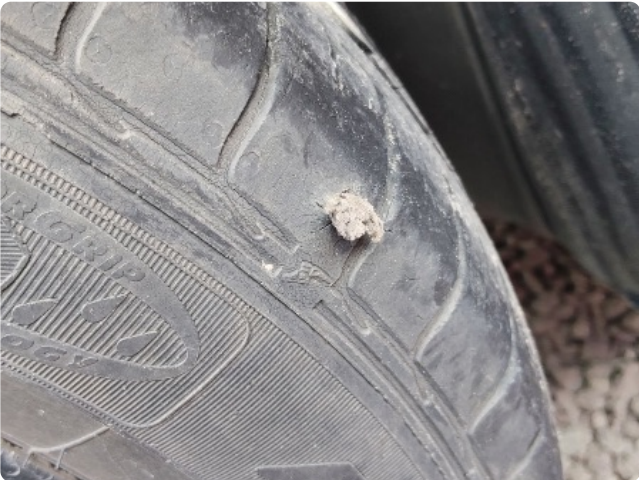
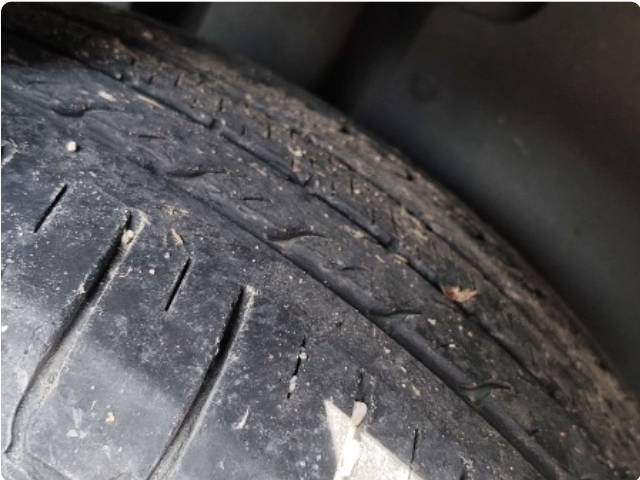
rear door

Rear Door

Repaint

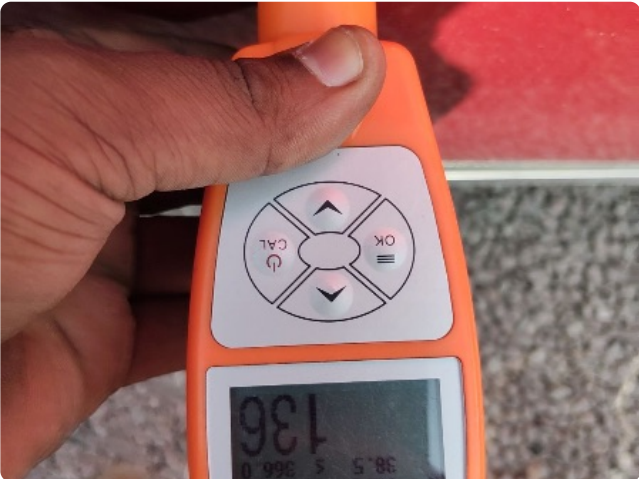
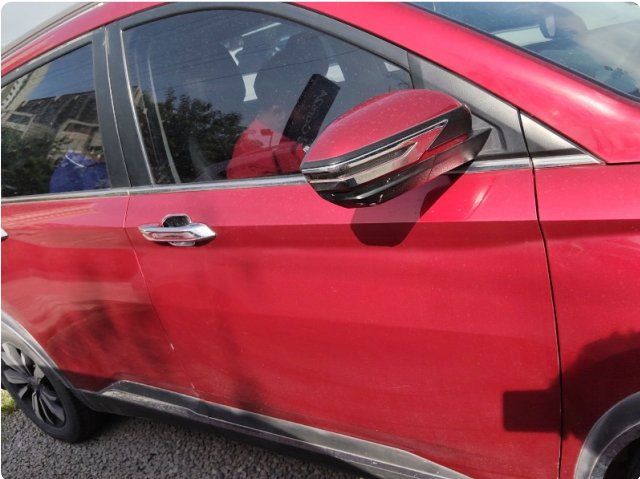
front door

Front Door

Repaint

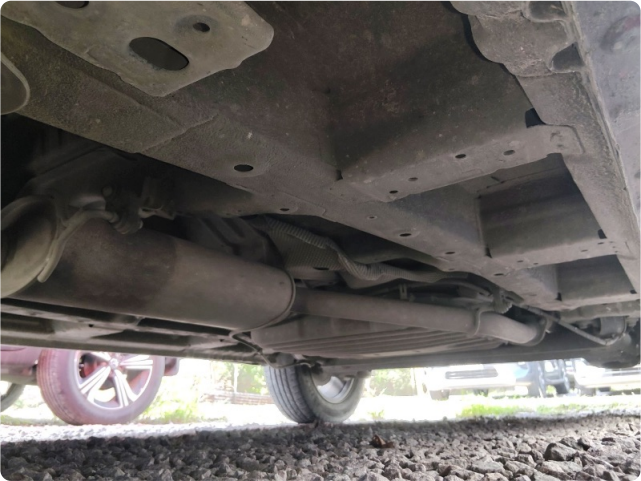
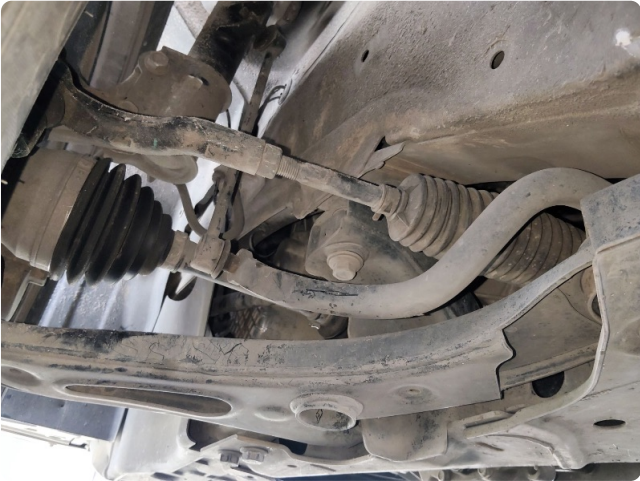
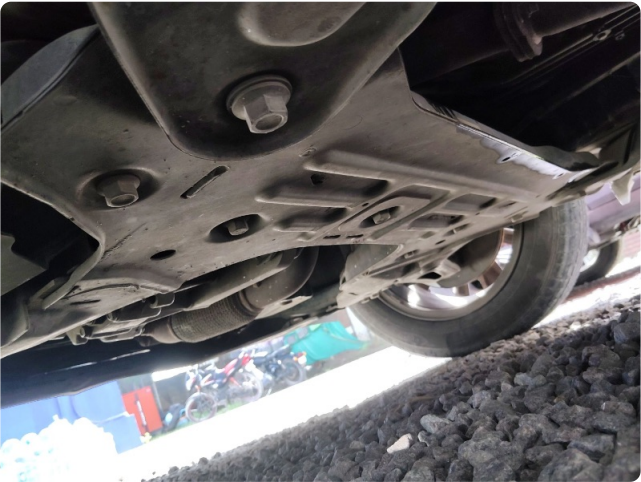
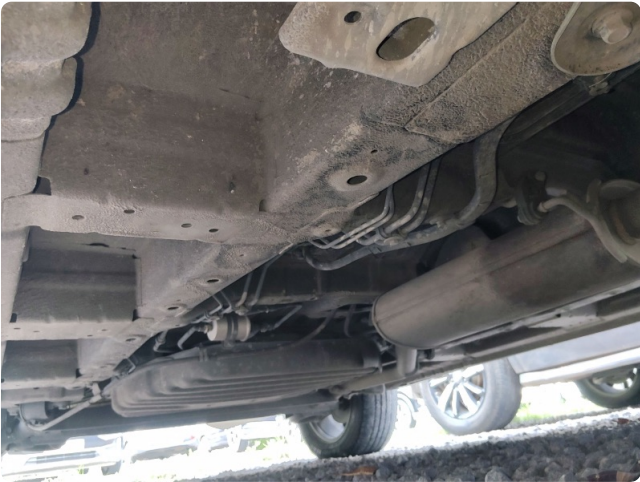
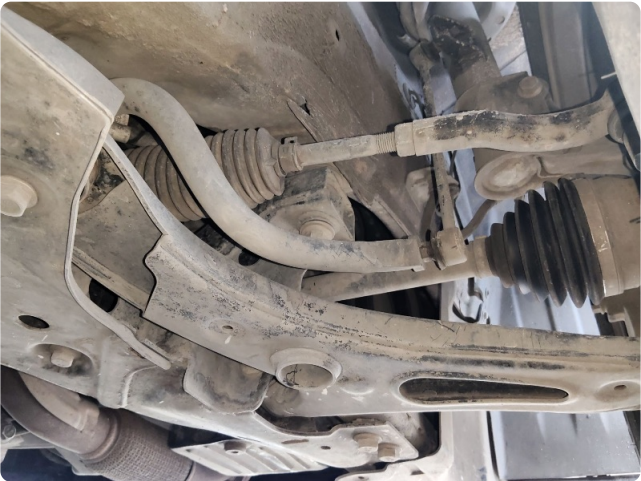
floor pan

Floor Pan

Good

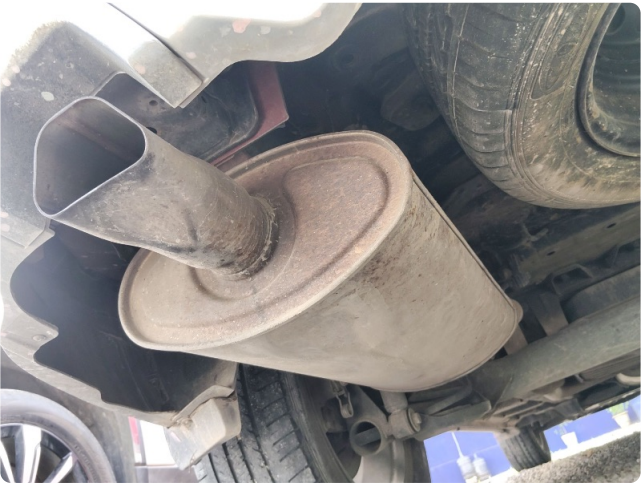
exhaust pipe

Exhaust Pipe

Good

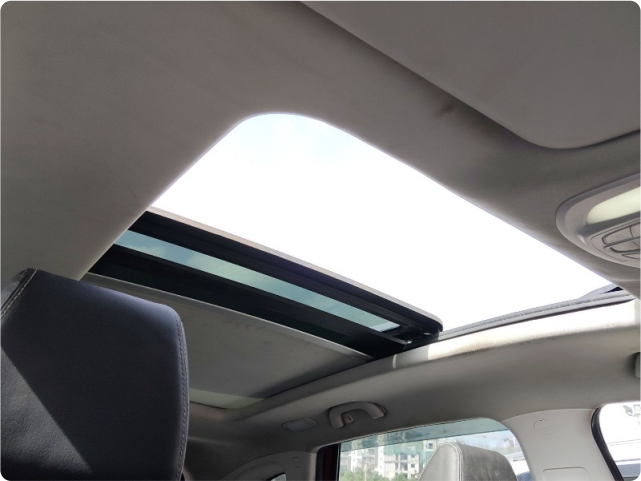
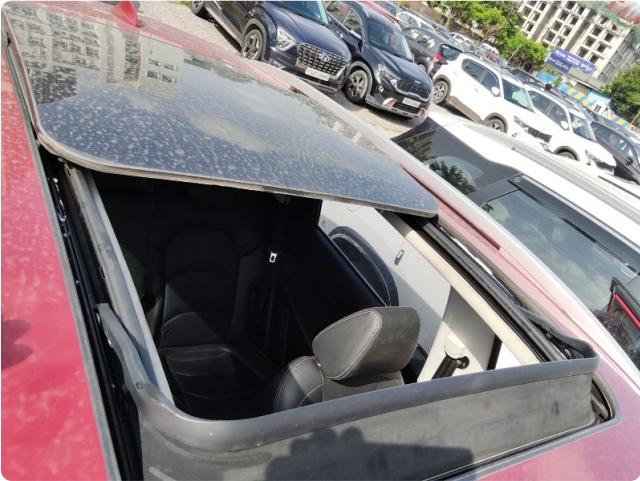
sun roof

Sun Roof

Good

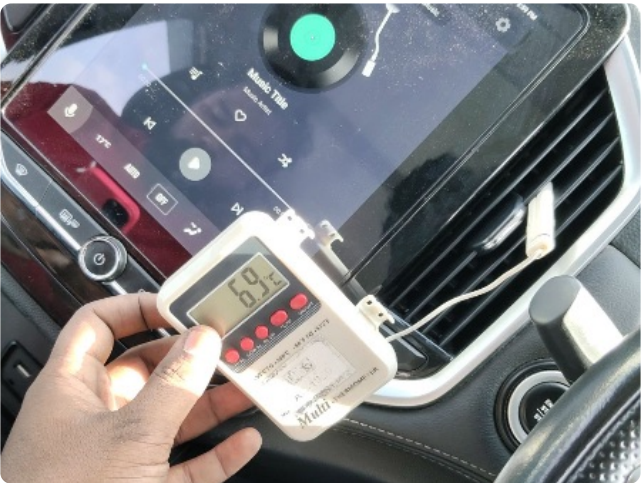
ac cooling

Ac Cooling

Excellent

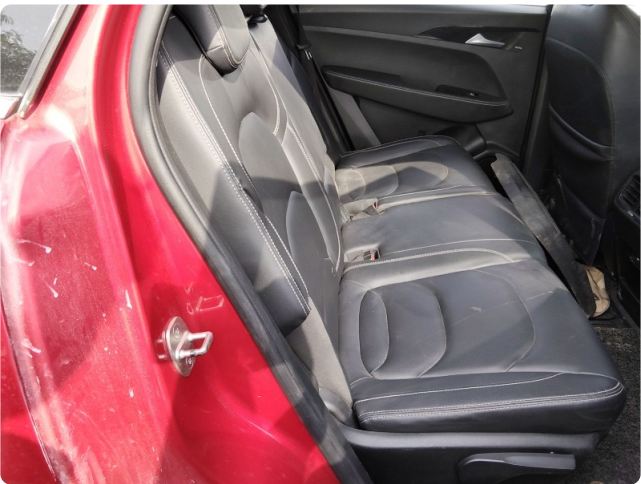
Rear Seats

Good

rear seats

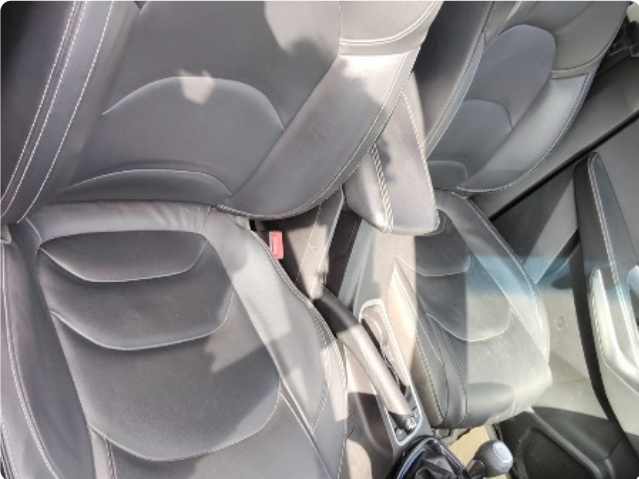
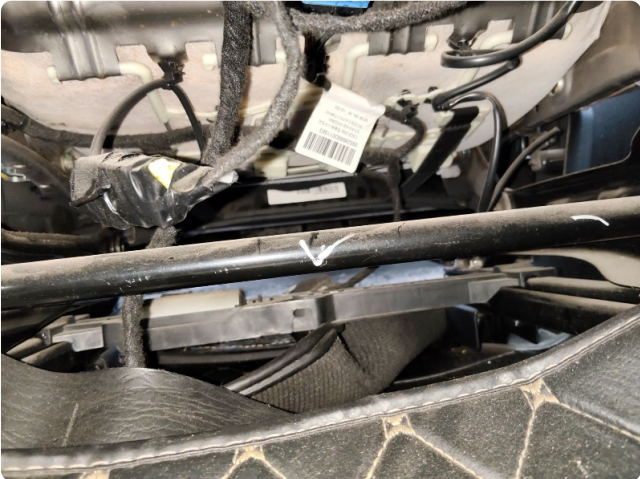
Driver Seat

Good

driver seat

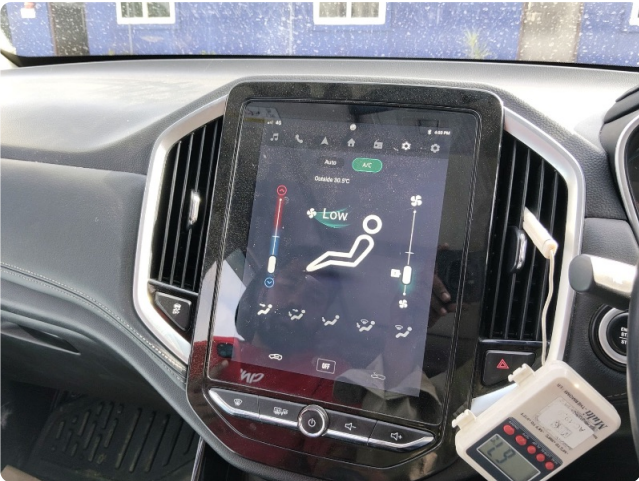
Infotainment

Working

infotainment

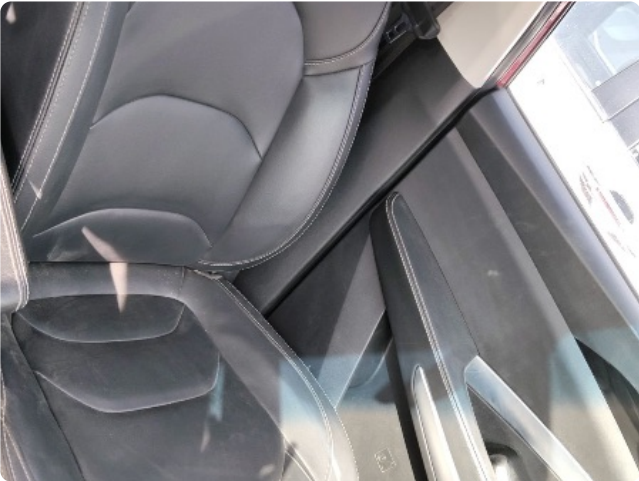
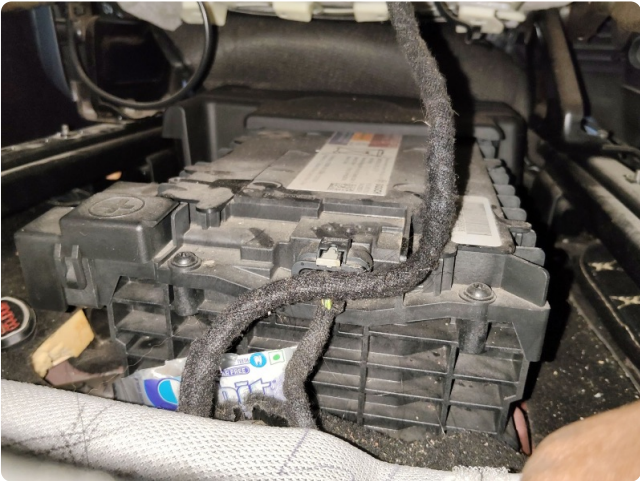
Passenger Seat

Good

passenger seat

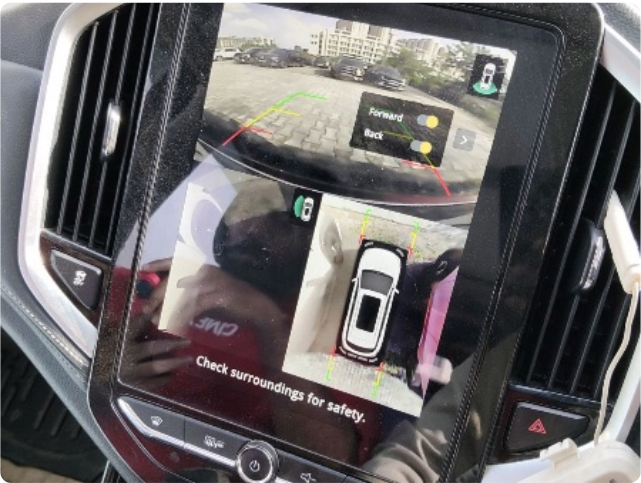
| Reverse Camera | Working | ● |

reverse camera

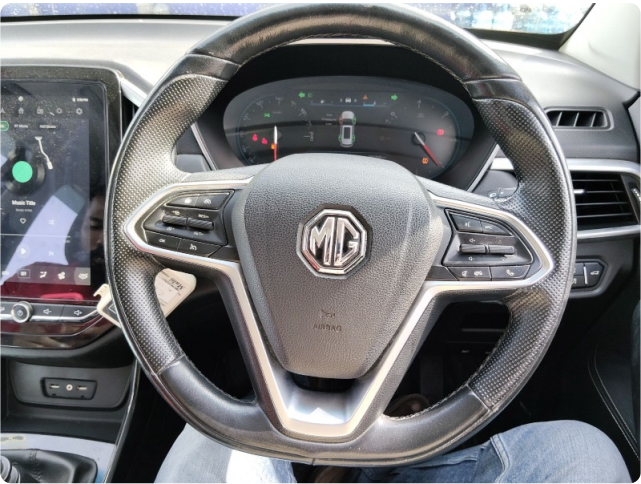
| Steering Wheel | Good | ● |

steering wheel

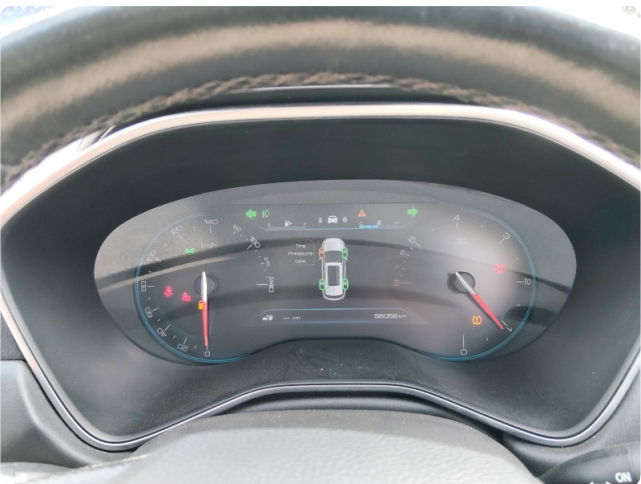
| Instrument Cluster | Working | ● |

instrument cluster

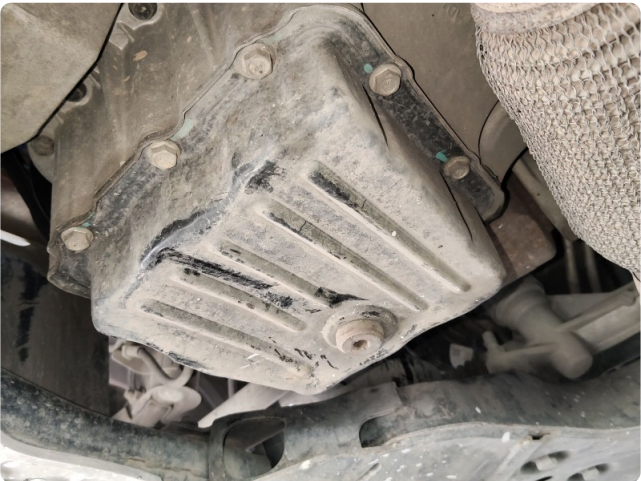
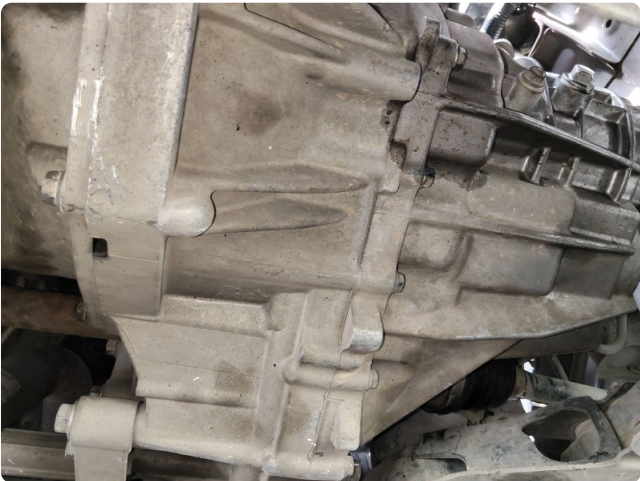
Sump

Good

sump

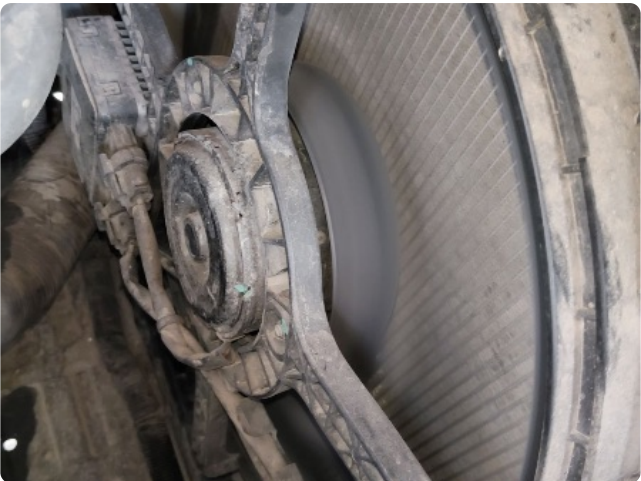
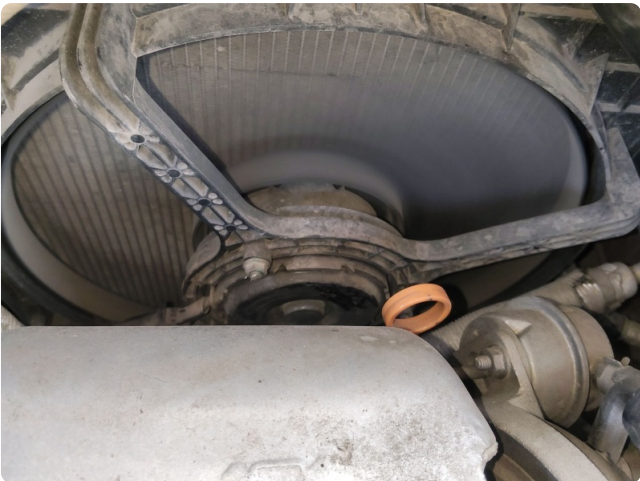
Radiator

Good

radiator

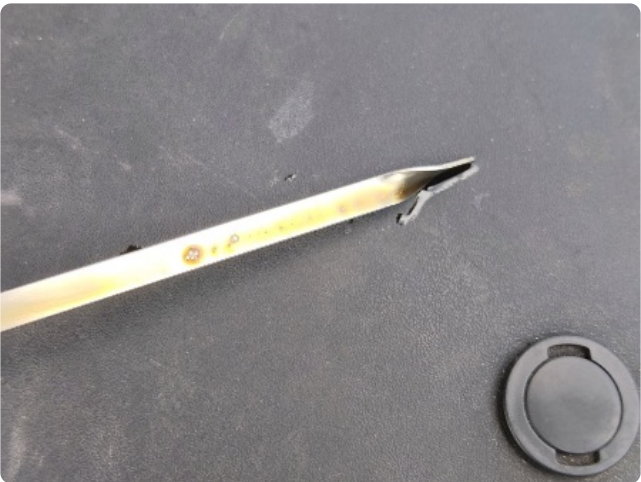
Engine Oil

Clean

engine oil

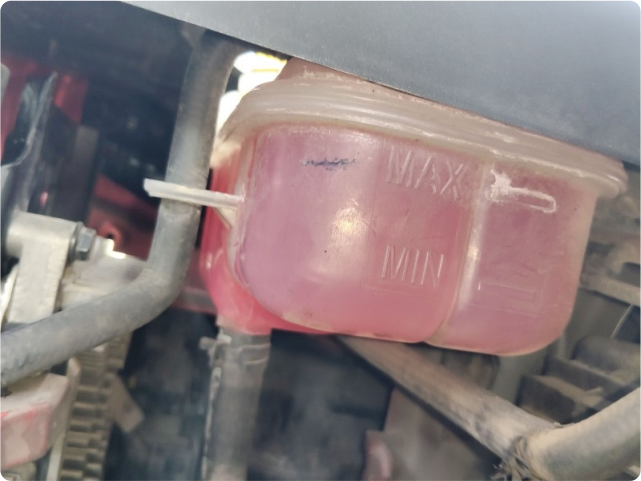
Coolant Level

Full

coolant level

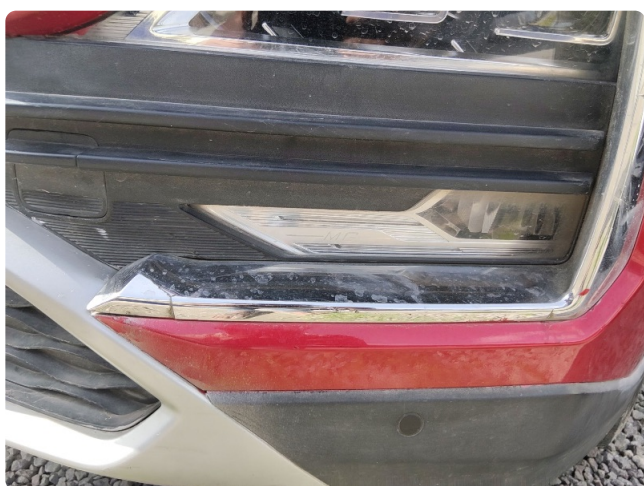
| Component | Condition | Status |
|---|---|---|
| Lh Fog Lamp | Good | ● |

lh fog lamp

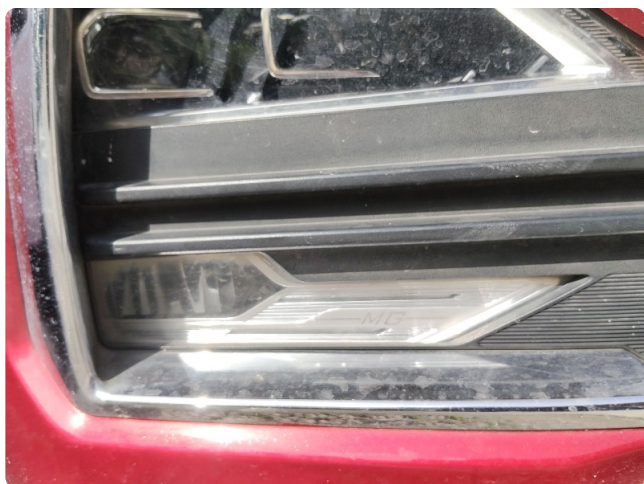
Rh Fog Lamp

Good

rh fog lamp

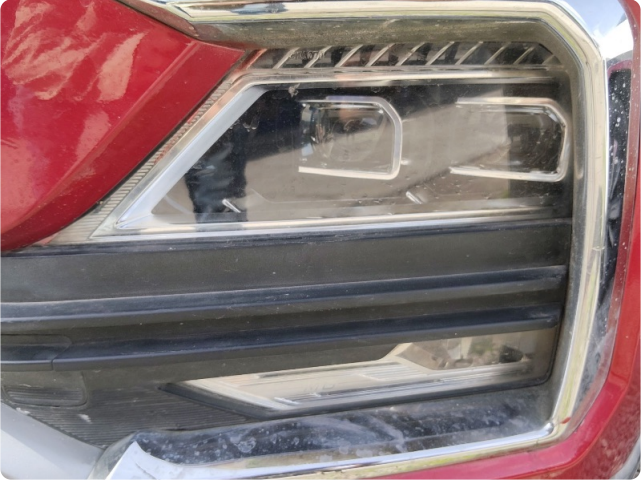
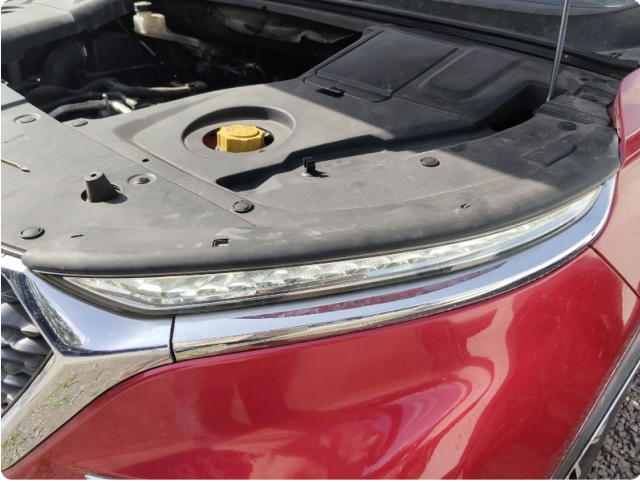
| Lh Head Light | Good | ● |
| <div><div></div><div></div></div> <div>lh head light</div> <div>lh head light</div> | | |

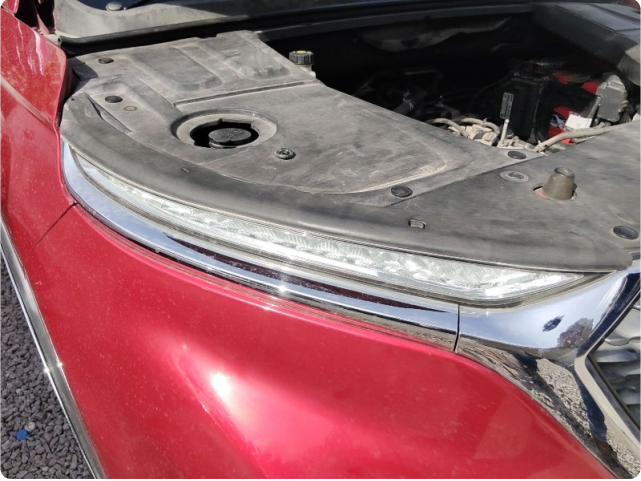
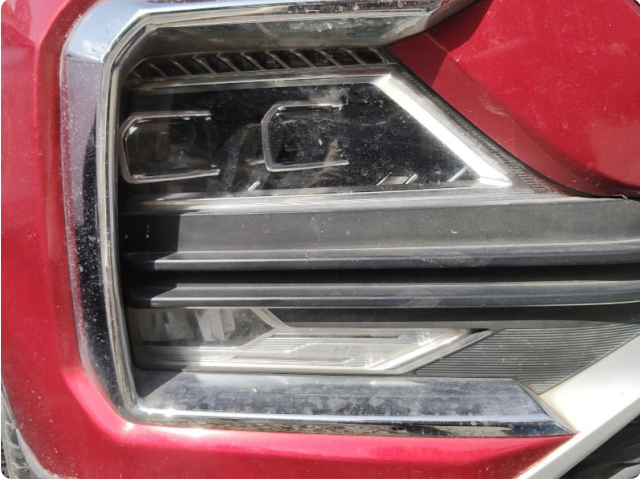
| Rh Head Light | Good | ● |
| <div><div></div><div></div></div> <div>rh head light</div> <div>rh head light</div> | | |
